# Project Report

Project number: 14-00192

## Overview

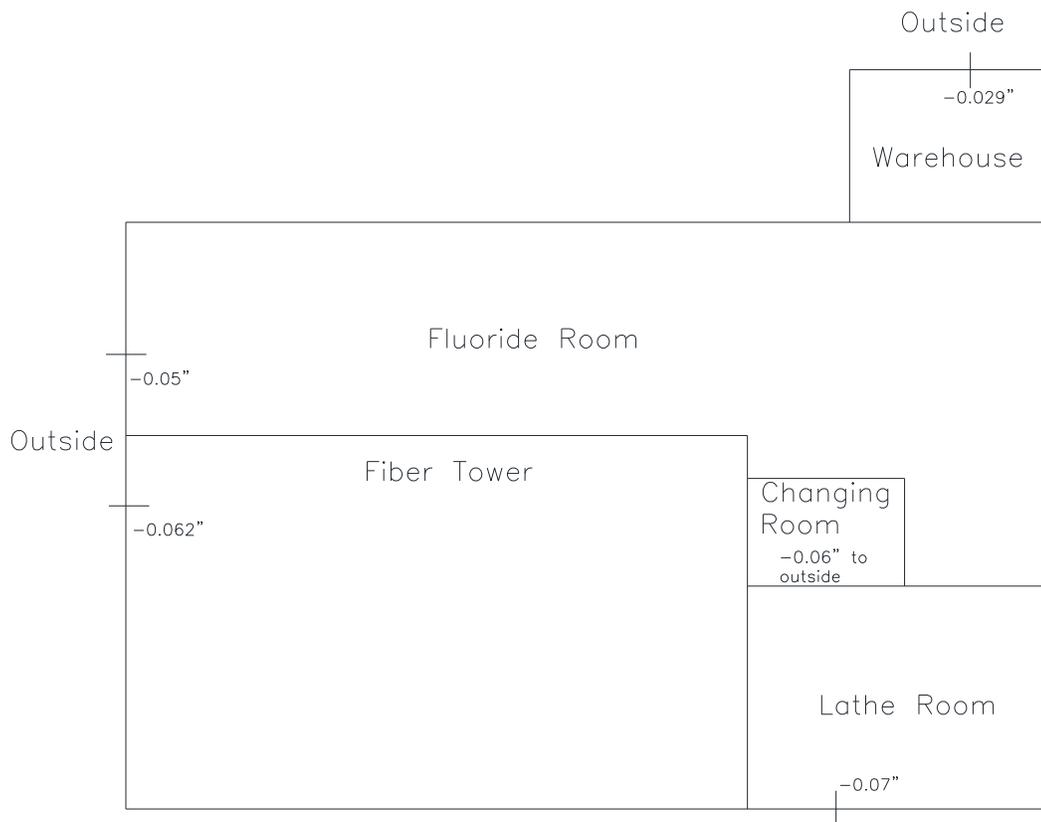
- b. Approximately 4,790 CFM of outdoor air (or air from an indoor source external to the space) is required to pressurize the space as it is currently constructed in addition to the 5,210 CFM required to offset the existing mechanical exhaust.
- 13. The space will not be able to maintain the specified temperature and humidity conditions with the Innovent unit operating with 100% outside air.
- 14. The illustration below shows the pressure differentials measured during our testing during the normal “as found” system operation with the zero reference being outdoors. All readings are in inches of water column (“wc).
