# Middle School

Summary Update of Diagnostic Work  
Performed Over a 3-Week Period

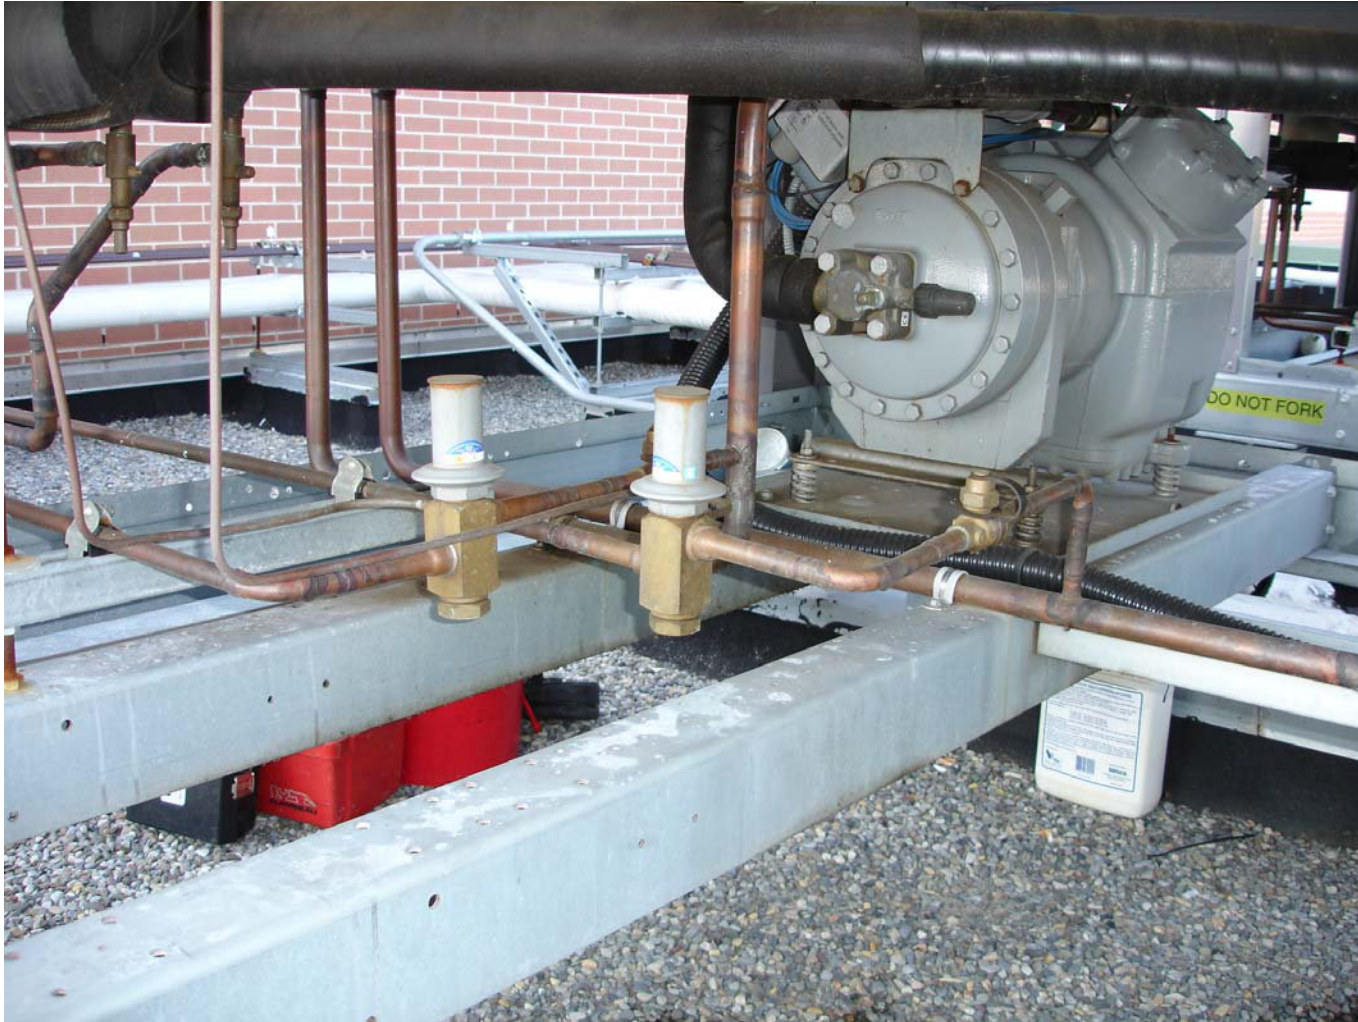
## Photo #1408

- Missing hot gas bypass solenoid valve and wiring upstream of hot gas valve. See photo #1408.
- Compressor #1 unloader incorrectly set causing compressor to operate mostly unloaded.

Hot gas bypass valves. Note missing solenoid valves.

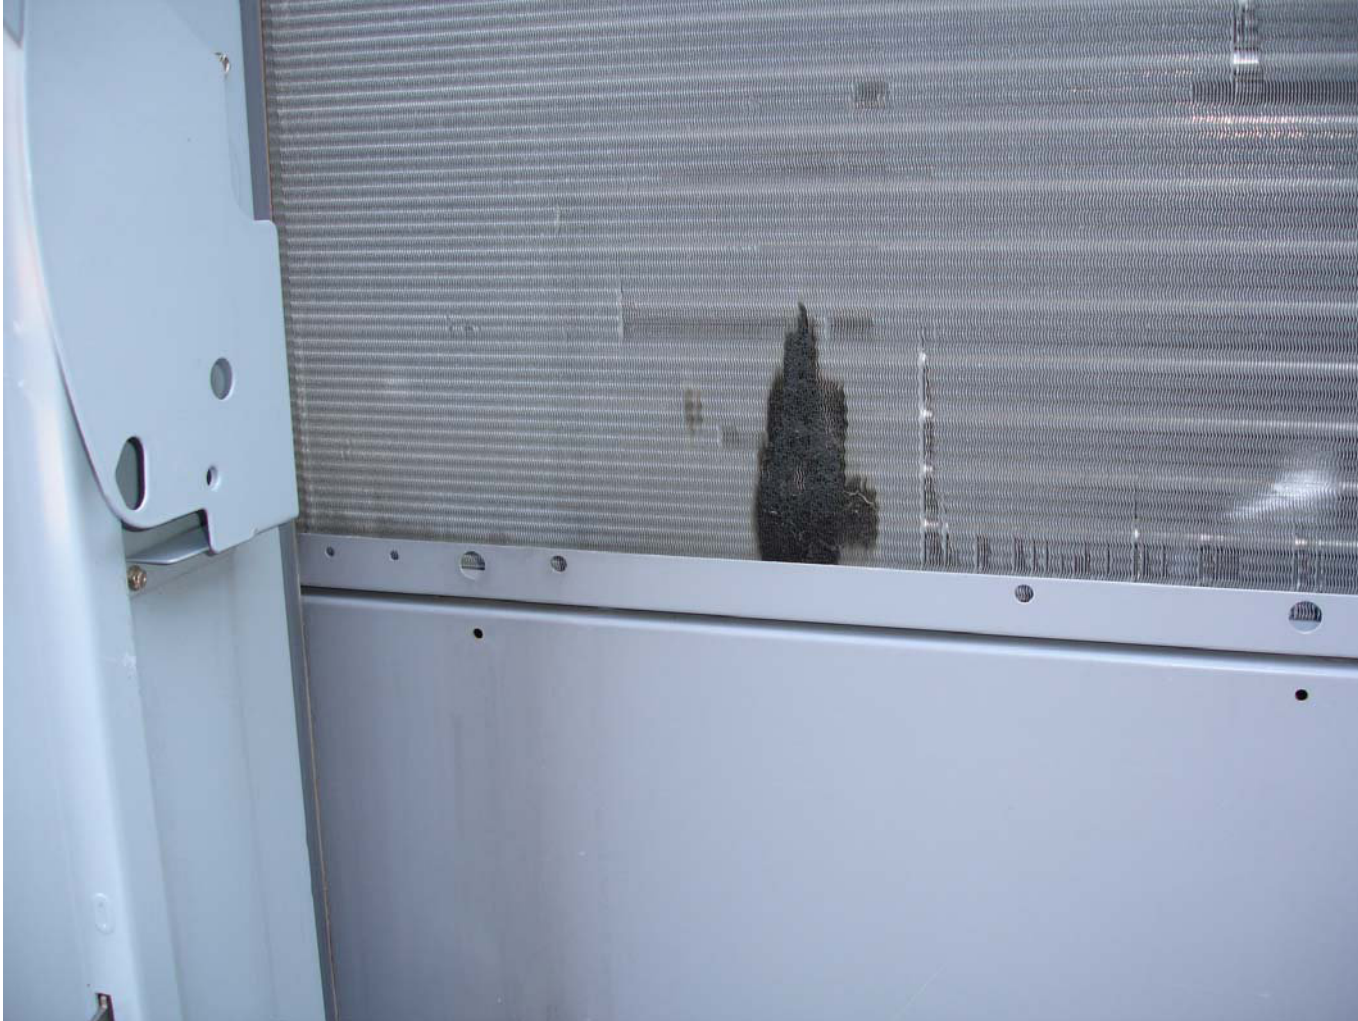
## Condenser coil photo #1402

- Condenser coil is matted. See photos #1405, 1406, 1429.
- Oily matted residue on a few spots on the condenser coil which could indicate a refrigerant leak at these locations. Possible oil stain on roof. See photo's #1402, 1403, 1407.

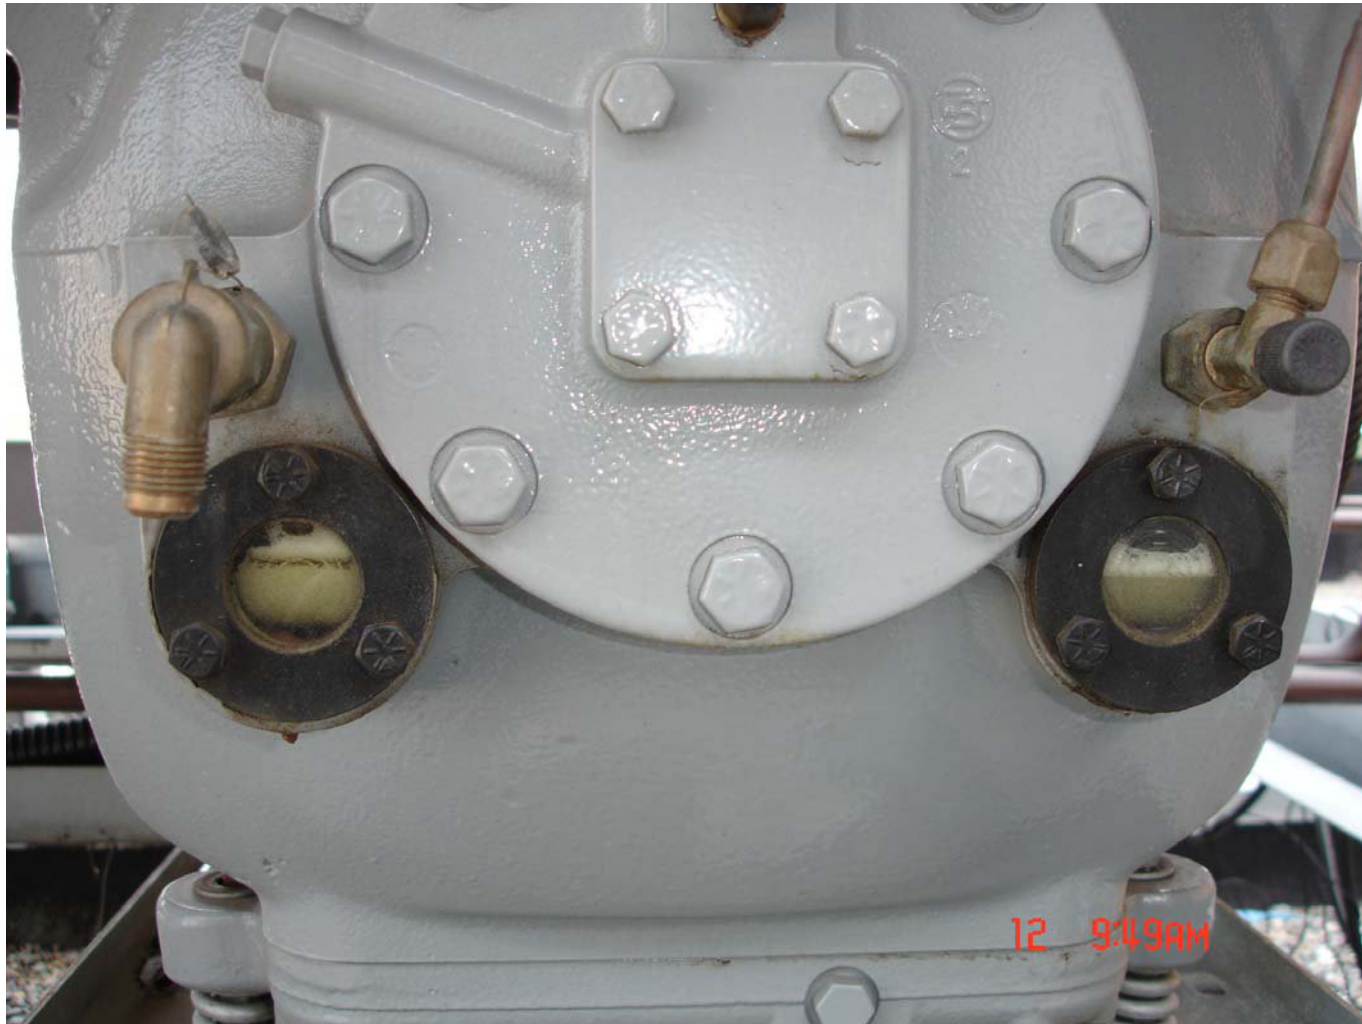
Compressor oil level photo #1434.

- Oil level in both compressors is higher than recommended by Carlyle (should be 1/8-3/8 gin the sight glass). See photo #1434.
- Net oil pressure on compressor #1 and #2 was 30 psig and 36 psig respectively (within the normal range).

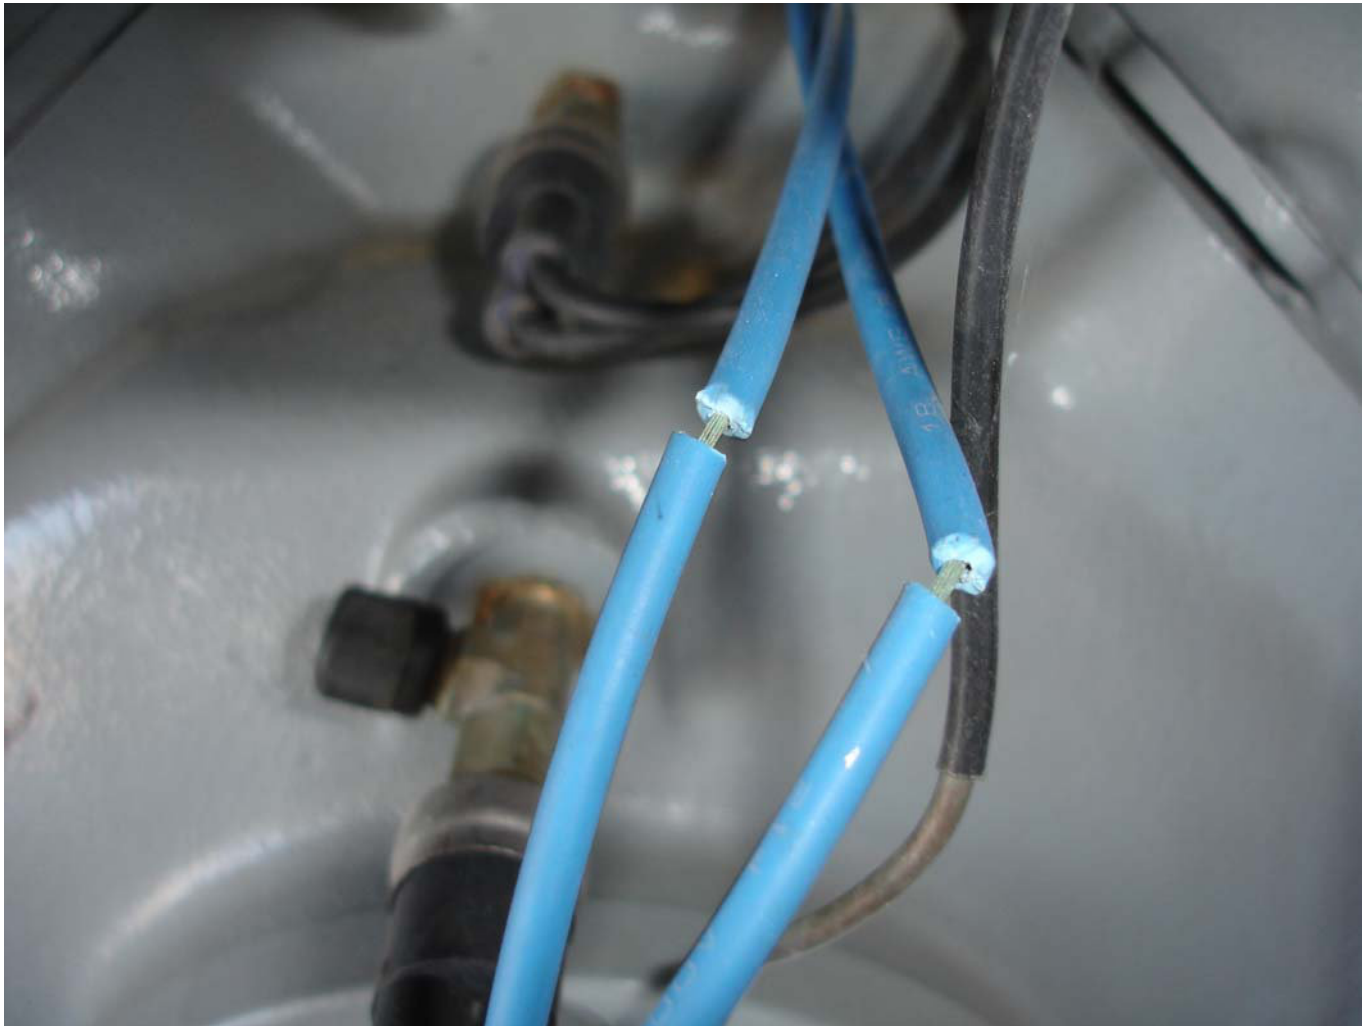
Compressor low pressure switch photo #1410.

- Both refrigerant sight glasses were clear when both stages were running.
- Low pressure switches on both compressors have insulation stripped to expose a small section of wire. See photo's #1410 and 1411.

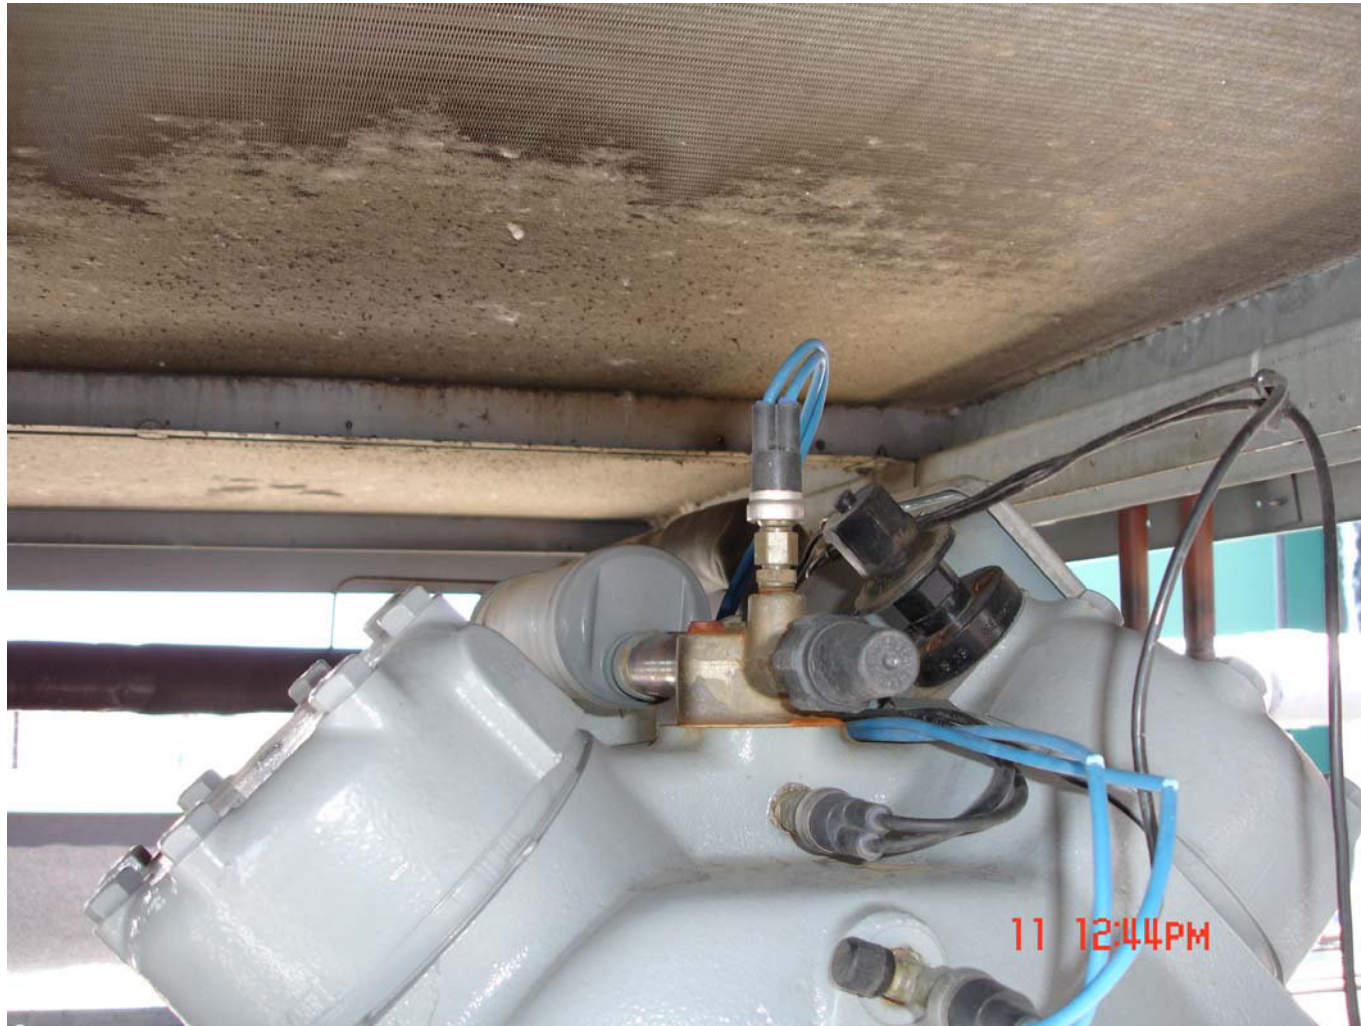
- The condenser fan pressure control is connected to the backseat port of the discharge service valve (factory). See photo #1429.

# Condenser fan cycling pressure switch photo #1429 (factory).

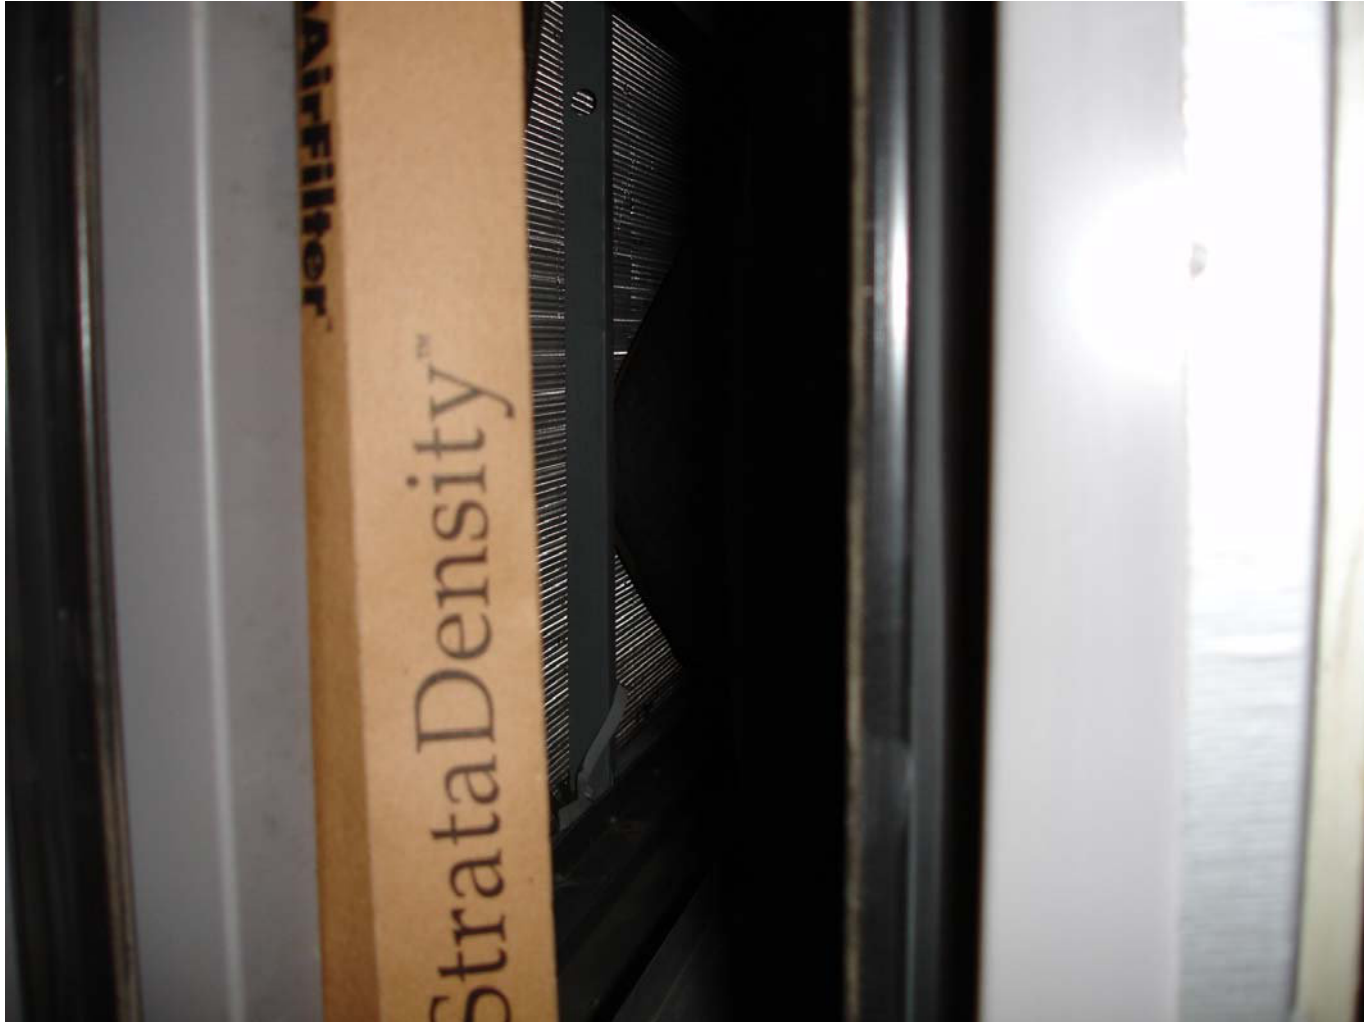
Air filter photo #1414.

- Air filters plugged, incorrect depth, and dislodged from rack. See photo's #1414-1416.
- Insulation missing on #2 suction line. See photo #1423.
- Penetrations for refrigerant piping not sealed and in some cases the piping is in direct contact with the sheet metal casing which will result in a future leaks. See photo's #1425, 1426, 1483, 1484.

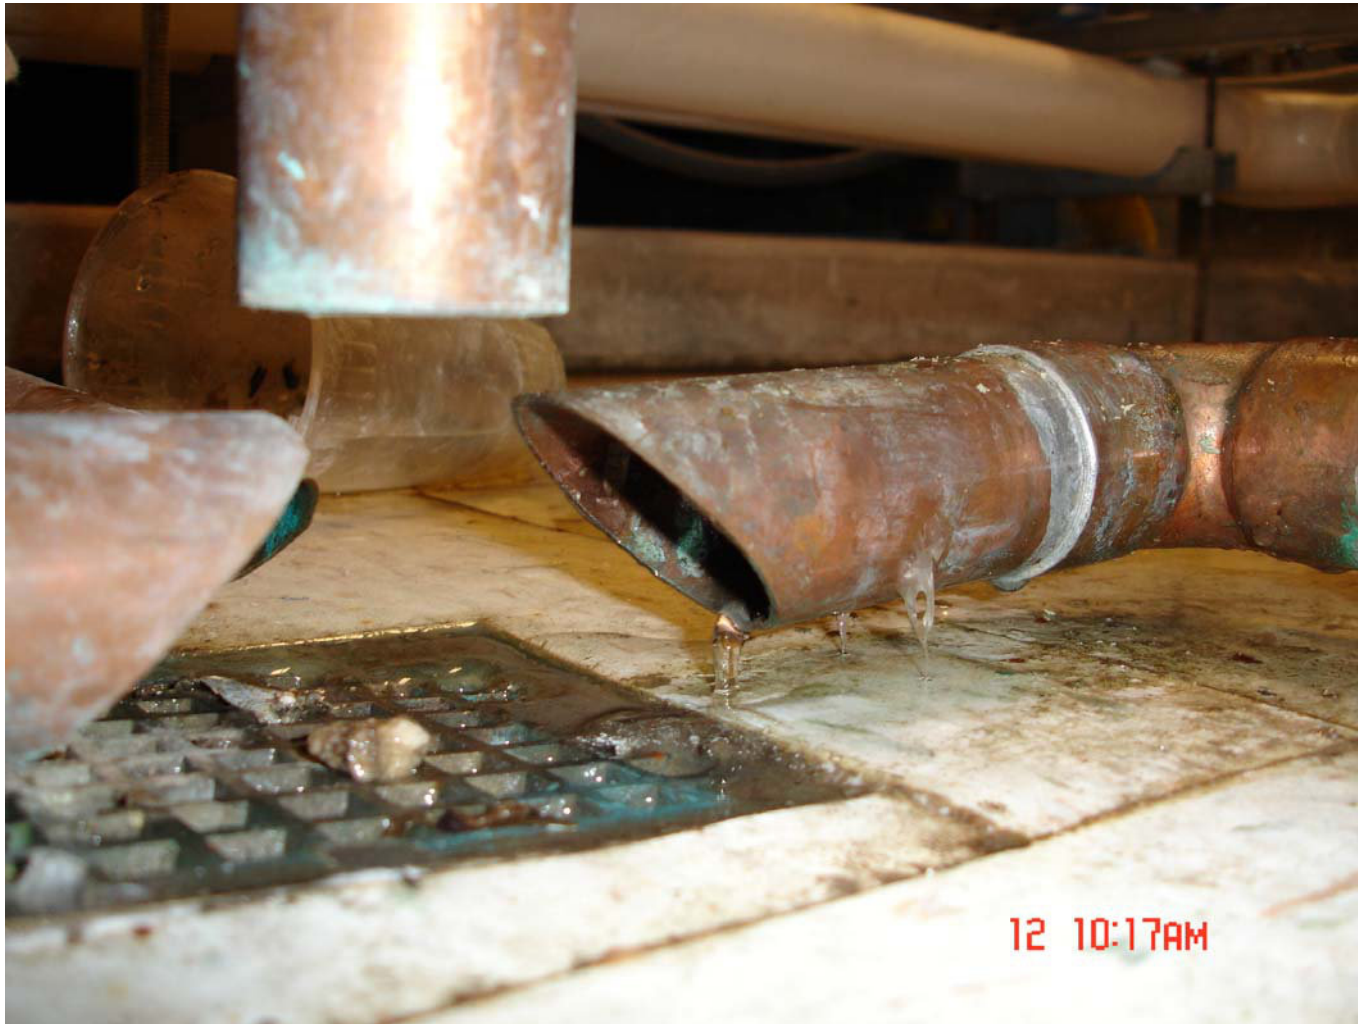
Condensate drain piping photo #1439.

- Refrigerant piping making metal to metal contact at casing penetration in some cases.
- Condensate drain piping drains short of the floor drain. See photo's #1439 and 1440.

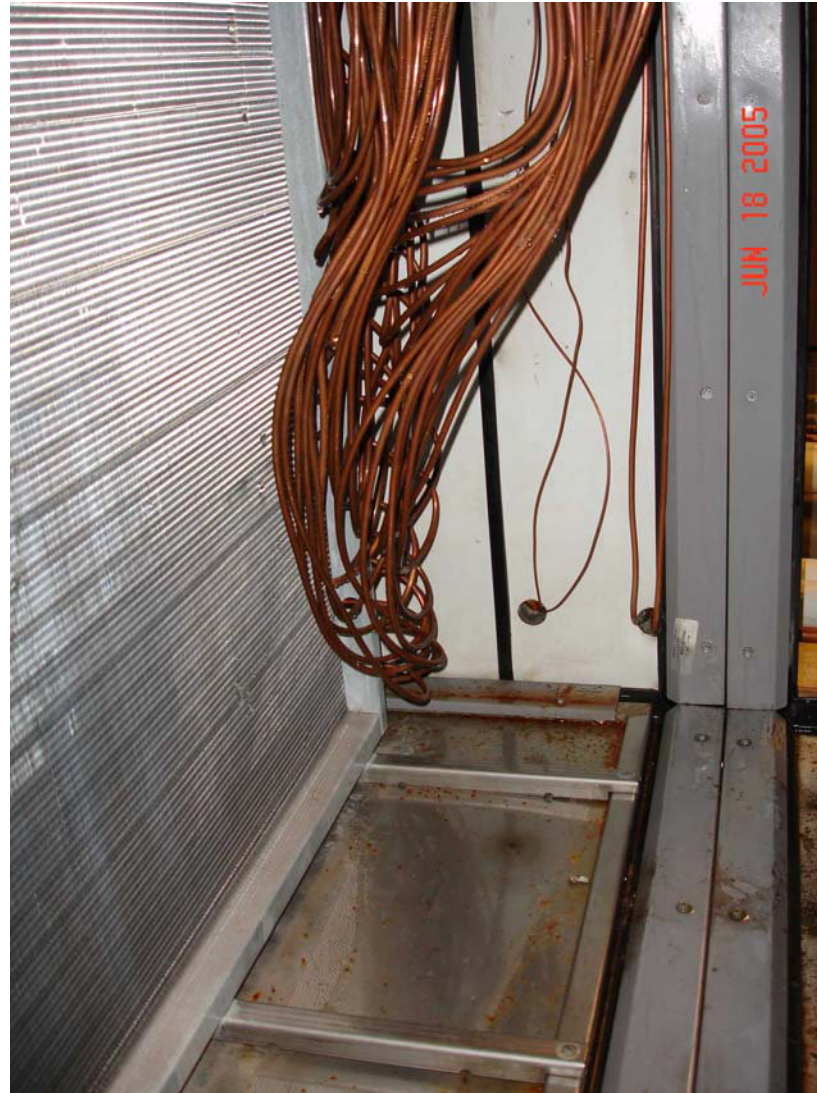
- Possible condensate carry-over from the cooling coil into the fan section. See photo's #1484, 1485, 1486.
- Condensate forming on the exterior of the duct work at the air handler and also in the boiler room (high dew point in the spaces). See photo's #1458, 1463, 1464.

Possible condensate carry-over photo #1484.

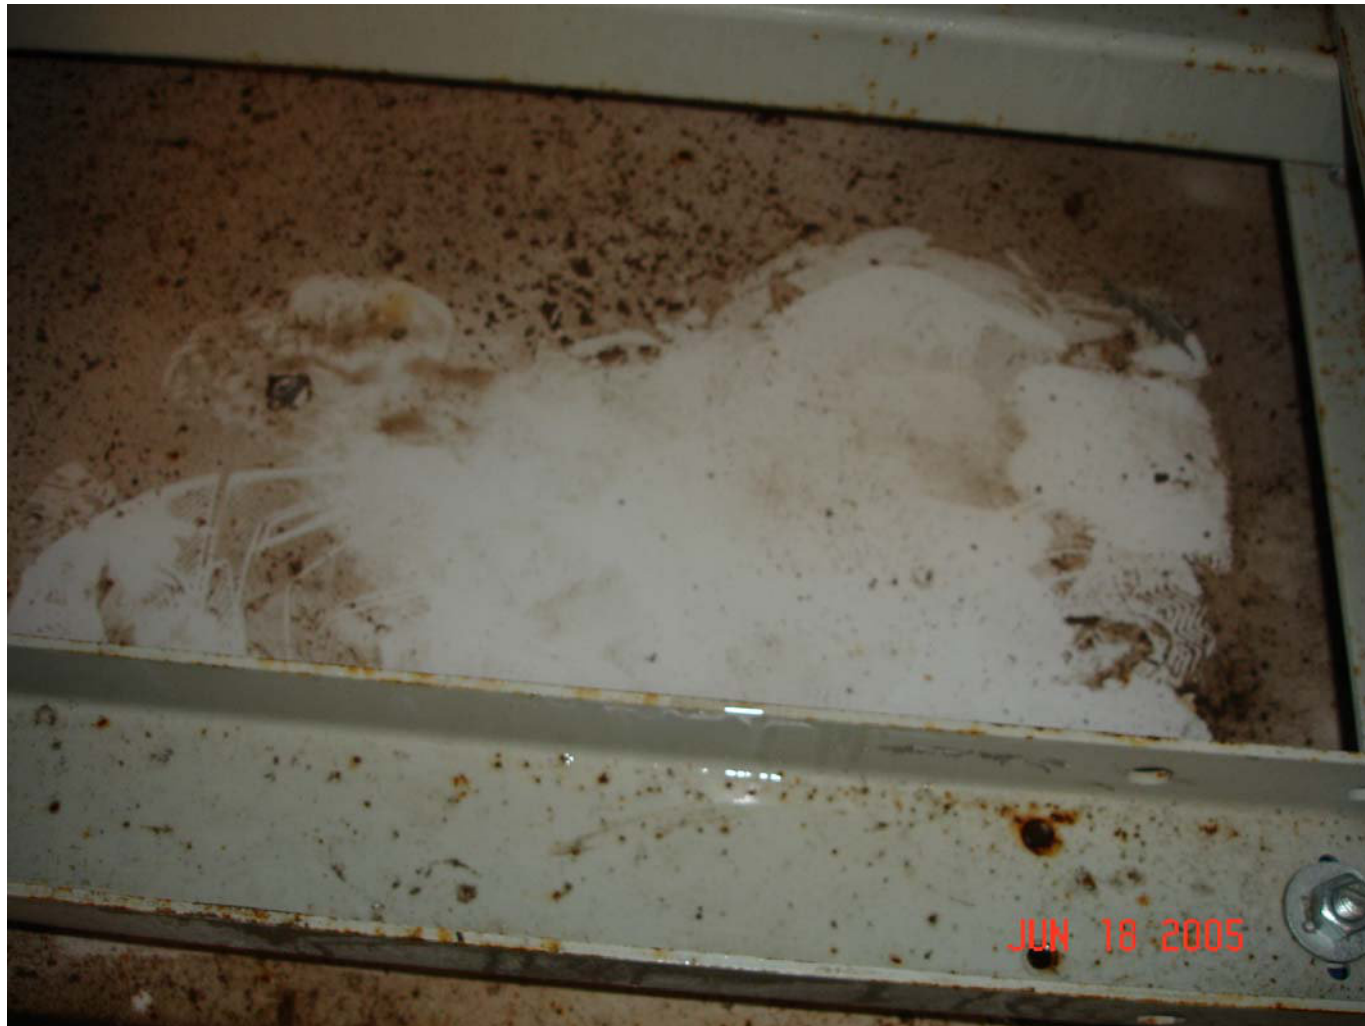
Possible condensate carry-over photo #1485.

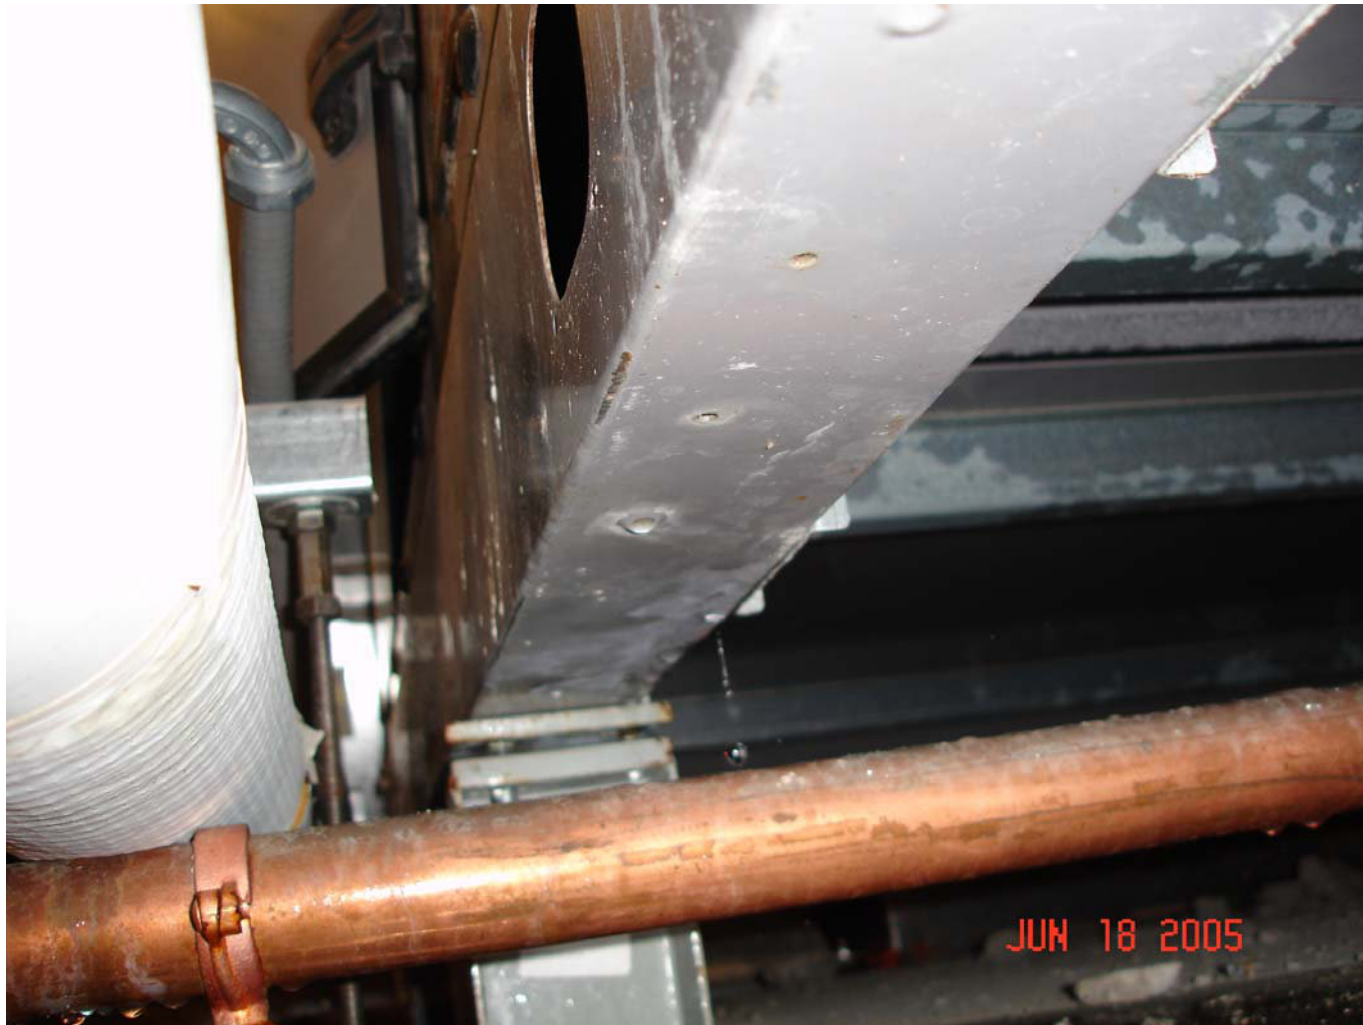
Possible condensate carry-over photo #1486.

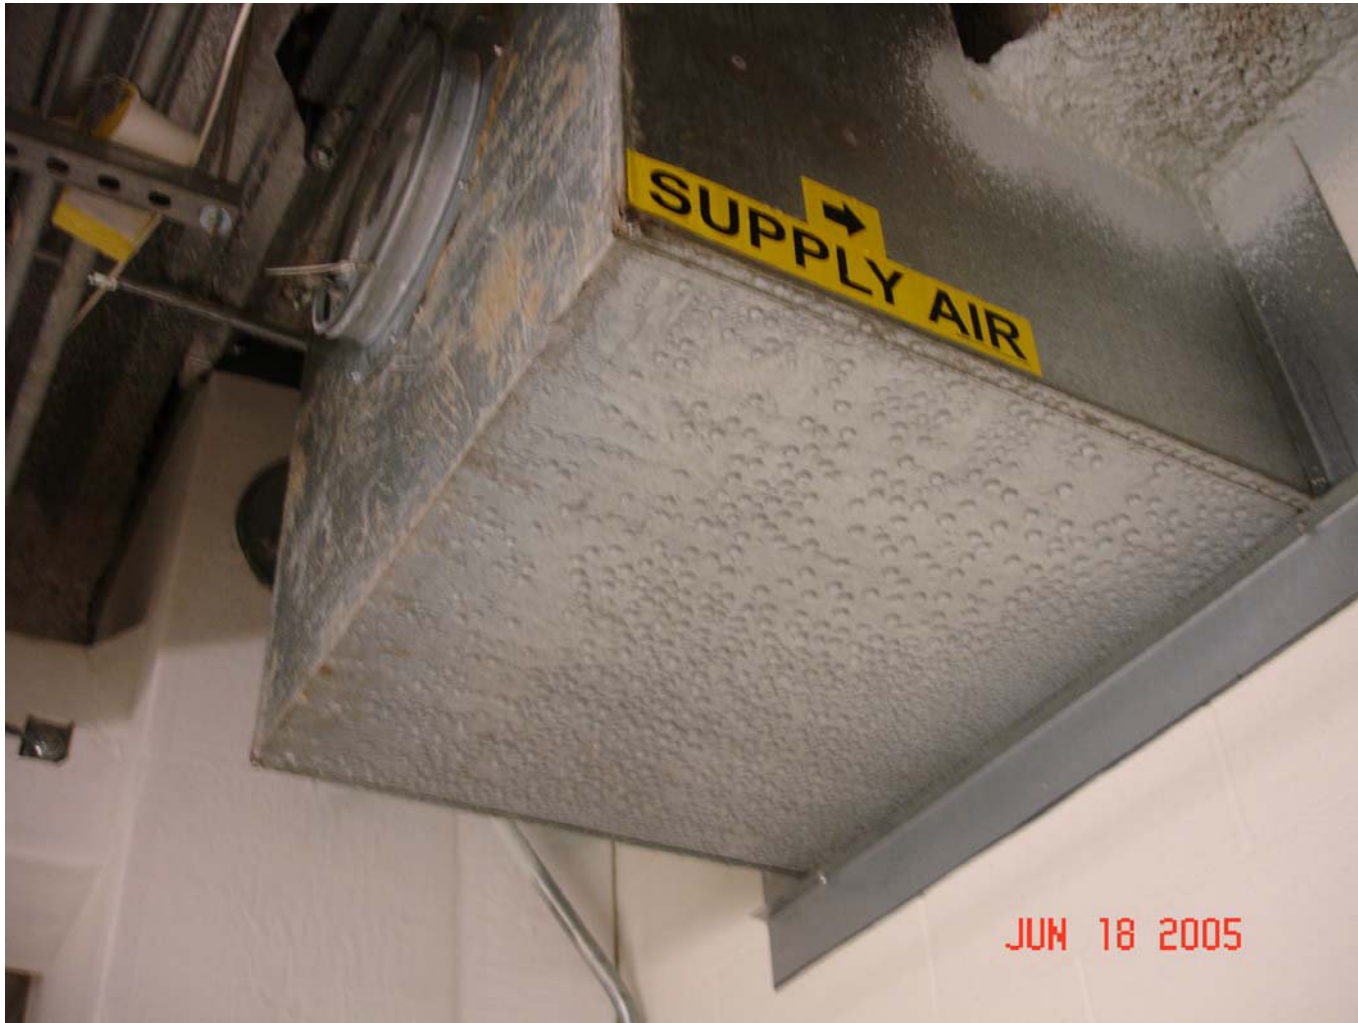
Condensate on exterior of duct photo #1458.

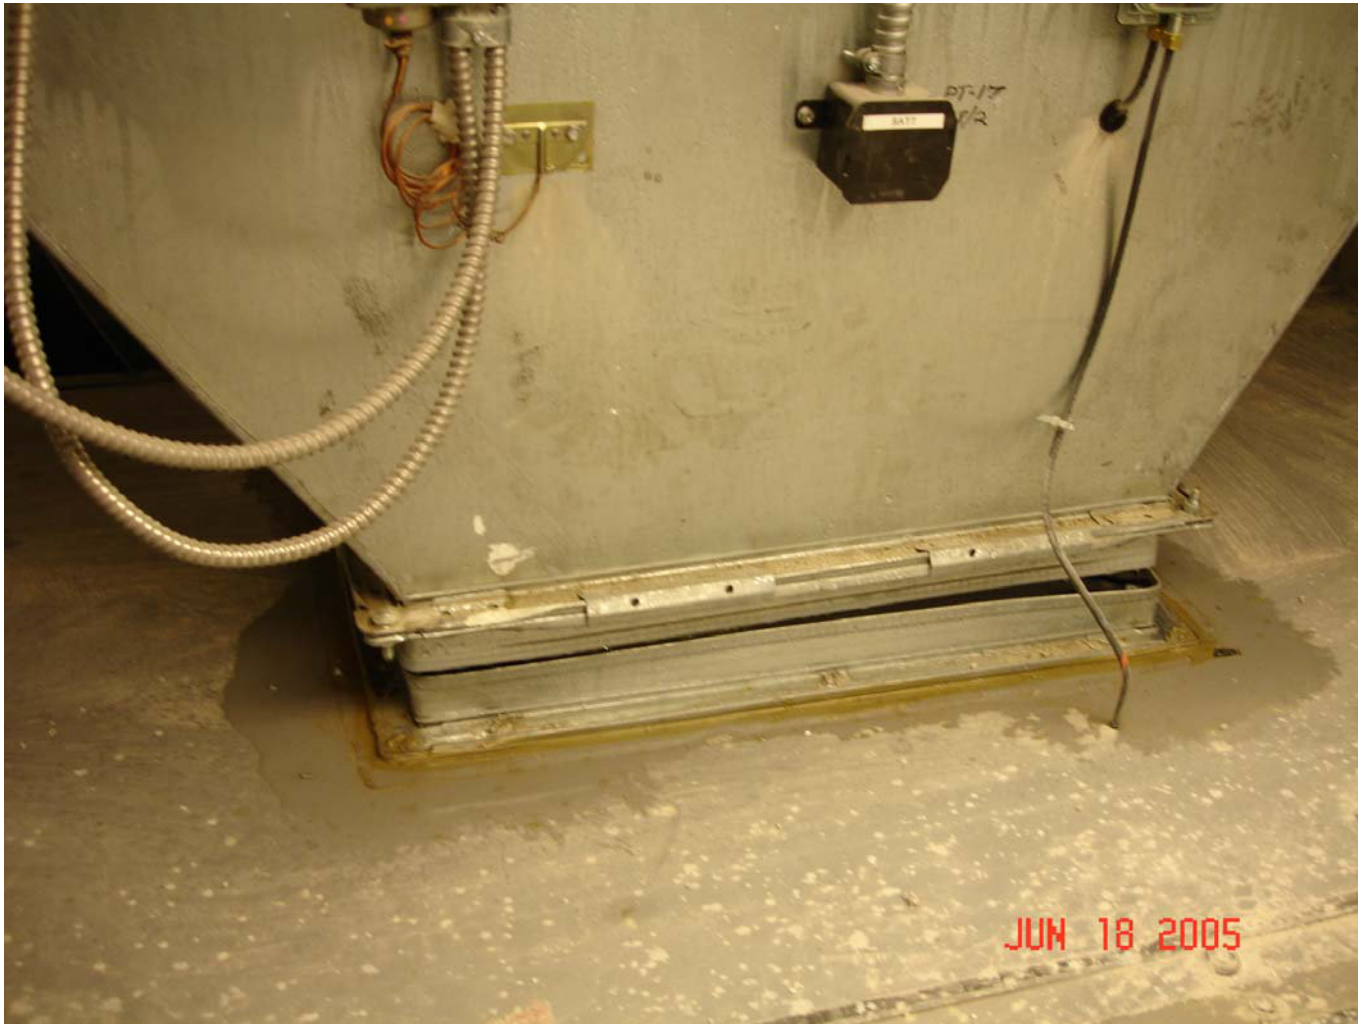
Condensate on exterior duct photo #1463.

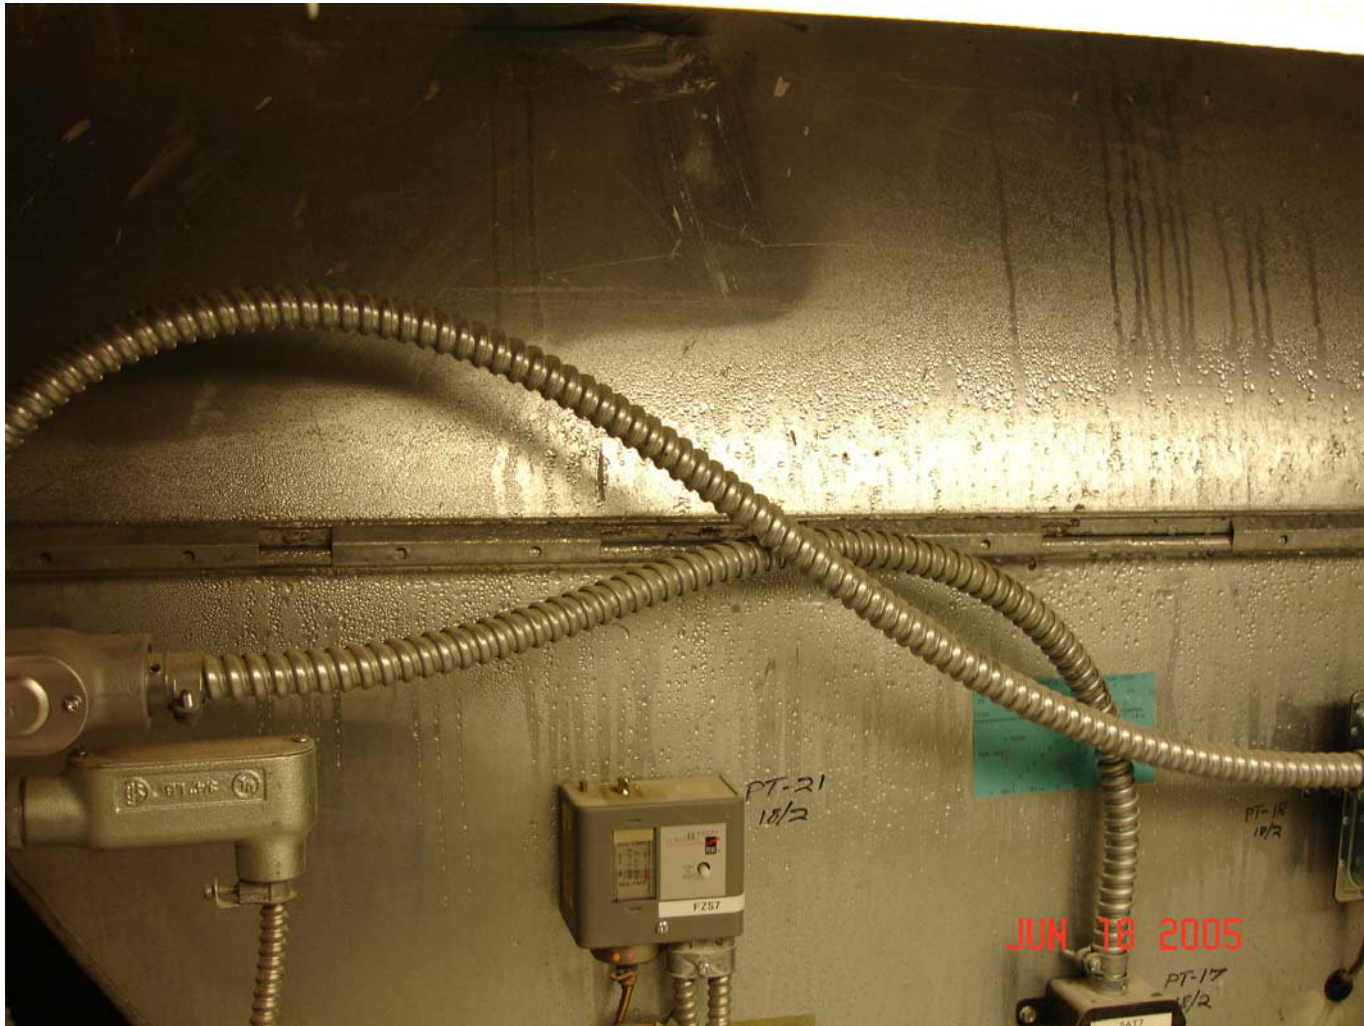
Condensate on exterior duct photo #1464.

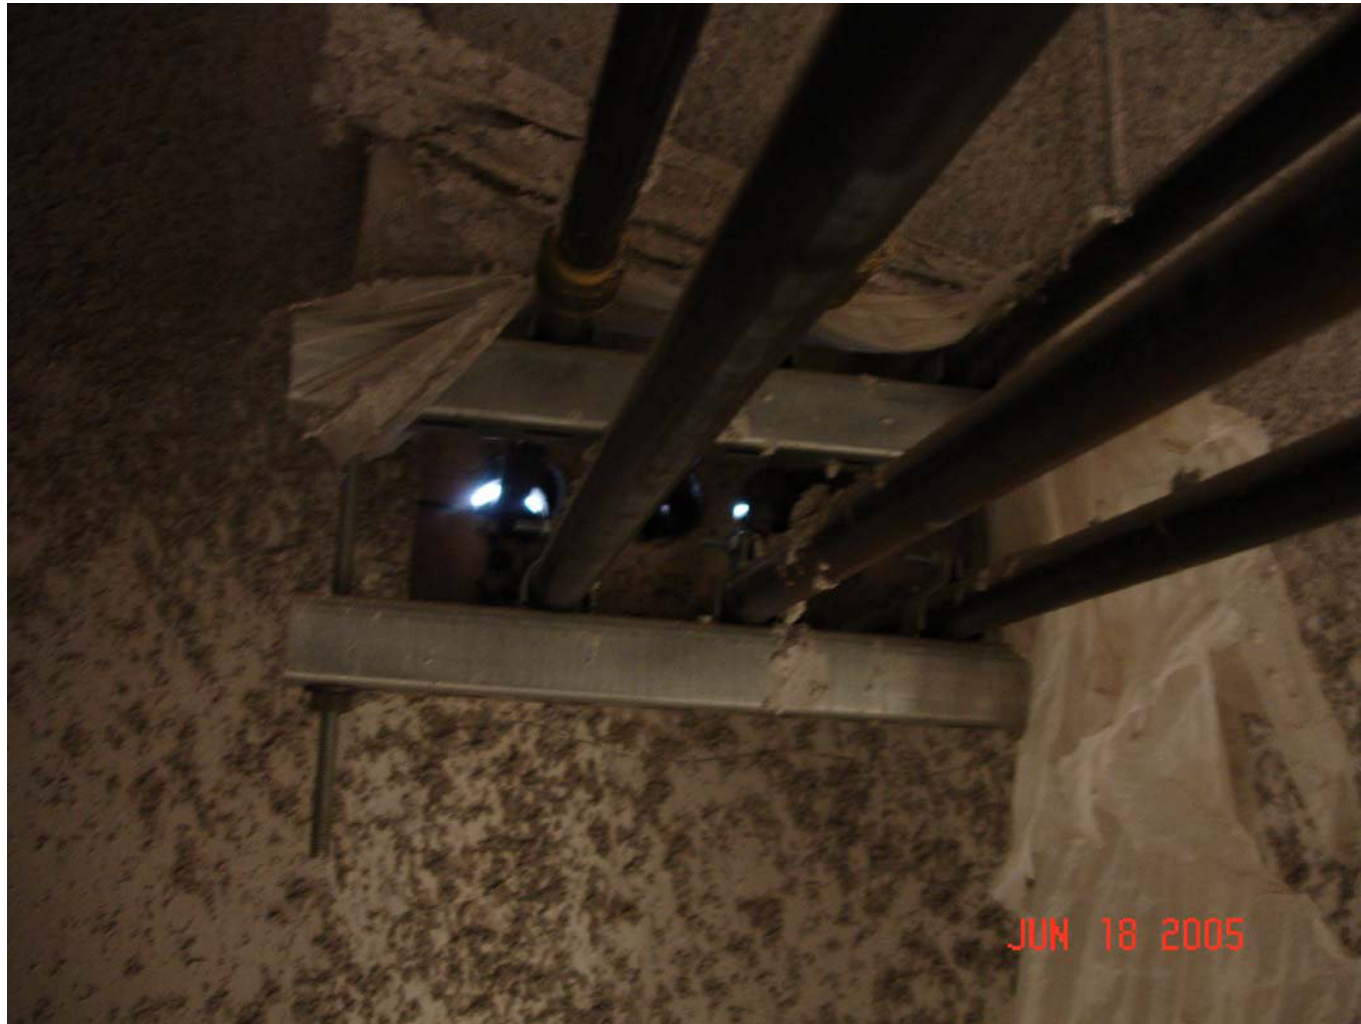
- Gas vent penetrations to outdoors are not sealed. See photo #1465.
- Air bypass from fan discharge to fan suction on the supply fan. See photo's #1475, 1476, 1479.

Gas vent penetration photo #1465.

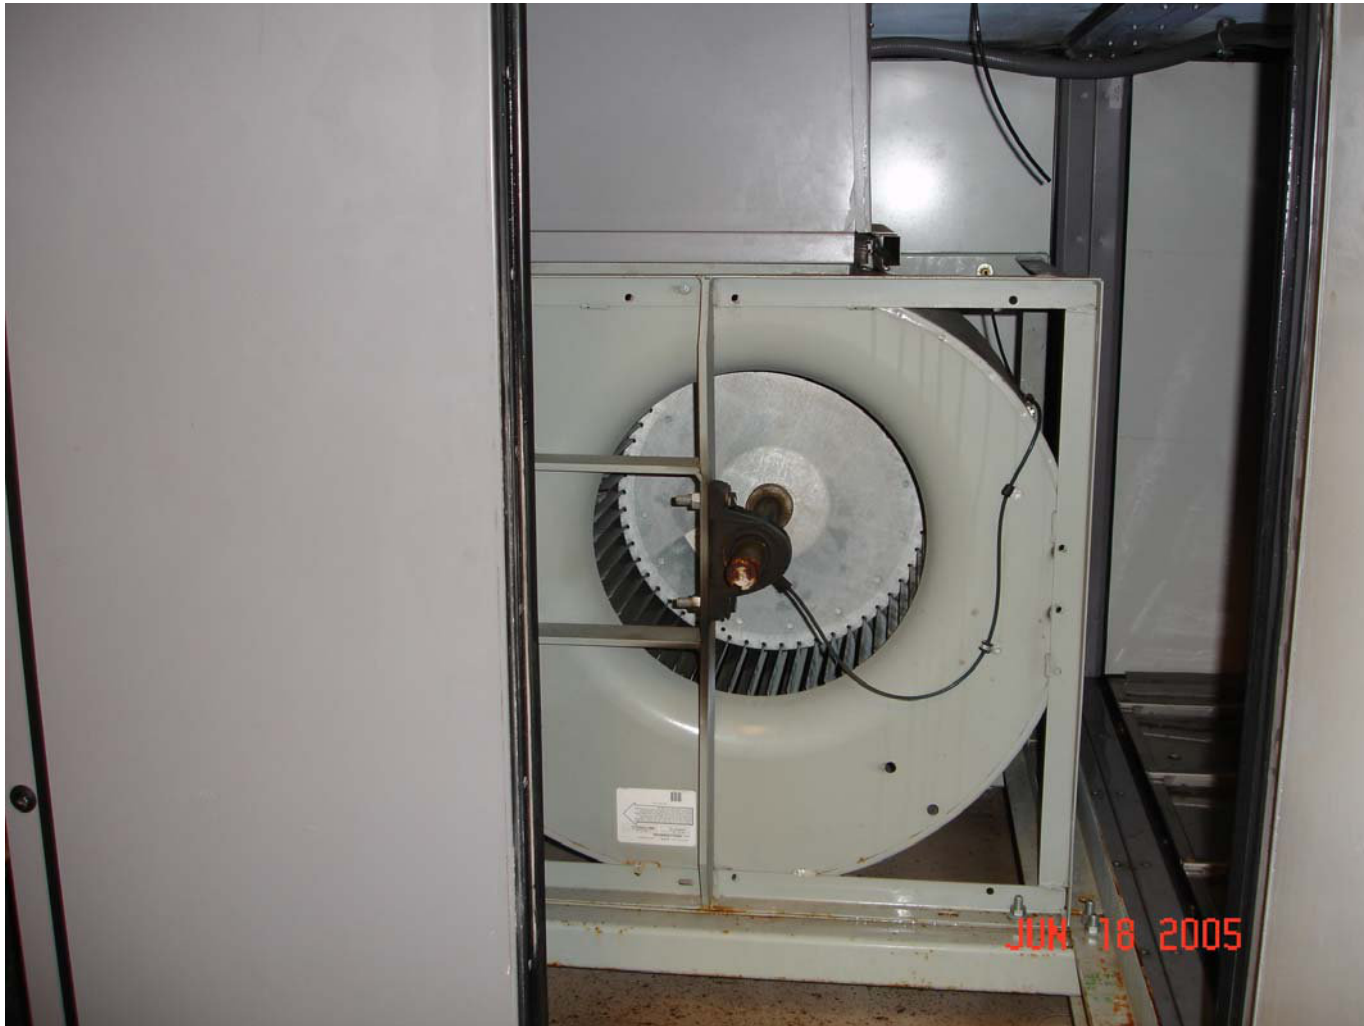
Supply fan air bypass photo #1475.

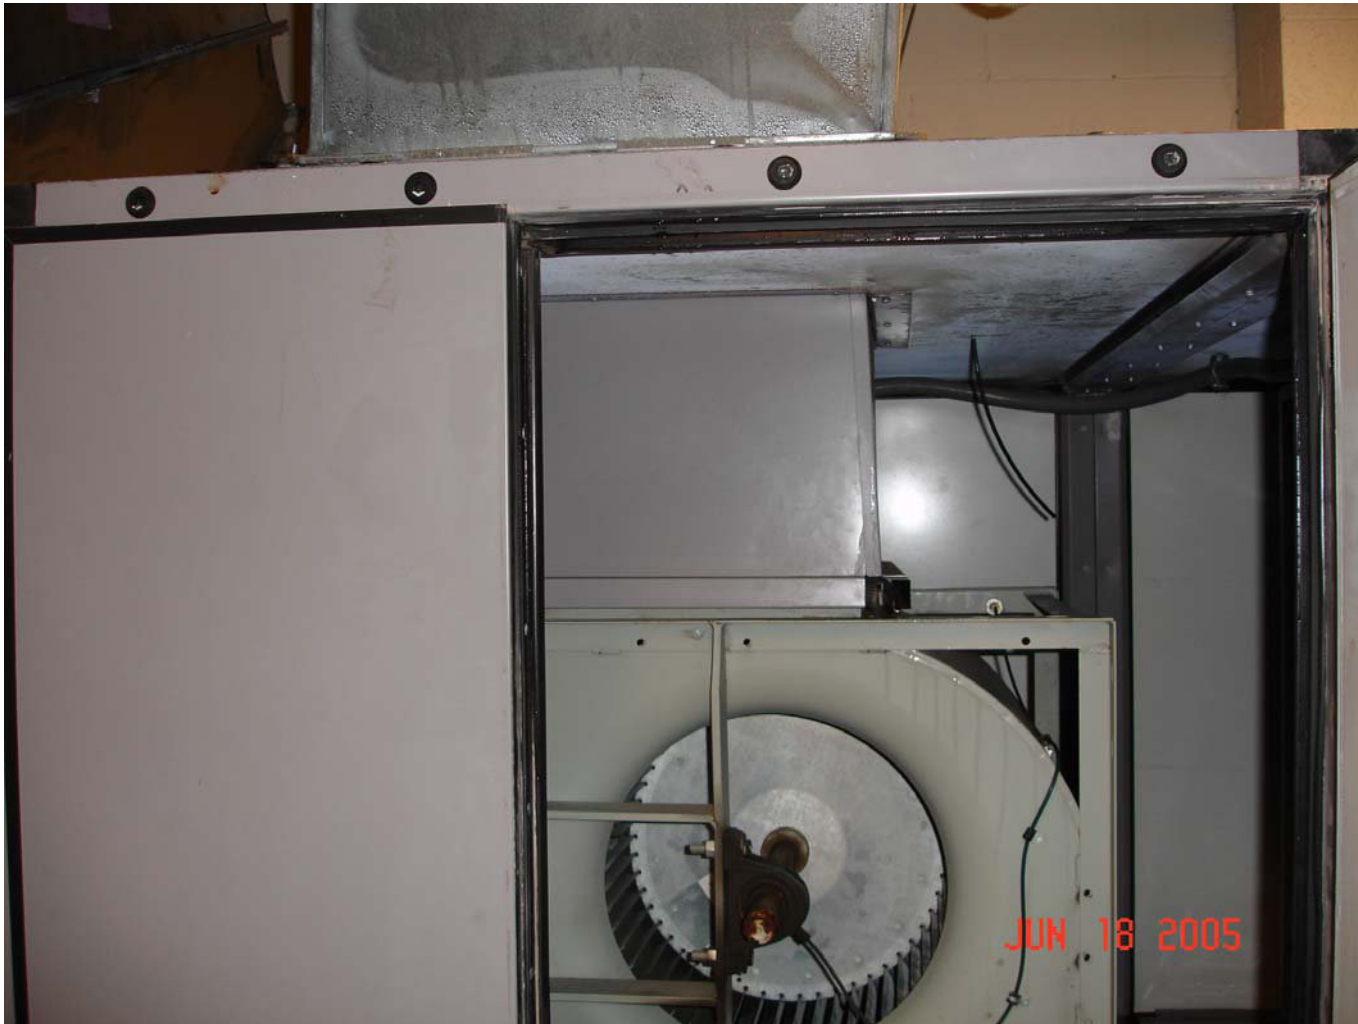
Supply fan air bypass photo #1476.
