# Middle School

Summary Update of Diagnostic Work  
Performed Over a 3-Week Period

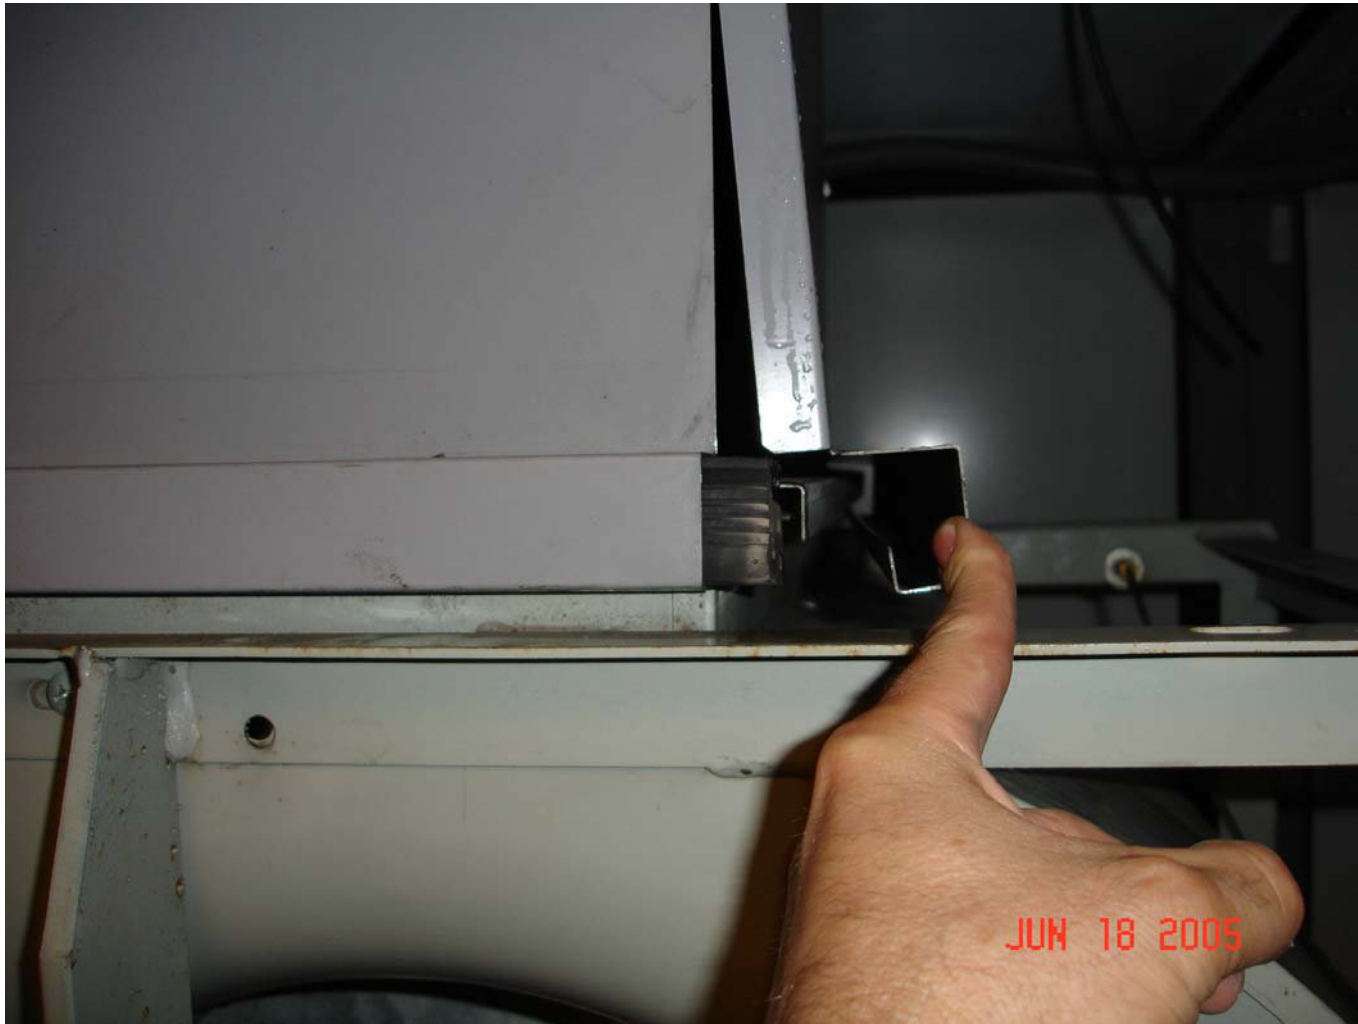
- Gas vent penetrations to outdoors are not sealed. See photo #1465.
- Air bypass from fan discharge to fan suction on the supply fan. See photo's #1475, 1476, 1479.

Supply fan air bypass photo #1479.

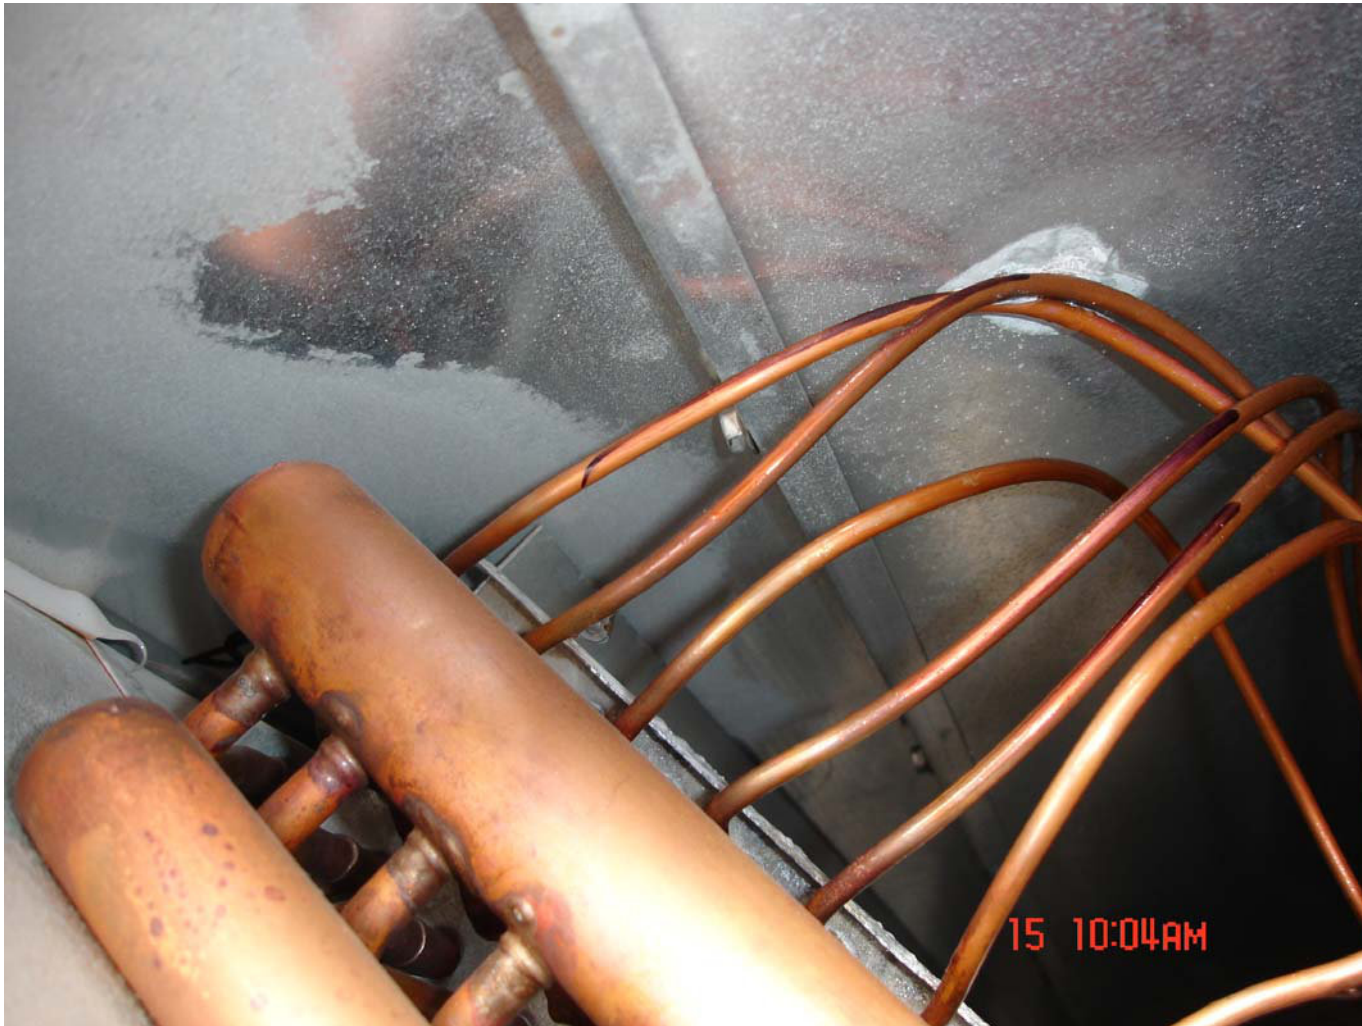
Distributor tubing photo #1449.

- Superheat on all circuits is a little on the high side (approx 25°). May require adjustment based on compressor discharge temperatures.
- Distributor tubing rubbing on the top of the unit. See photo's #1449 and 1450.

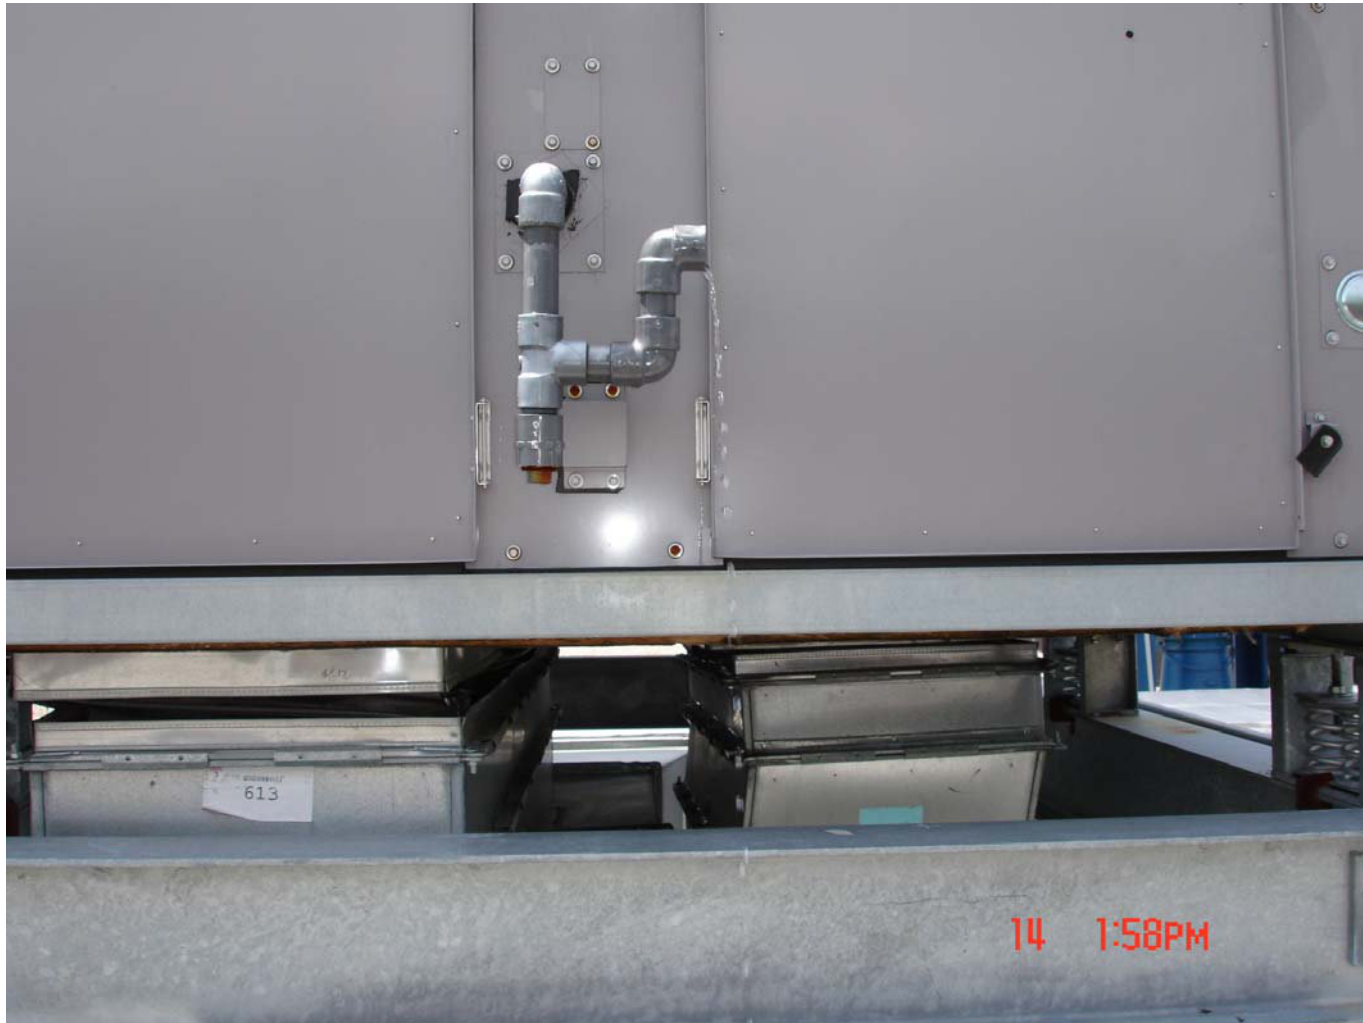
## Condensate drain photo #1447.

- Condensate discharges directly to the roof from a relatively high outlet (possible future roof problem). See photo's #1447, 1448.
- Supply air reset (by CCN controller) requires further investigation. Measurements were taken along with several screen captures but the data has not been processed.

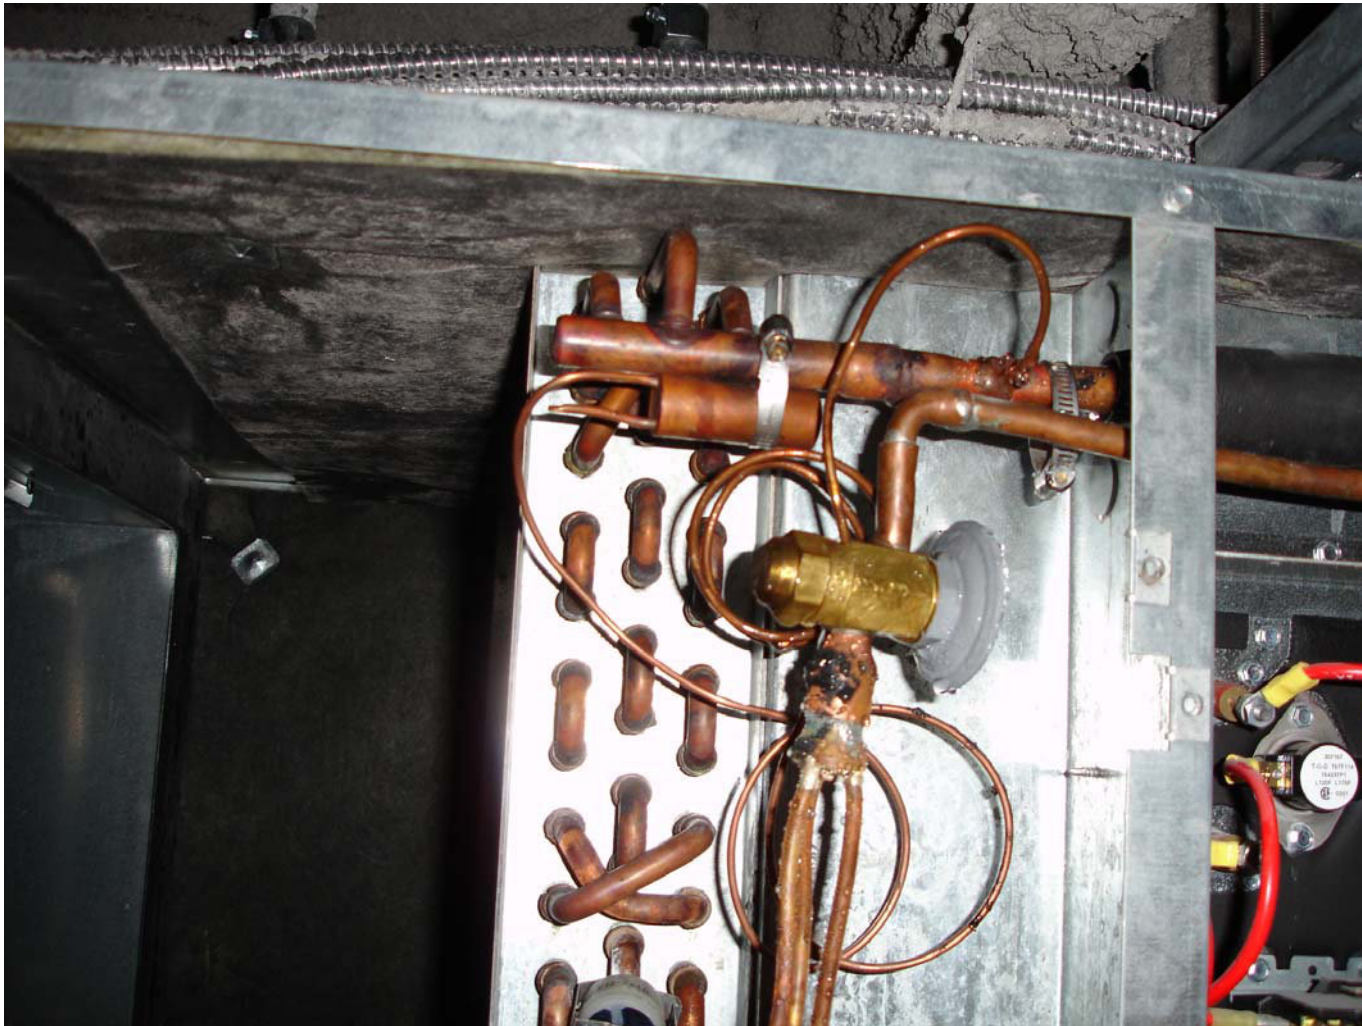
- Found faulty expansion valve. See photo's #1400, 1401.
- Dirty filter. See photo's #1396, 1397.

Expansion valve photo #1400 showing liquid entering suction line through external equalizer. Note condensate.

- None. Reported problem to construction manager and correction was assigned to others. Disposition unknown.

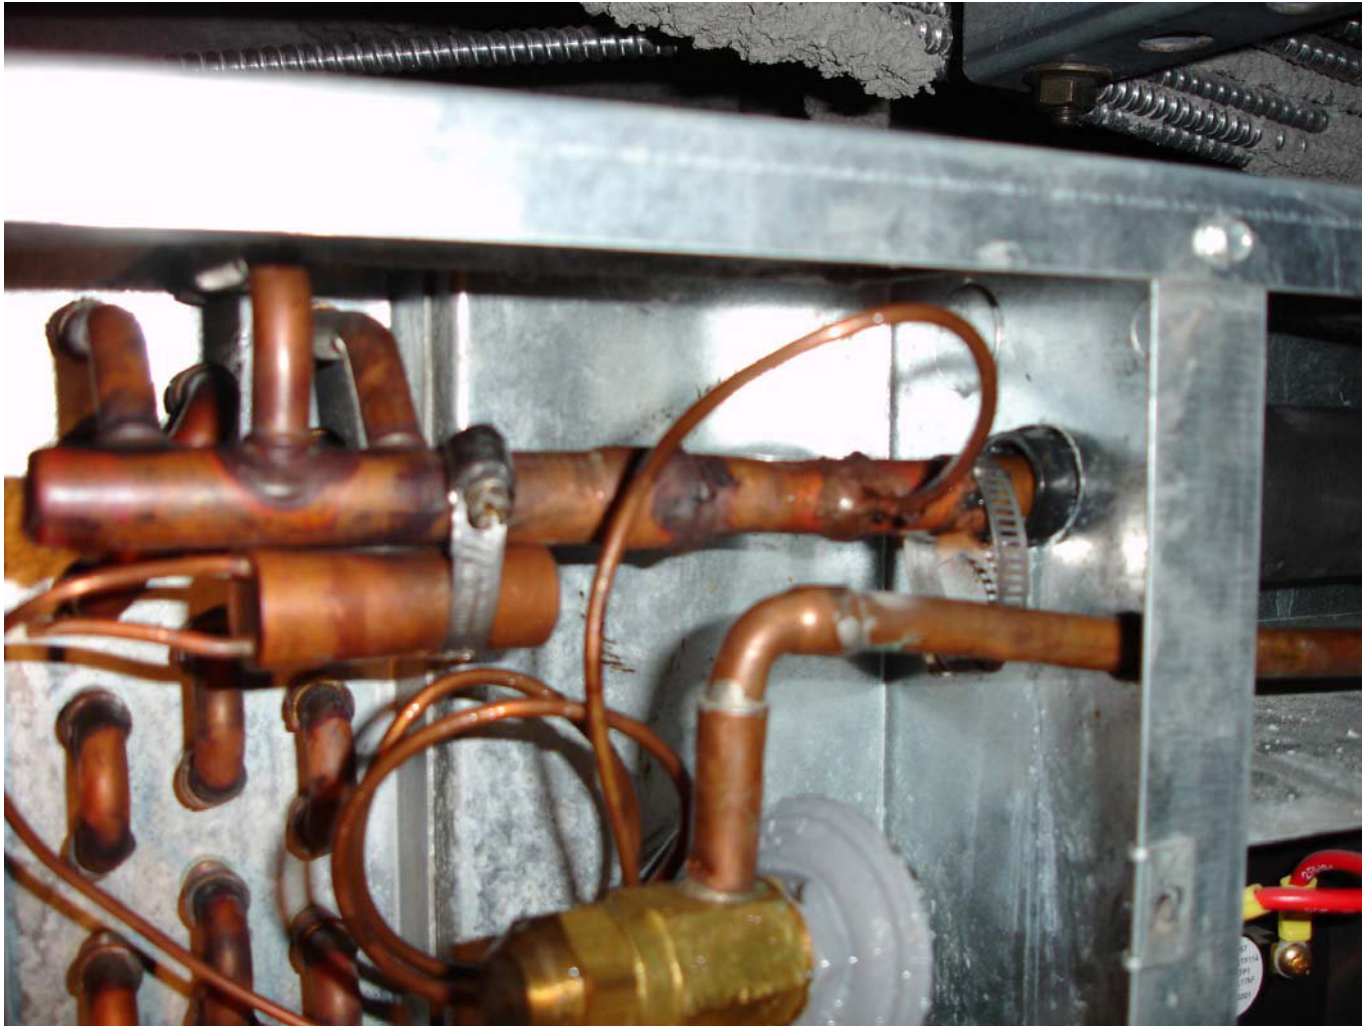
Expansion valve photo #1401 showing liquid entering suction line through external equalizer. Note condensate.

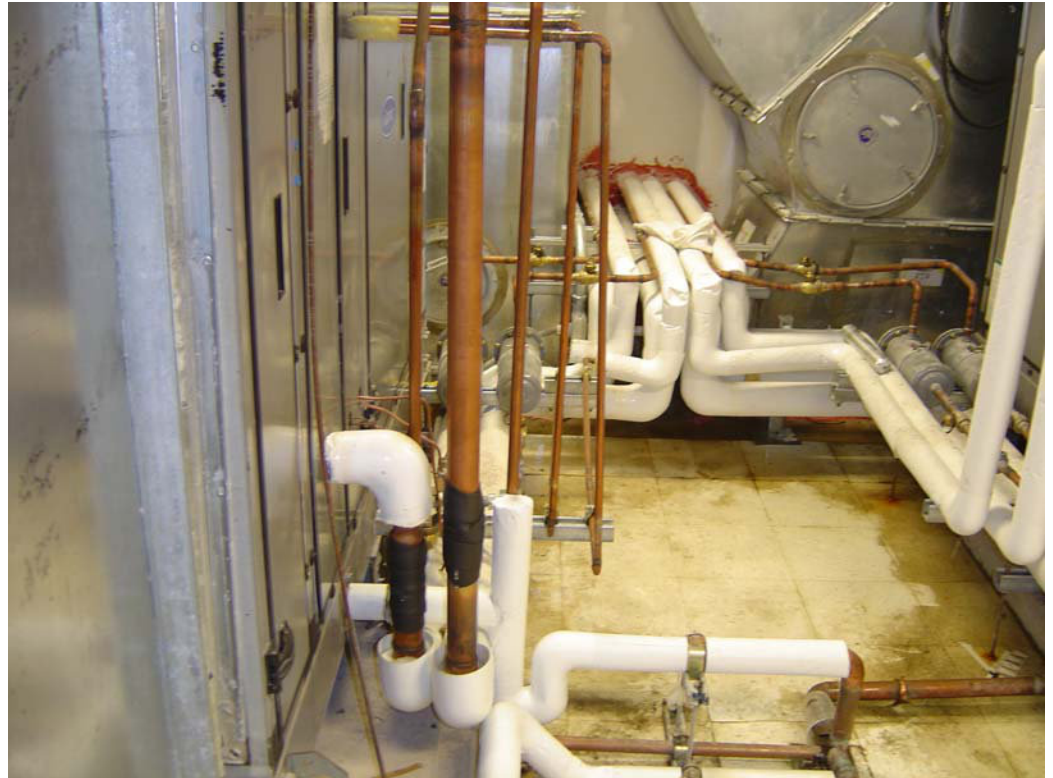
## Air handler 6, Photo #1409

Poor drain connection.  
Condensate draining to floor.

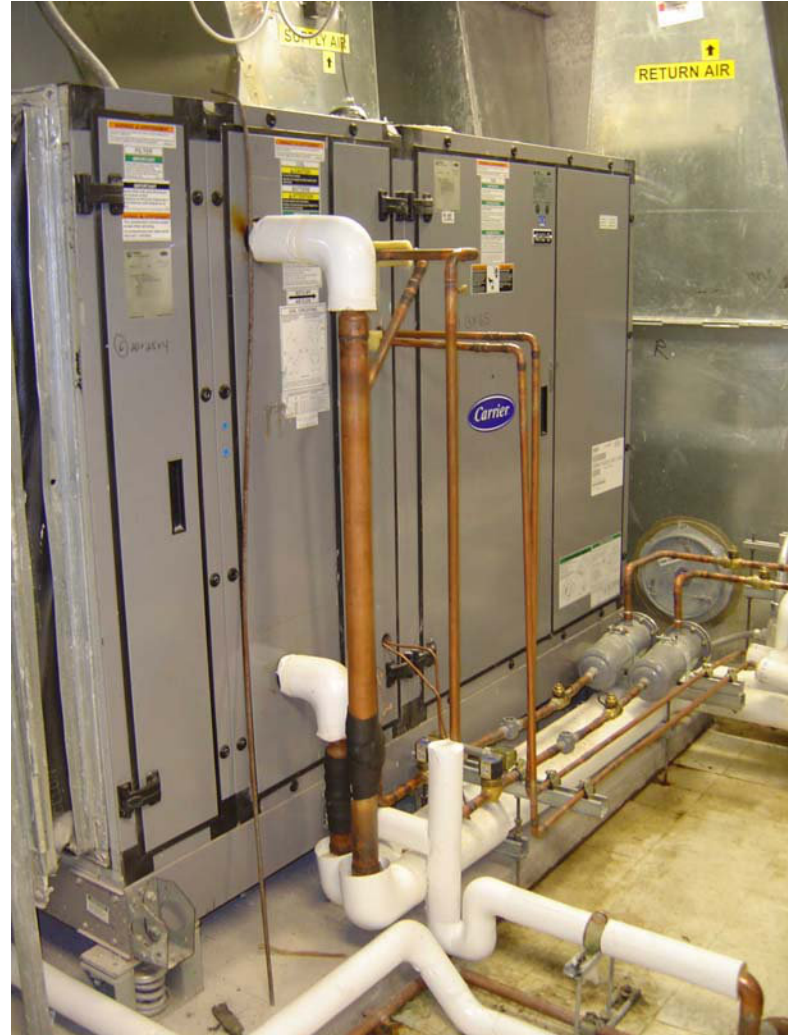
## Air handler 6, Photo #1409

Suction line insulation missing which adds to condensate problem.

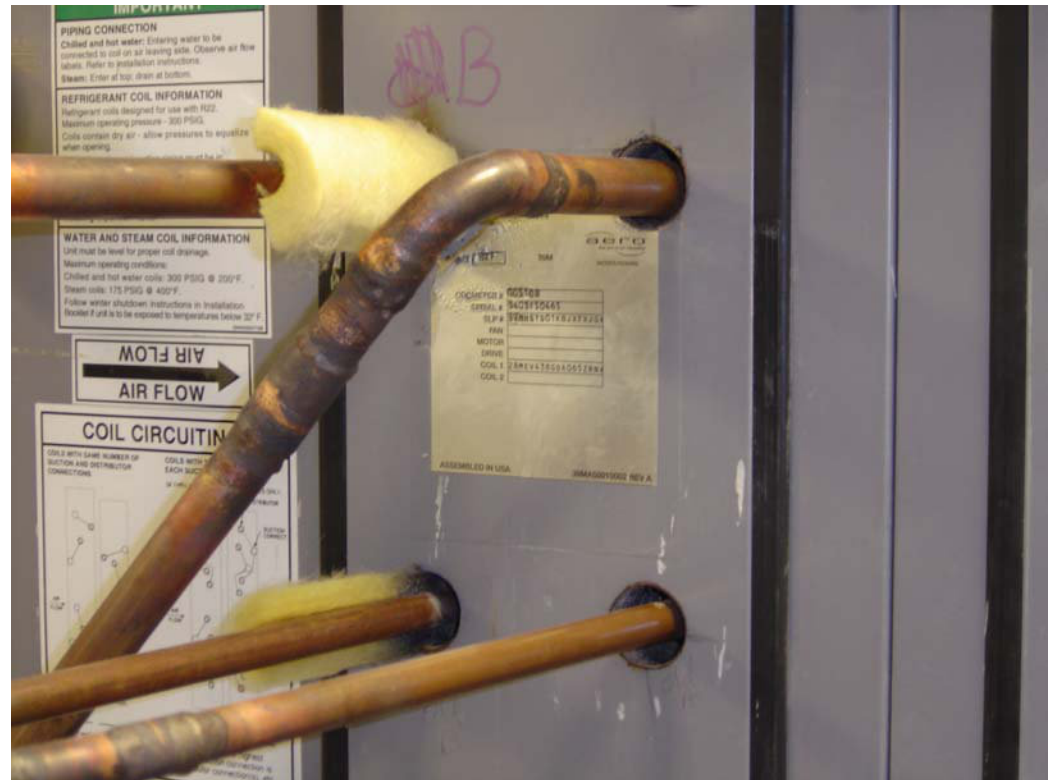
## Air handler 6, photo #1410

- Penetrations not sealed.
- Metal to metal contact between copper and sheet metal.
- Uninsulated piping.

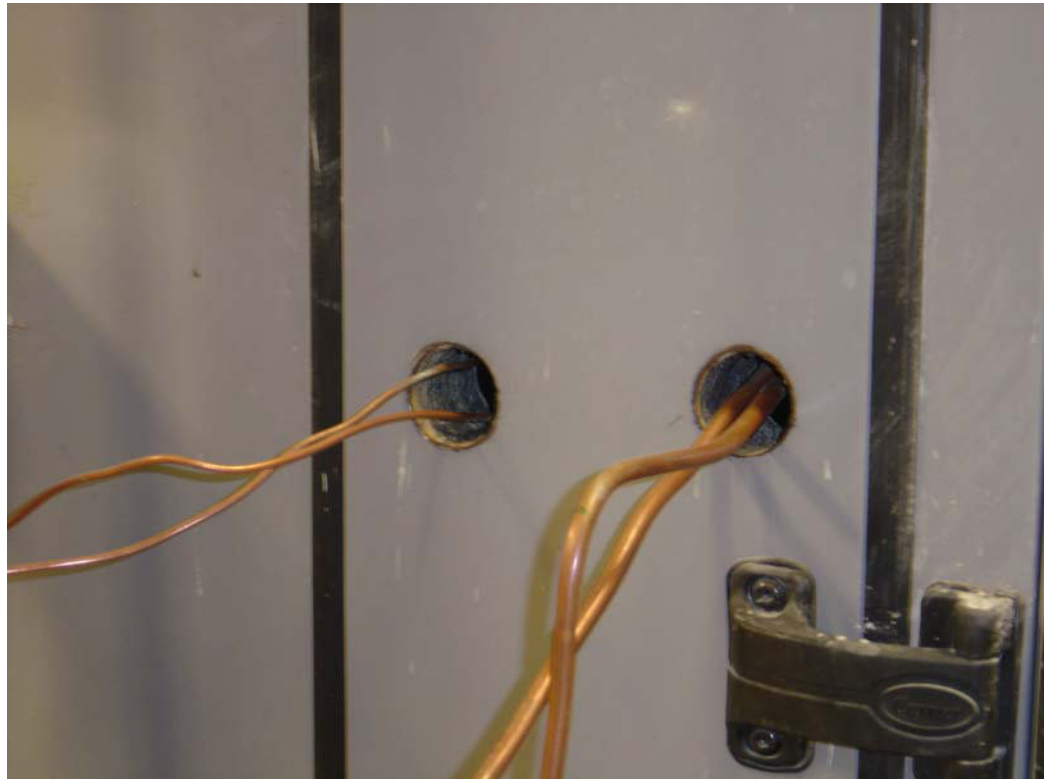
## Air handler 6, photo #1411

- Copper tubing in contact with sheet metal.
- Penetrations not sealed.

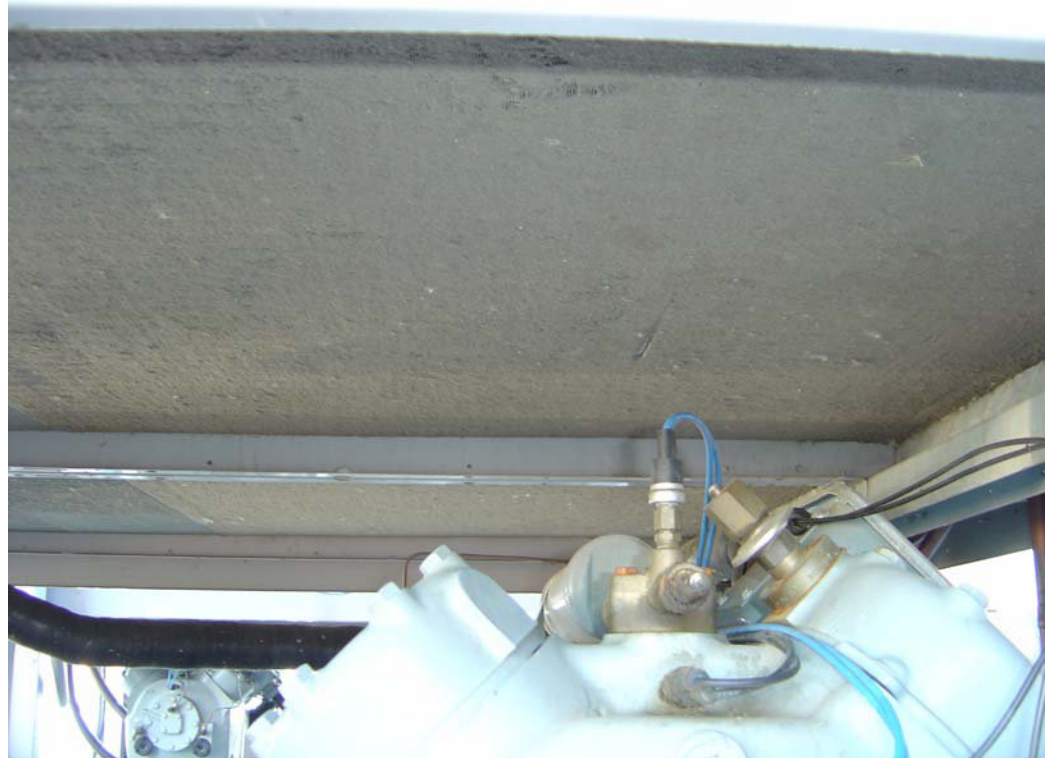
## Condensing unit 6, photo #1413

- Dirty condenser coil.
- Service valve missing cap.

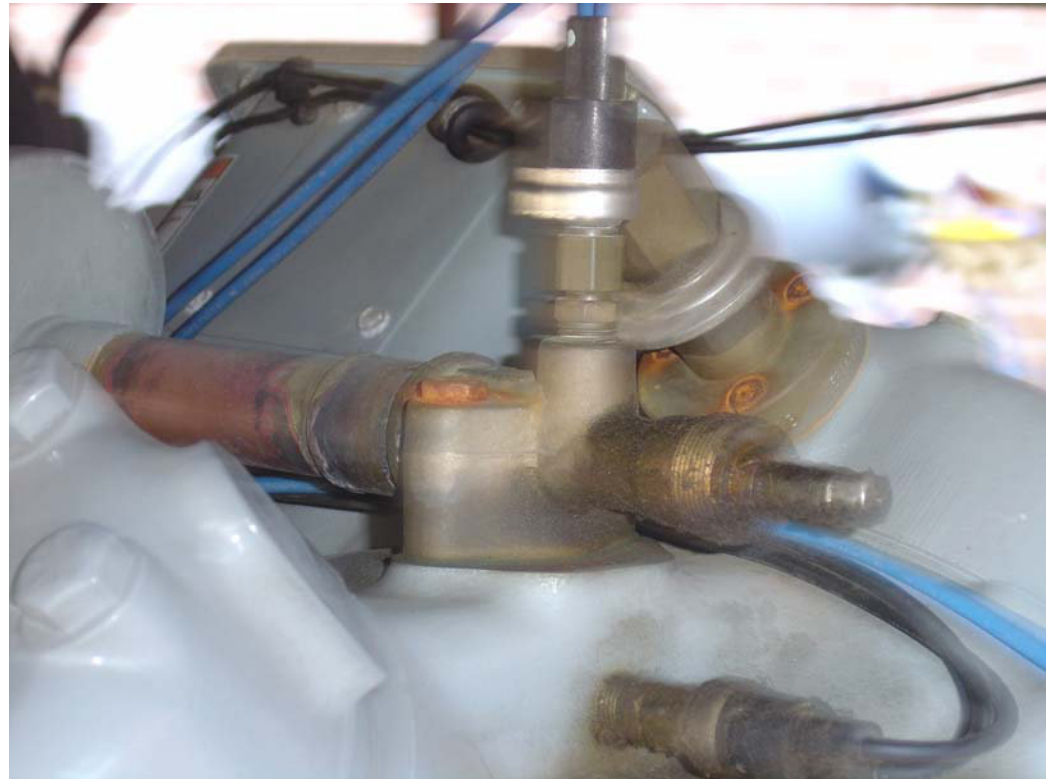
## Condensing unit 6, photo #1419

- Missing refrigeration valve caps.
- Evidence of leaking due to missing cap.

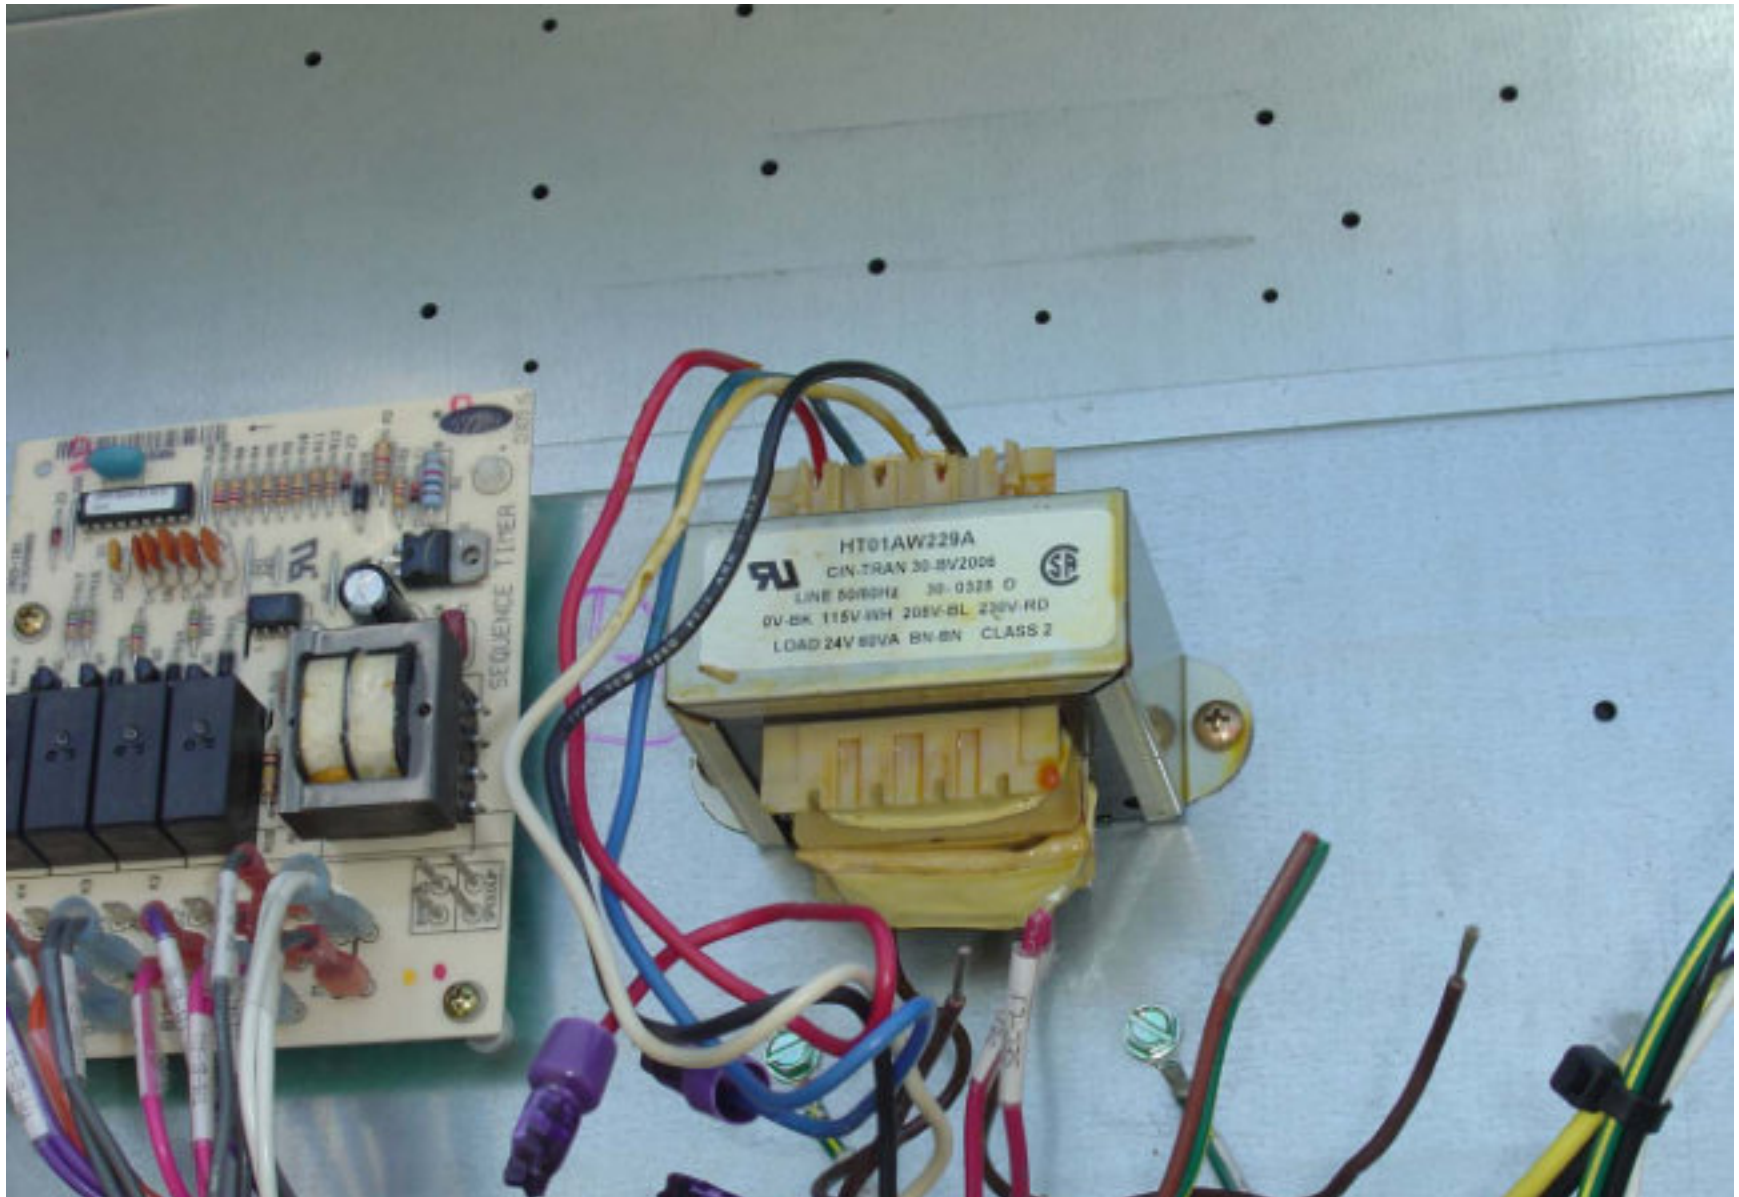
- Compressors not operating and condenser fans running.
- Faulty transformer for safety lockout circuit.
- Circuit #1 running high discharge pressure and high subcooling.
- Circuit #1 superheat a little low at the compressor.
- Reheat valve for 3<sup>rd</sup> floor reheat (RHV-9) bleeding by when closed.
- Dirty and matted condenser coil.

Condensing unit 6, photo #1420, faulty transformer

- Replaced faulty control transformer.
- Started unit.
- Took a full set of readings.
- Adjusted superheat on circuit #1 to 24 deg.

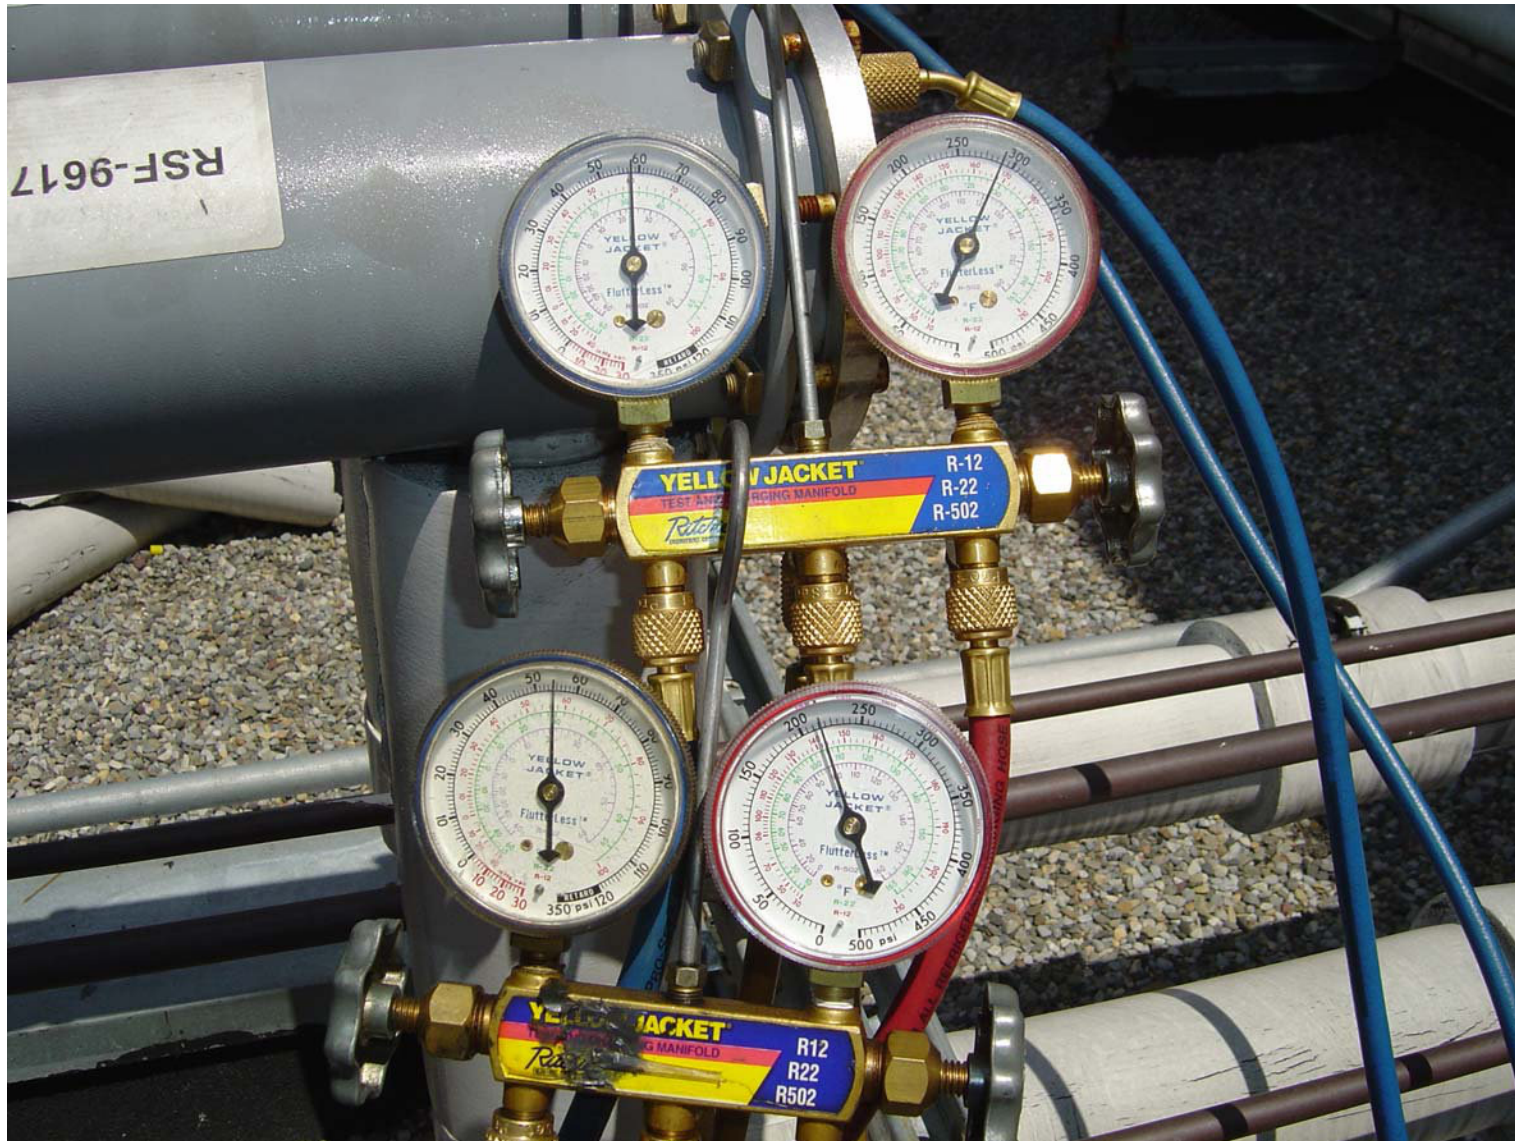
- Circuit #1 is running high head pressure. Could be overcharged. This should be investigated further addressed.
- Circuit #2 compressor oil level is high (7/8 glass).

Condensing unit 6, photo #1420, discharge pressure comparison ckt #1 vs. ckt #2

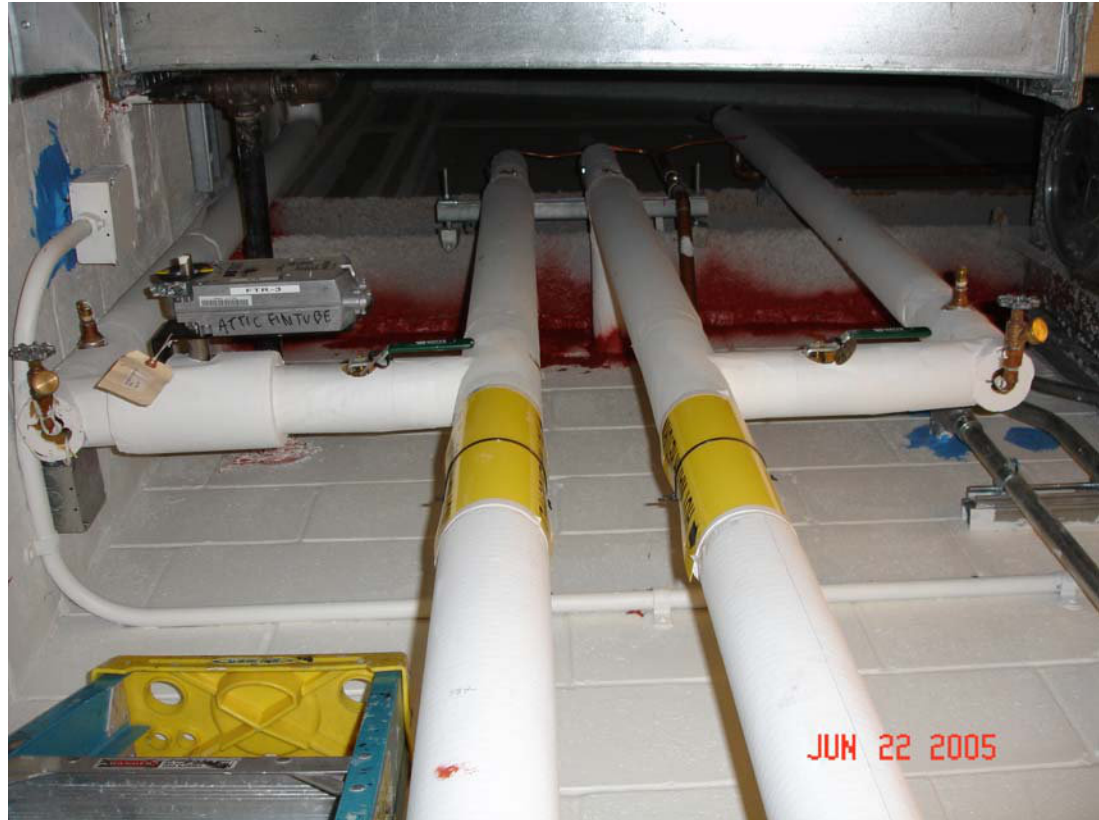
## Attic finned tube radiation, photo #1576

- Attic loop is piped to the main boiler loop (180 deg). Attic loop water is not reset based on outdoor temperature.

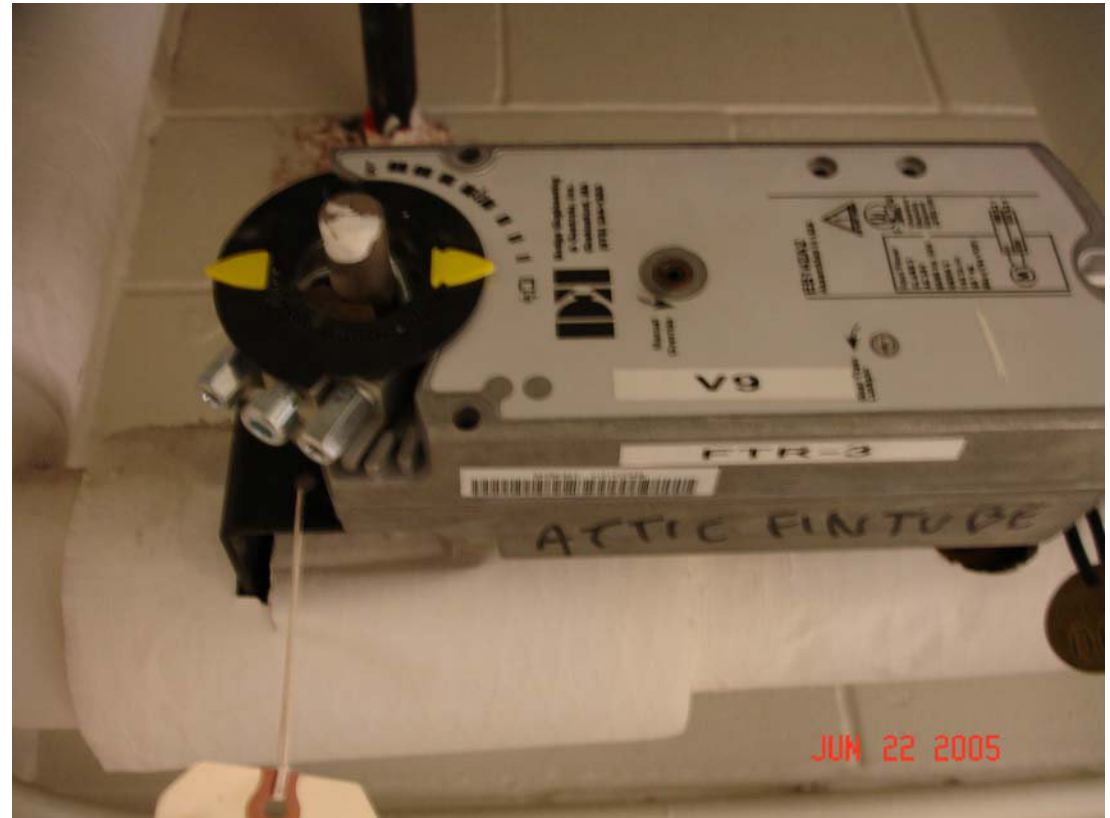
## Attic finned tube radiation, photo #1575

- Unable to locate source of control. Valve is in the 100% open position. Anytime the boiler pumps are on this will allow full flow.

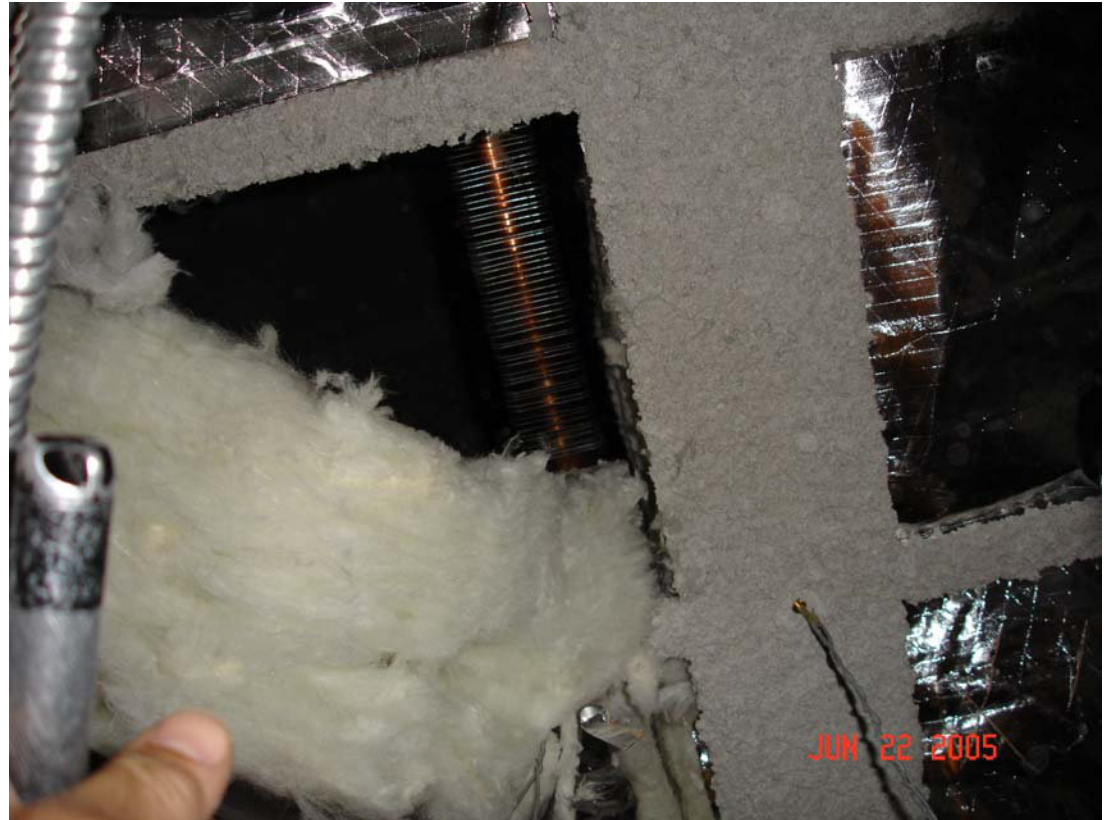
## Attic finned tube radiation, photo #1576

Finned tube installed above insulation in corridor.  
Question for Engineer: Is this correct?

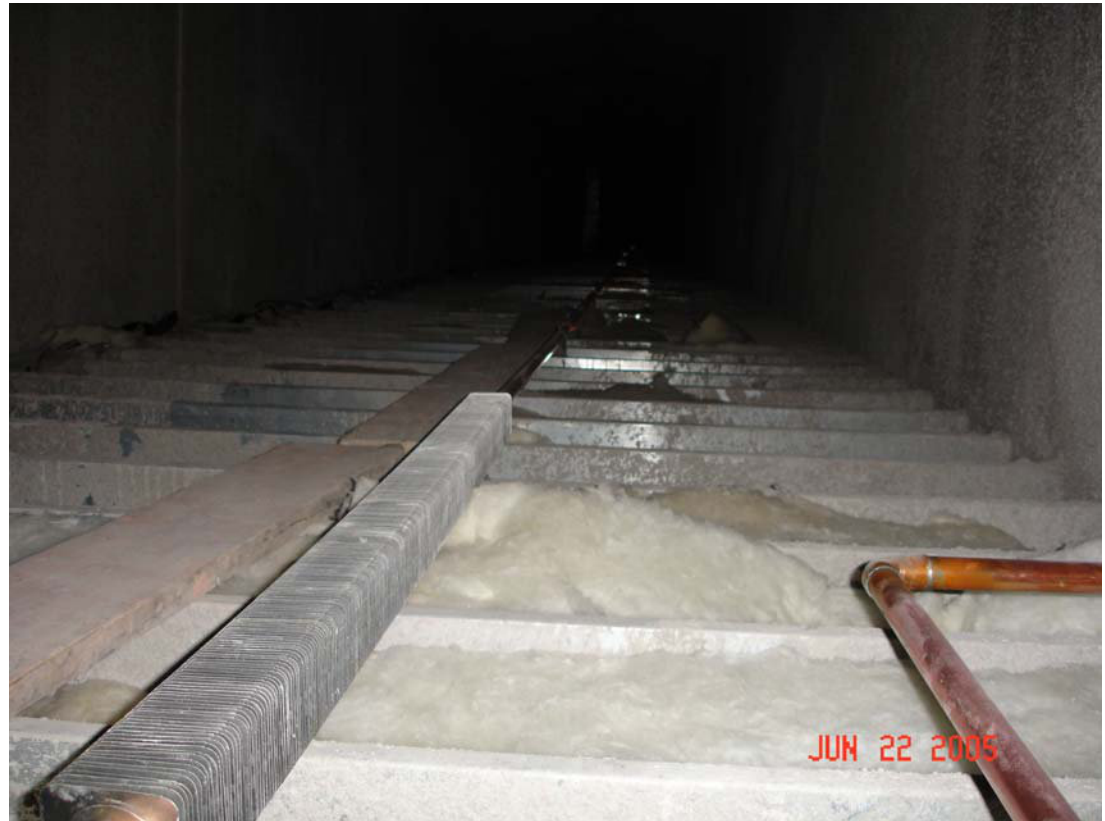
## Attic finned tube radiation, photo #1585

Finned tube and piping  
installed above insulation in  
uninsulated attic space.

Is this correct?

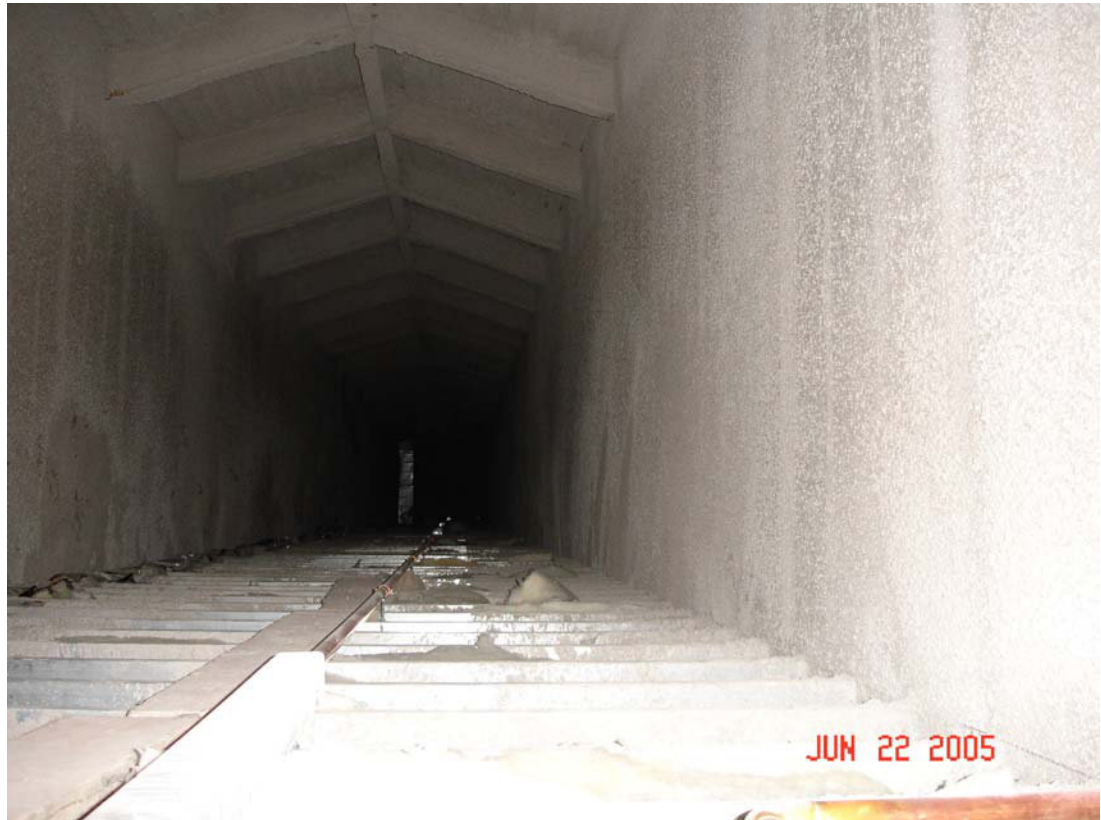
## Attic finned tube radiation, photo #1587

Another photo of the attic radiation in the uninsulated space. This photo is above the corridor on the 3<sup>rd</sup> floor.

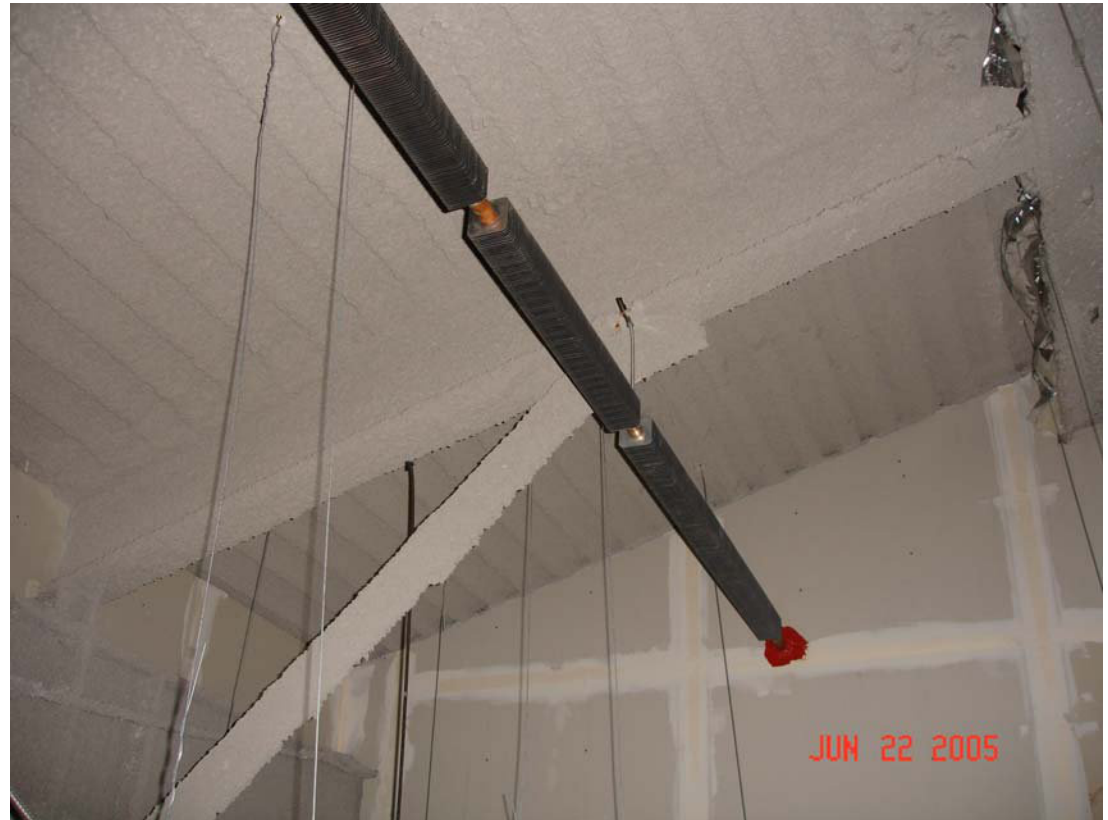
## Attic finned tube radiation, photo #1588

- This photo shows attic finned tube radiation. Actual piping is reversed from that shown on drawing. Since flow was also reversed, the only impact is the 16' sections and the 18' sections of finned tube are installed on the opposite side of the building from how it is shown on drawing #M7.

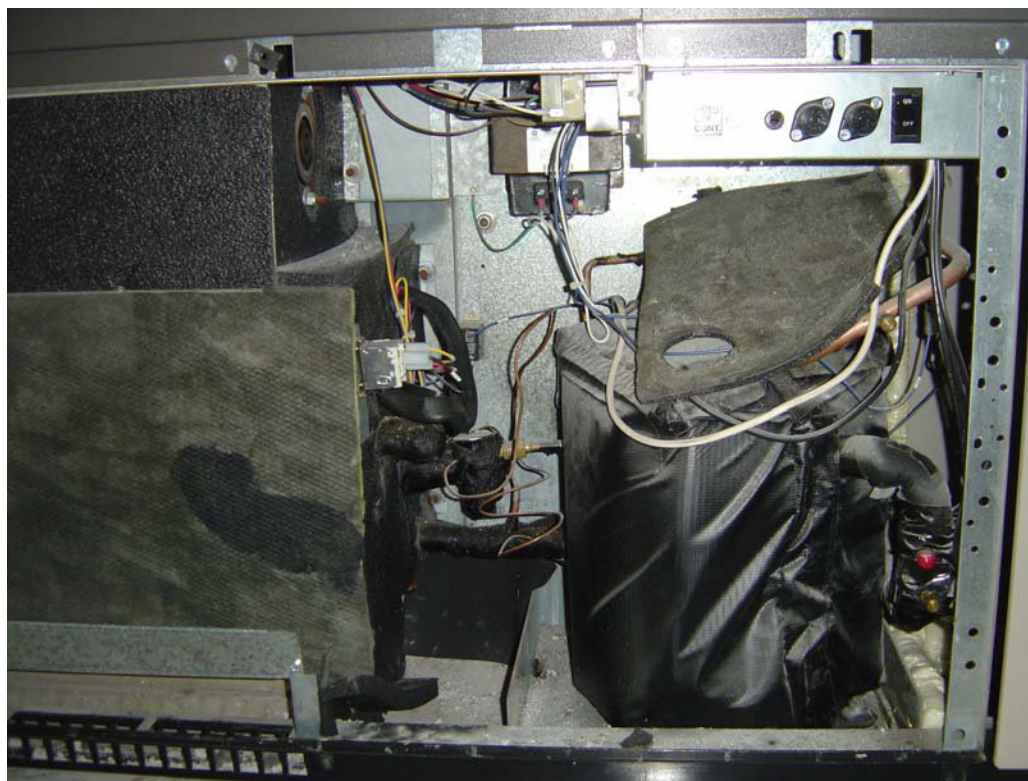
## Unit ventilator, Photo #1389

- The electrical box insulation has fallen off on all units. We (MSC) re-glued this last winter but the adhesive apparently did not adhere properly since the casing temperature was low. Welded pins should be used.

Electrical panel insulation loose. Insulation glues to the bottom of the electrical panel.
