# Middle School

Summary Update of Diagnostic Work  
Performed Over a 3-Week Period

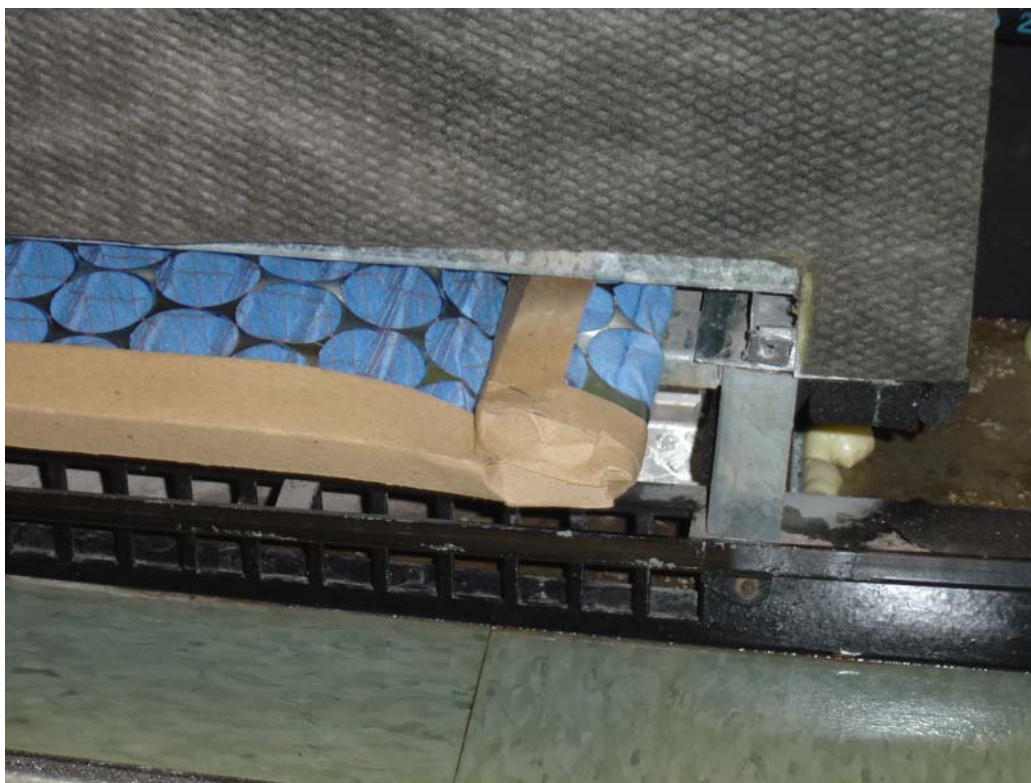
## Unit ventilator, Photo #1390

Improper filter installation.

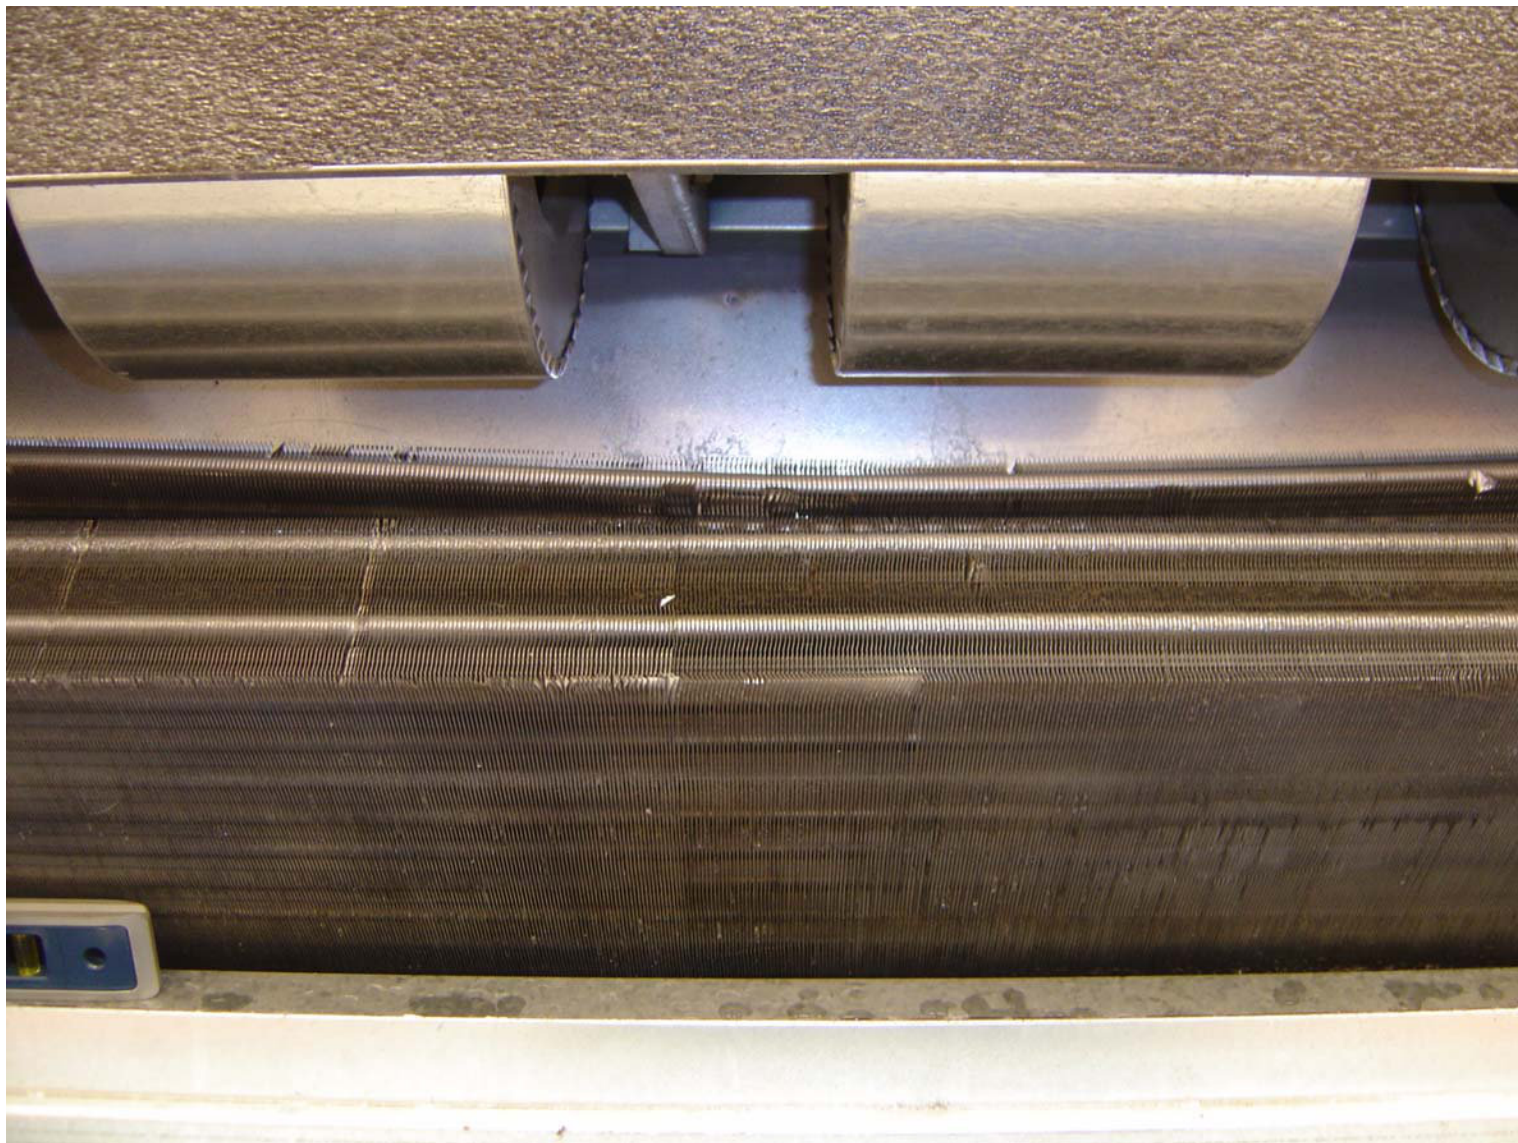
- Room 227: Unit off due to condensate leak. Unit has been leveled (by others) but the condensate pan is still sloped away from the drain. The heating coil on this unit is slightly buckled indicating damage at some point. See photo #1404.

Unit ventilator, Photo #1404  
Note bowed coil

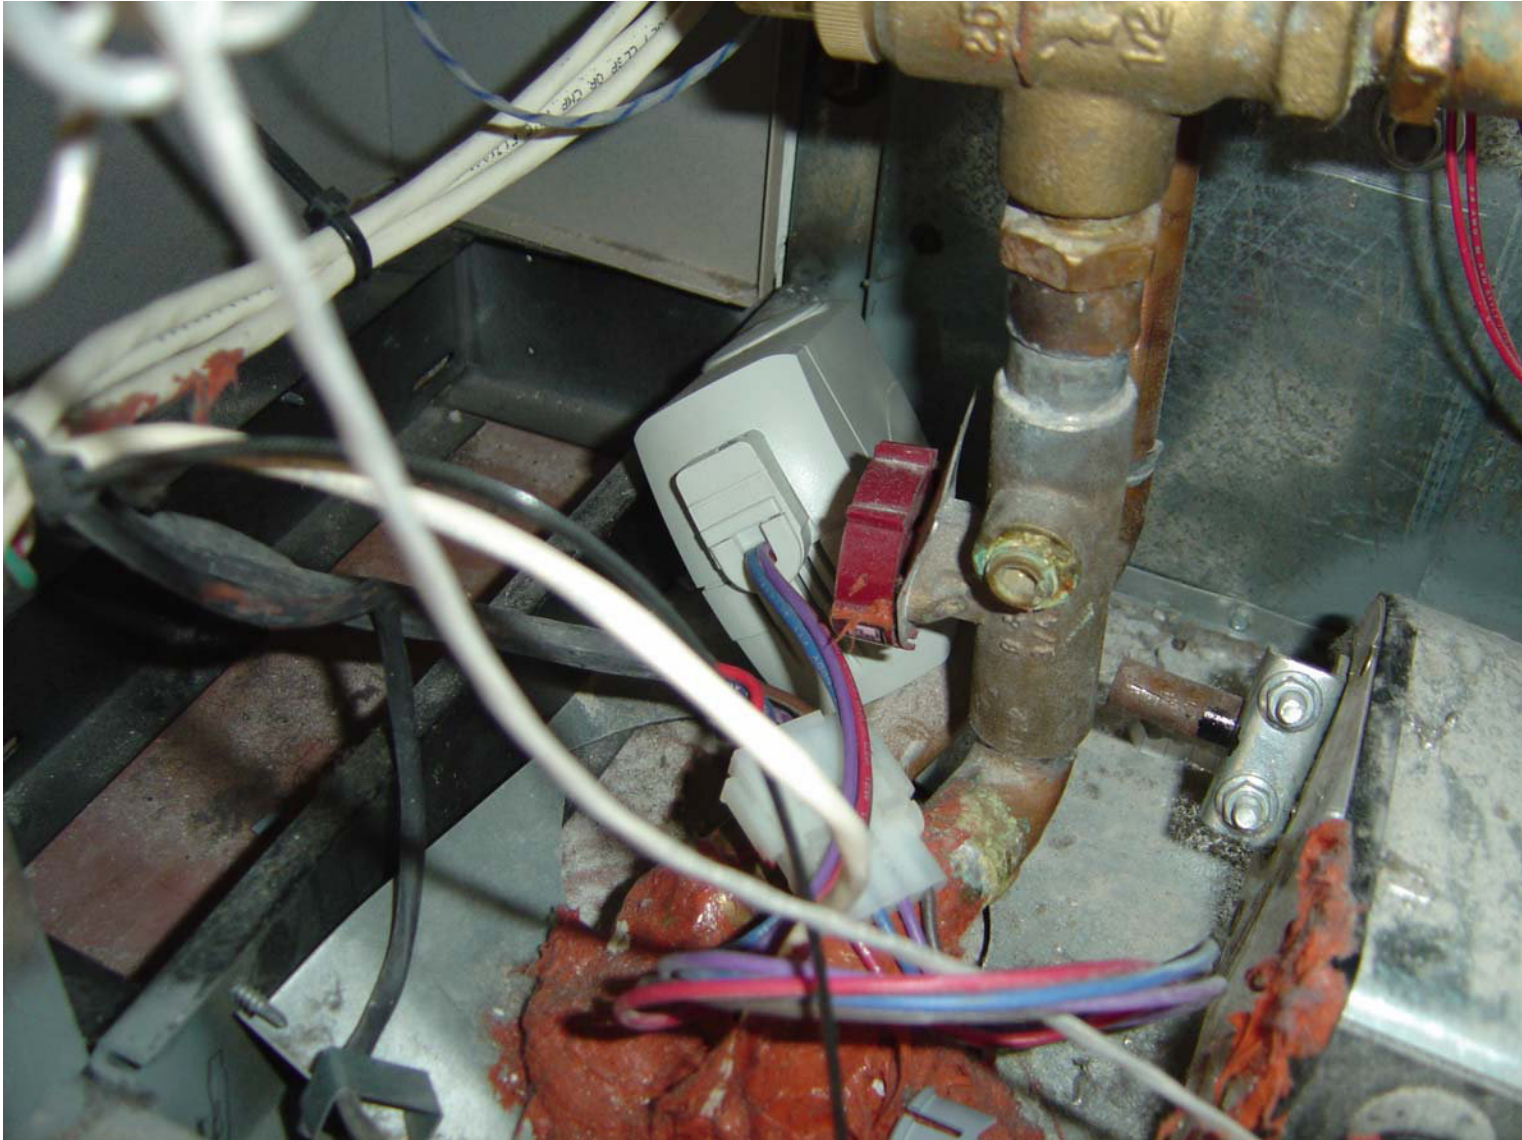
- Room 224: Heat valve actuator is hanging alongside valve and is not attached. See photo #1425.
- Room 306: Compressor noisy at startup.
- Room 111: Found wiring harness to motor pulled out.

Unit ventilator, Photo #1425 Valve actuator not attached to 3-way valve. Attachment device snapped.

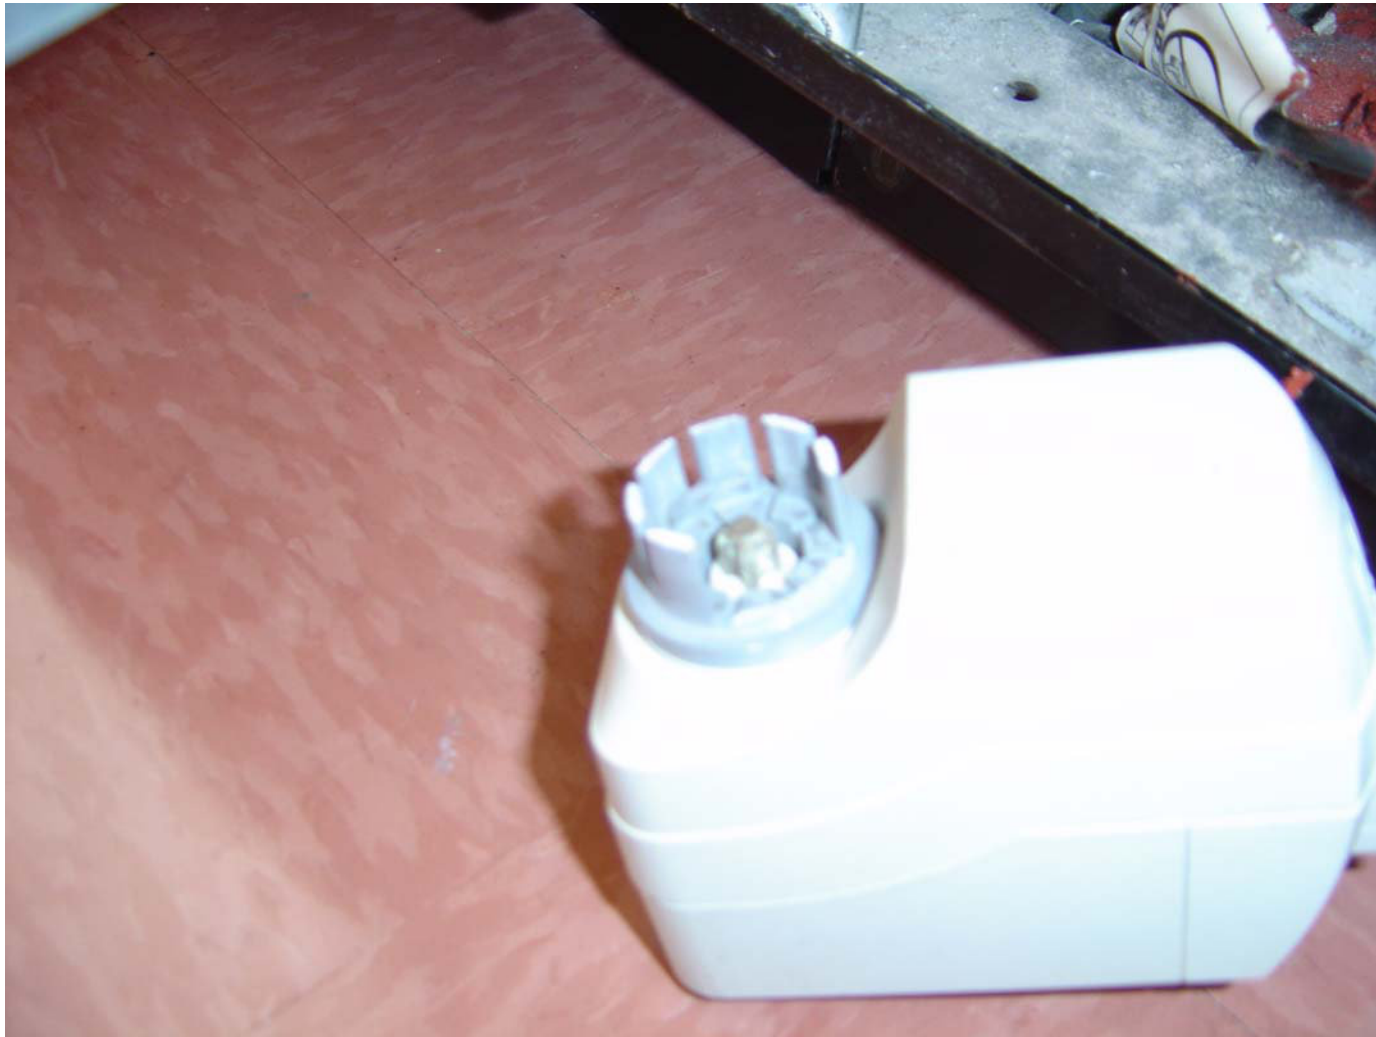
Unit ventilator, Photo #1426. View of broken attachment device for above actuator.

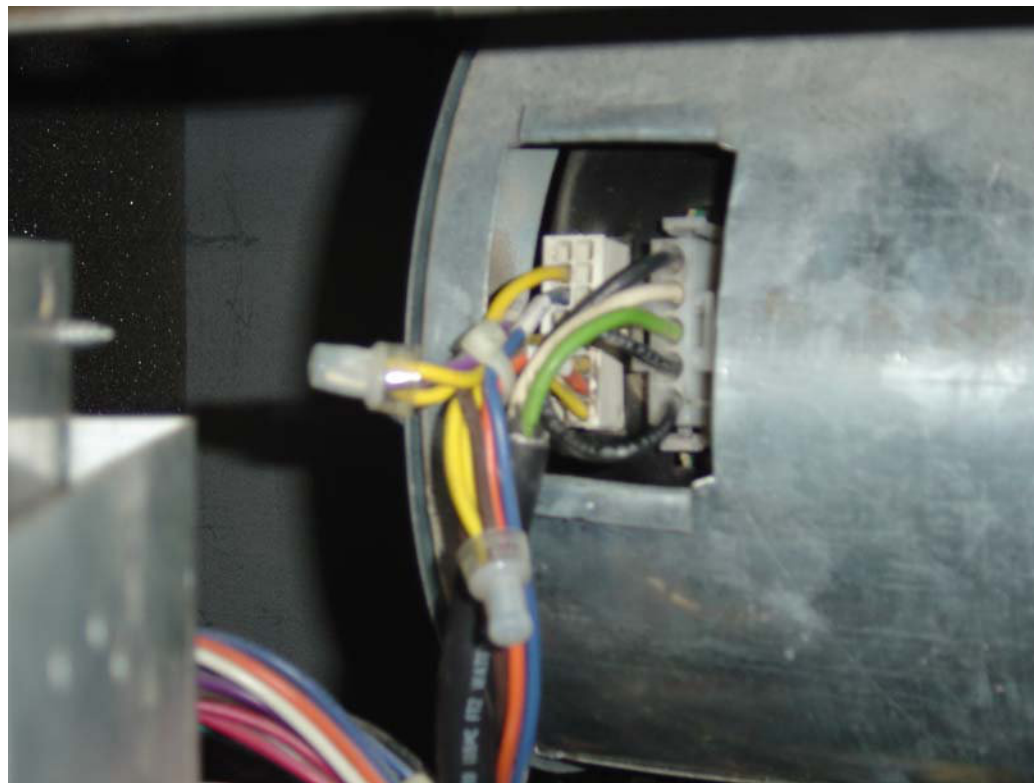
## Unit ventilator, Photo #1393

The fan motor power and control connectors were found disconnected on room 111. The fan was not operating but the compressor was still cycling on and off on the mechanical freeze-stat supplied by the manufacturer.

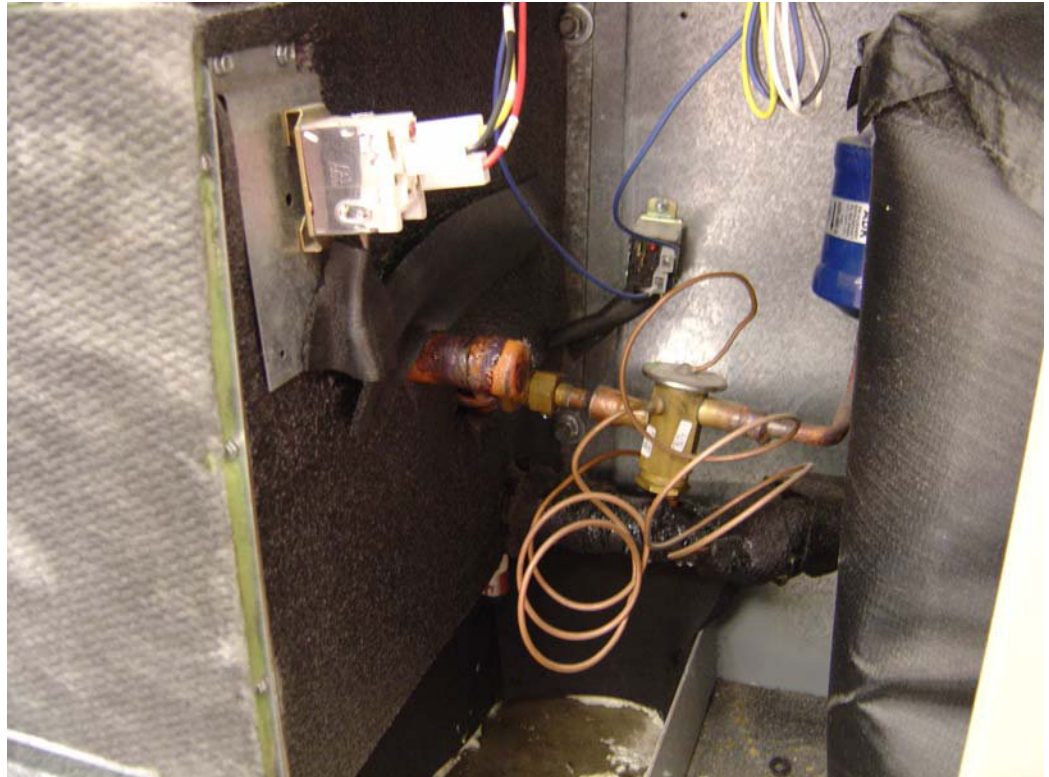
## Unit ventilator, Photo #1392

Expansion valve and distributor sweating in compressor compartment. Insulation is missing.

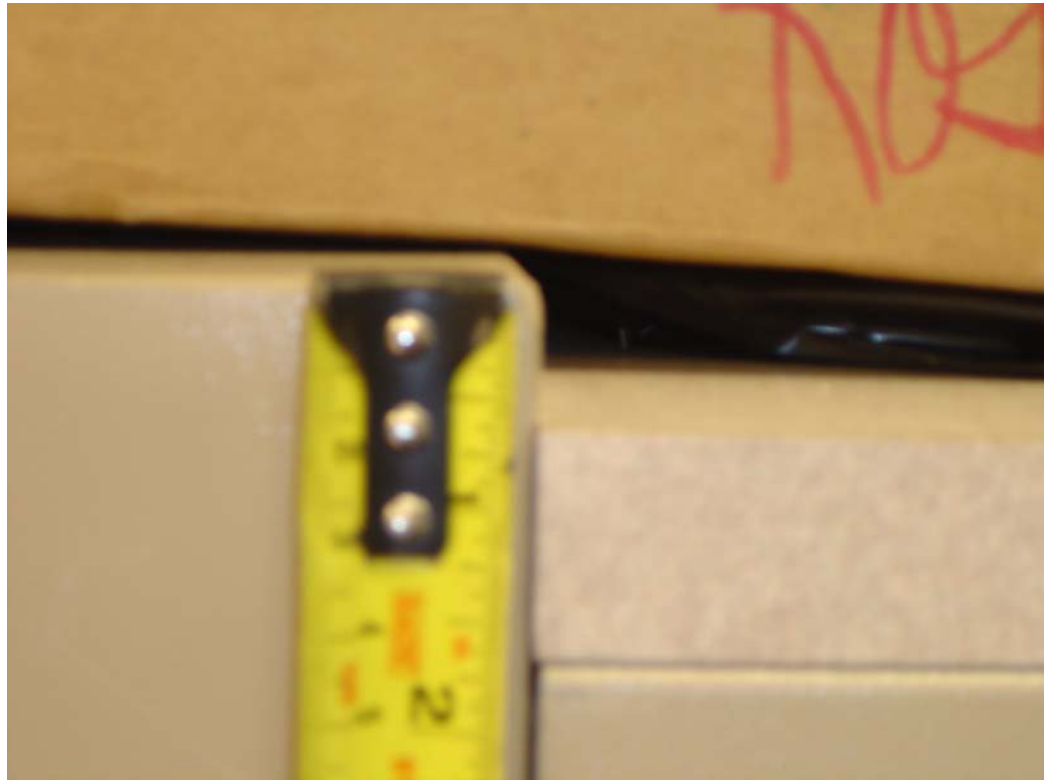
## Unit ventilator, Photo #1406 room #227

- Photo shows approximate 5/8" deviation between top of unit and adjacent book shelf after shimming (by others).
- Unit still leaks as condensate pan is distorted.

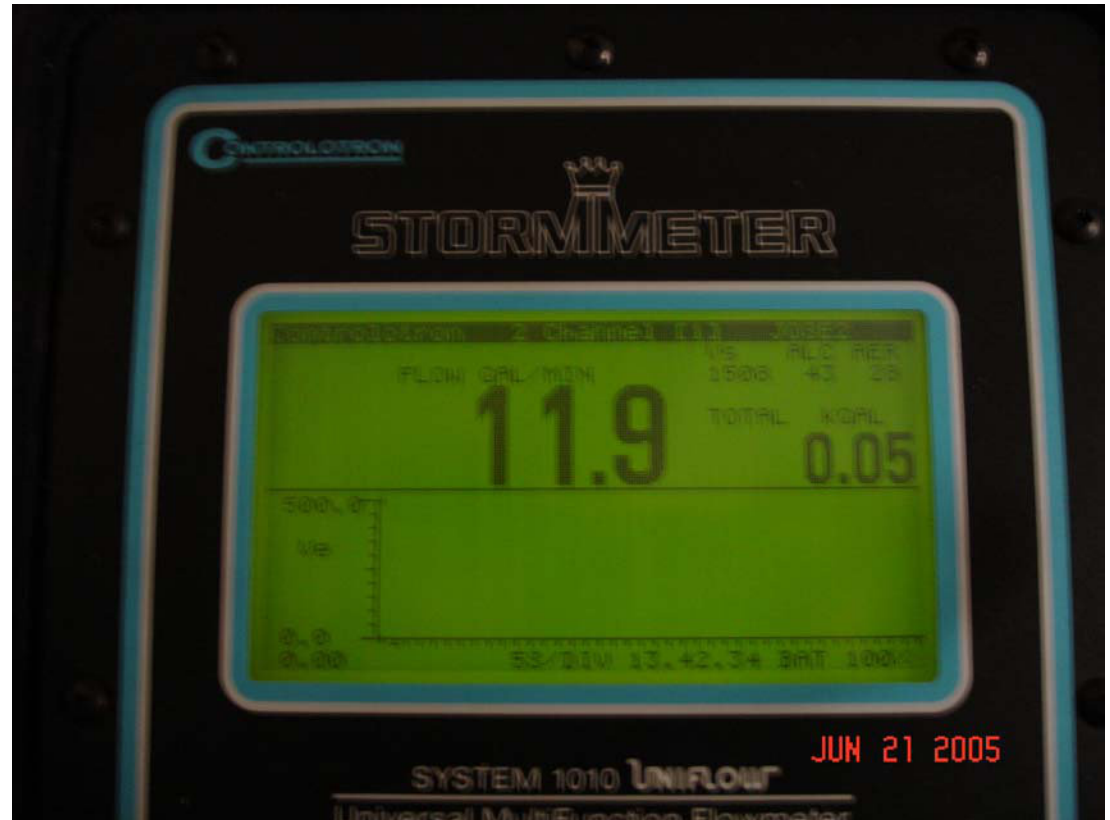
## Radiant loop, Photo #1559

- Pump PR1 / PR2 (radiation pumps) flow found at 11.9 GPM at the pump station. (see photo #1559). Design flow is 40 GPM. Balancer's report shows a flow of 12.2 GPM.
- Flow rate at the Principals' office varied from 0.36 to 0.45 GPM (design is 0.98 GPM). Flow dropped to 0.26 GPM when the zone valve in an adjacent room was opened.
- No pressure taps on pumps to allow a cutoff test.
- Strainers clean.
- Found 2" circuit setter closed. The 1" circuit setter was 100% open.

Ultrasonic flow meter. Shows GPM flow on radiant loop as found.

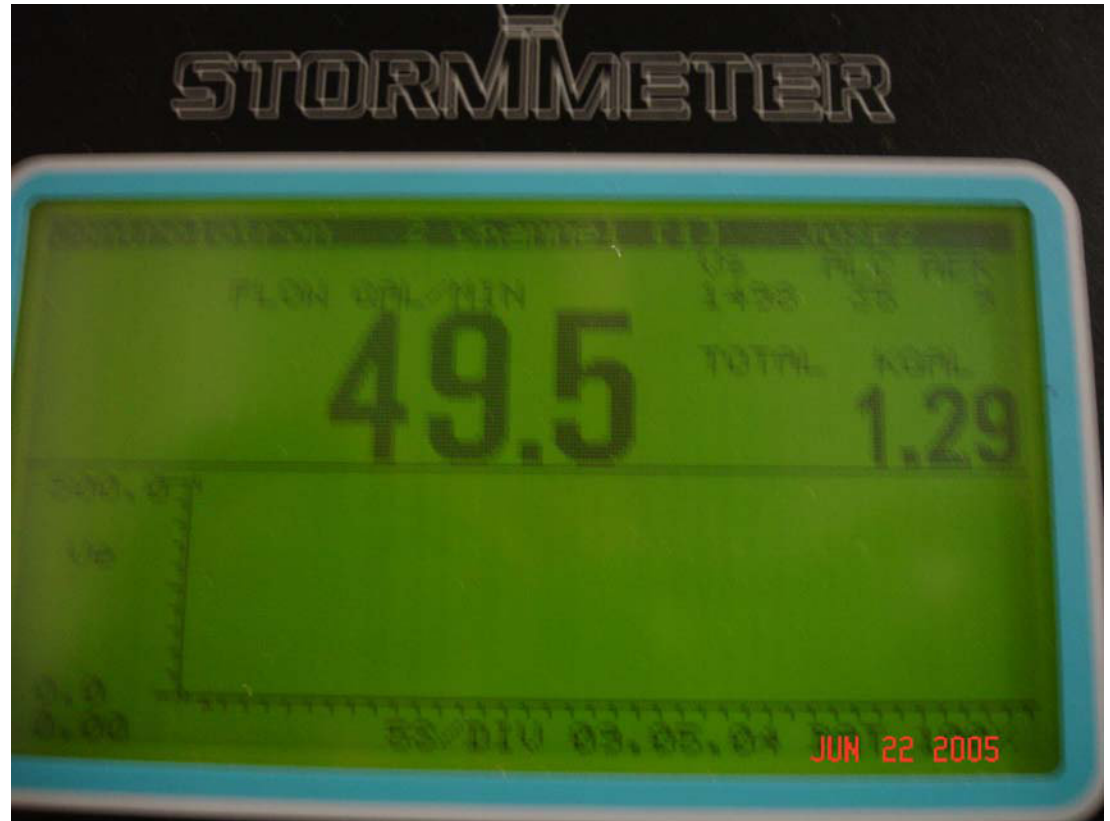
## Radiant loop, Photo #1574

Ultrasonic flow meter. Shows GPM flow on radiant loop after the 2" circuit setter was opened.

- Set 2" circuit setter to fully open. Pump flow increased to 49.5 GPM.
- Set the circuit setter to approximately 30 GPM to distribute as intended by the Engineer.
- Re-measured flow in Principals' office at 1.48 GPM. No true balancing valve installed to balance each zone of baseboard.

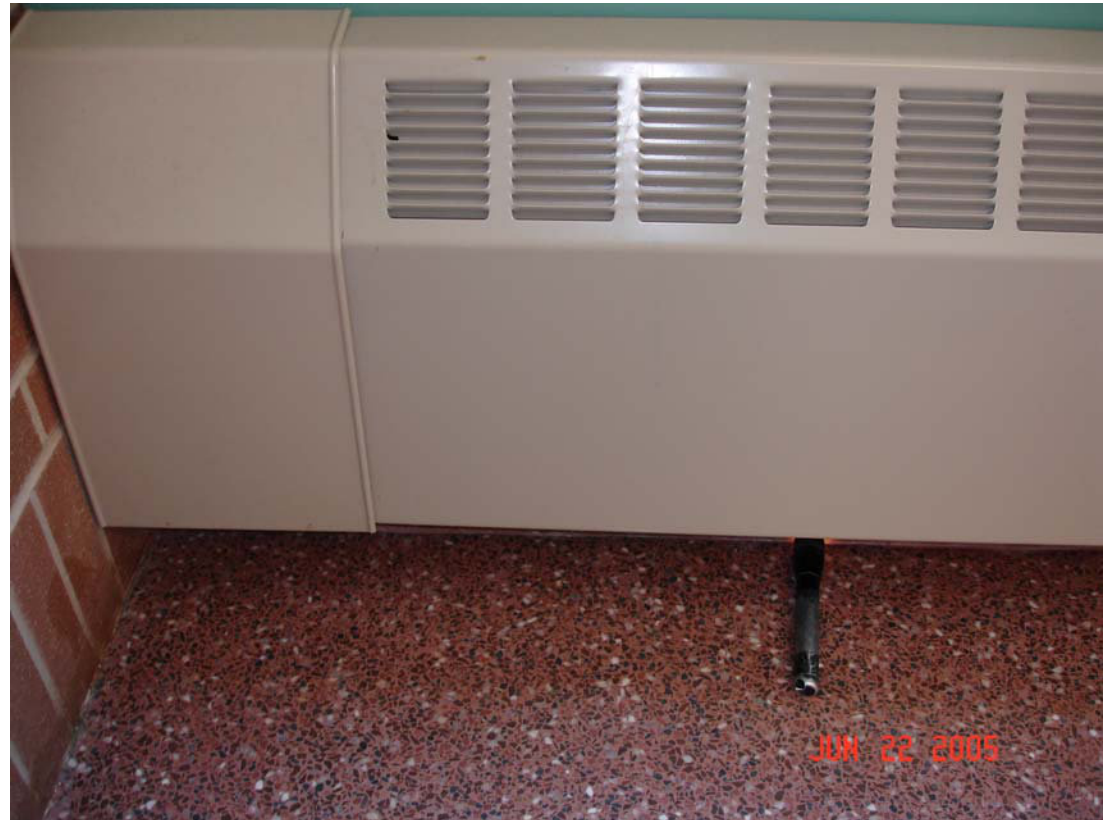
## Radiant loop, Photo #1590

Typical baseboard cover.  
Thermostatic radiator valve is  
installed at the location of the  
flashlight on the floor and is  
not readily accessible.

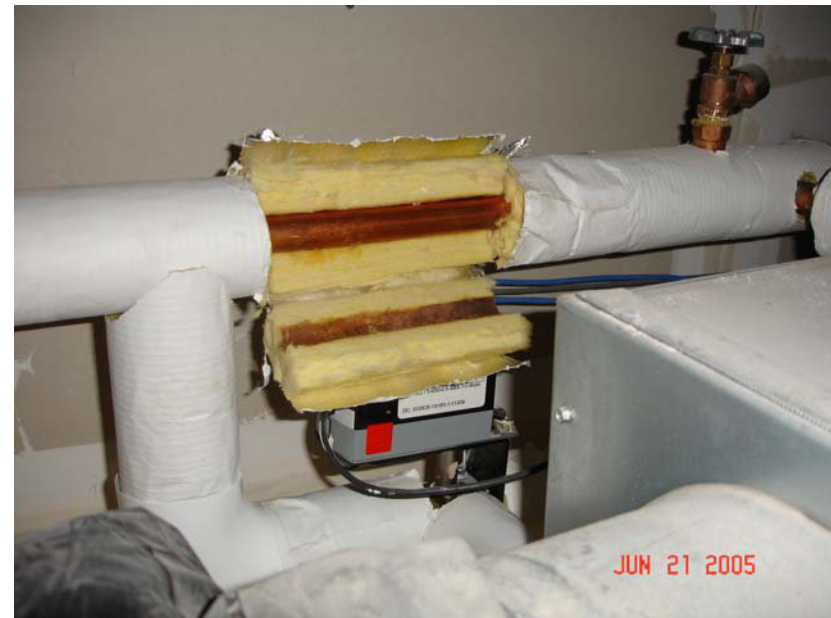
## VAV 104 , Photo #1547

- VAV reheat actuator on 3 way valve would not move when commanded by controller. Problem must be investigated and corrected.

View of balancer's flow reading location. AI took flow readings on the other side of the tee and read 0.75 GPM. The balancer reported 0.1 GPM. Flow is available, but the 3-way will not permit it to flow through the coil.

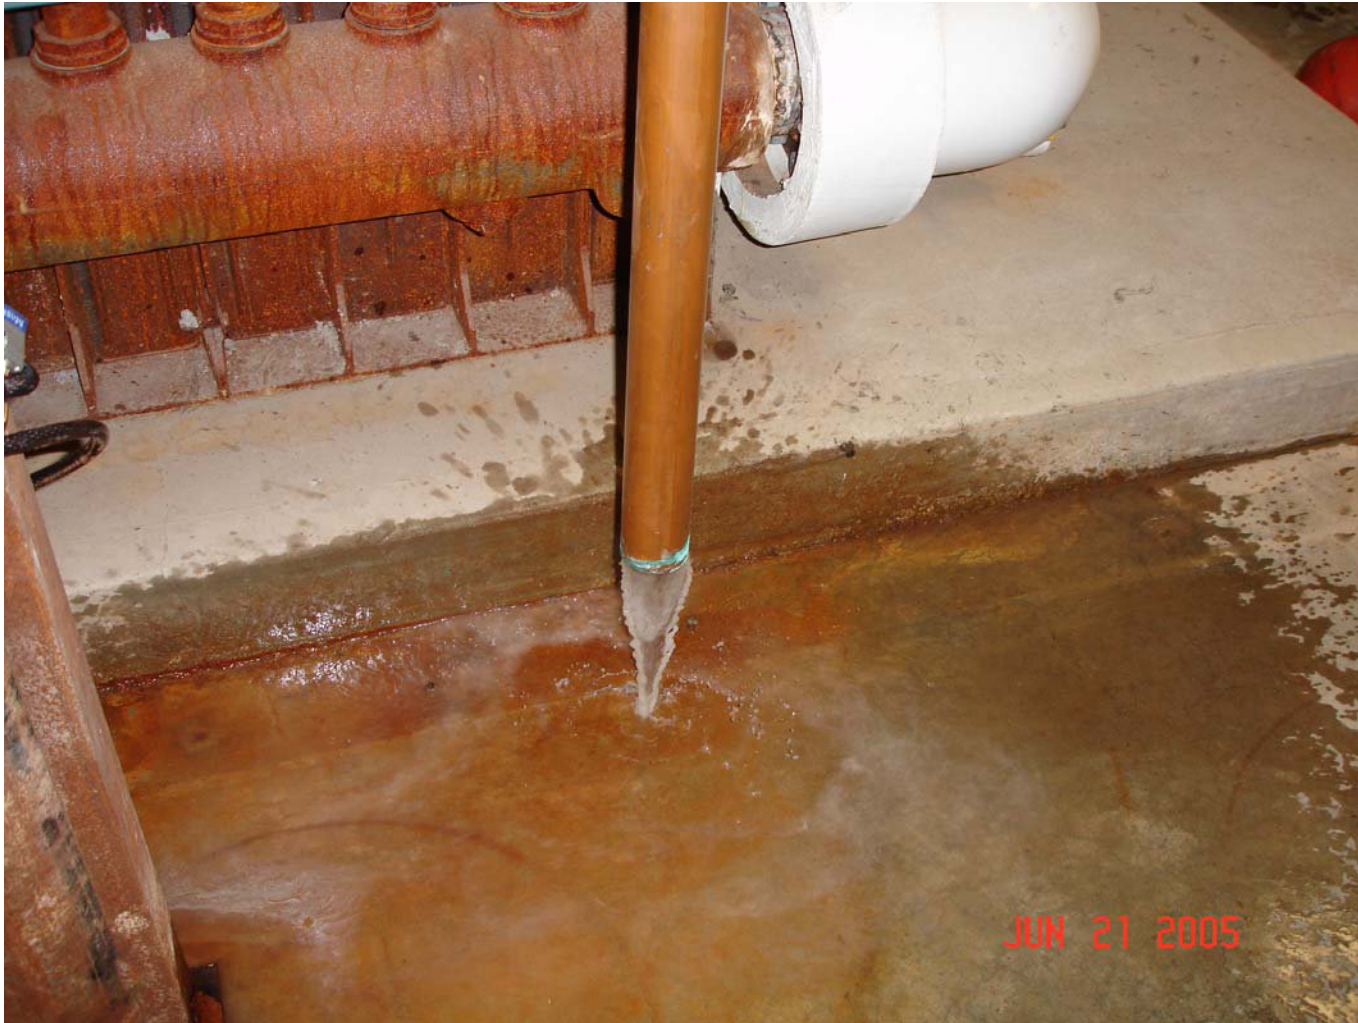
- Relief valves on both boilers are lifting each time the boilers fire from a cold start.
- Makeup valve set for 32 psig.
- Induced draft fan belts slapping and very loose.

Boiler photo #1528  
Relief valves lift as boiler heats

- Investigate and determine the cause of the relief valves lifting.
- Install a gauge between the makeup regulator and the ball valve to provide a gauge reading after adjustment.
- Repair belts.
- Boiler control circuit including outside air damper control were not tested.

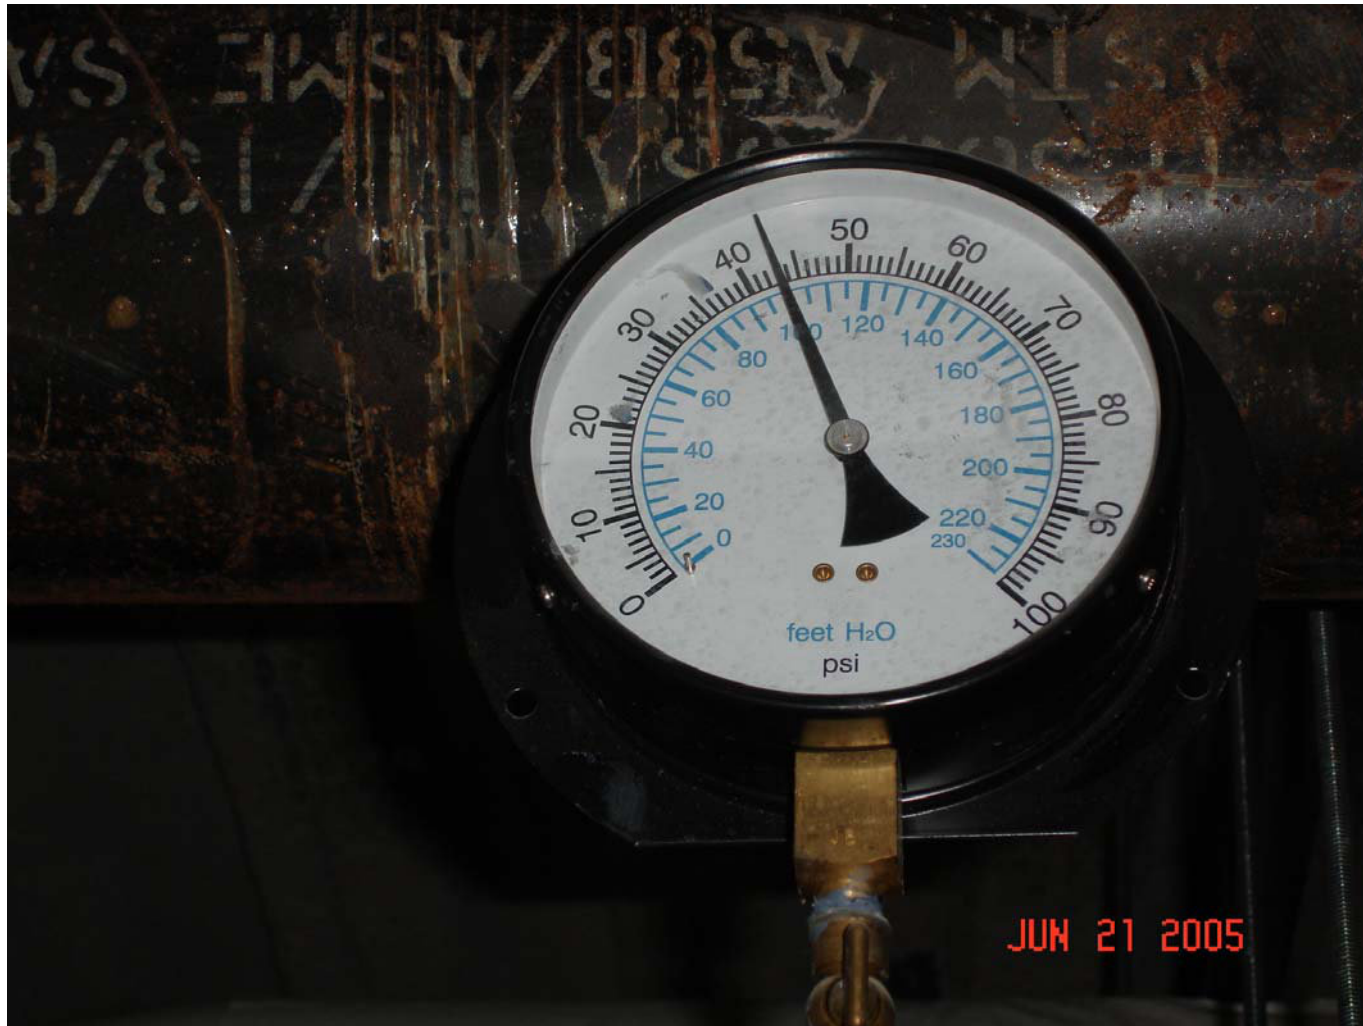
Boiler photo #1533  
System pressure above setting of relief valves
