Project Report

Project number: 17-2306

This report pertains to heat recovery unit HRU-4. This unit was reported as not operating in a stable condition. It was further explained that the BMS cannot provide a stable negative static pressure condition in the exhaust duct upstream of the HEPA filter bank. This unit is equipped with a VI as the volume control method. This report outlines the observations and steps taken to attempt to identify and correct the problem. Extensive records were provided to Engineer as proof that fan selections were the cause.

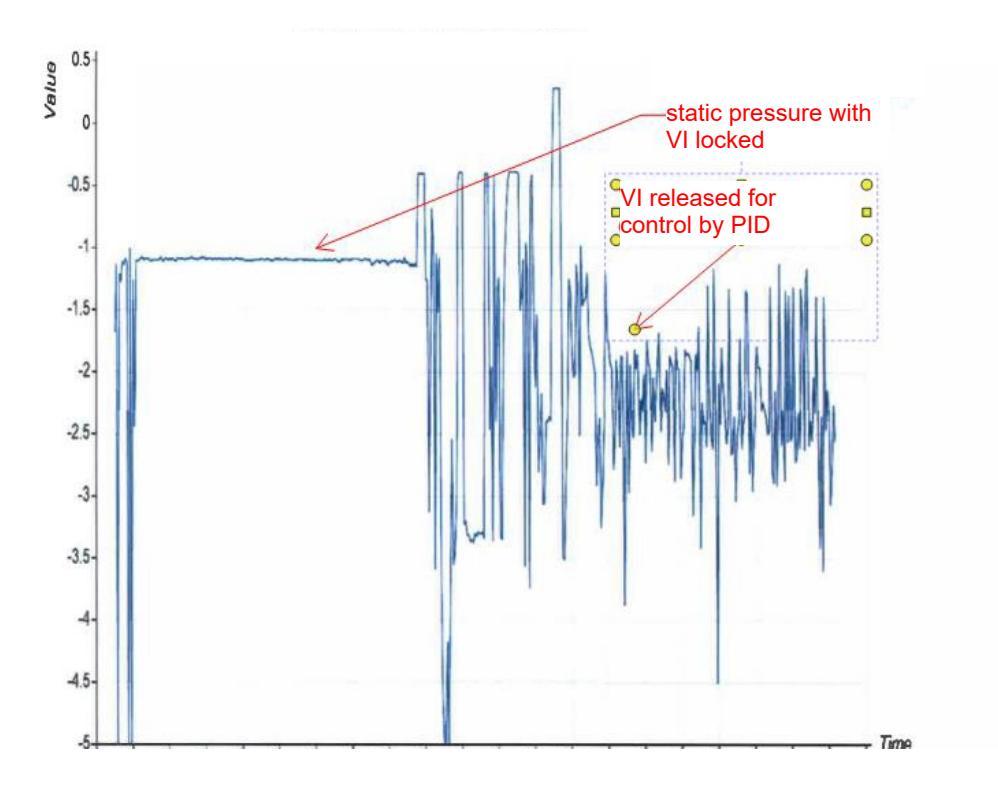
a. Tom reported that the system locked overnight, there were no reported static pressure excursions in the trend log (see below). The trend log for this is a 15 minute window.

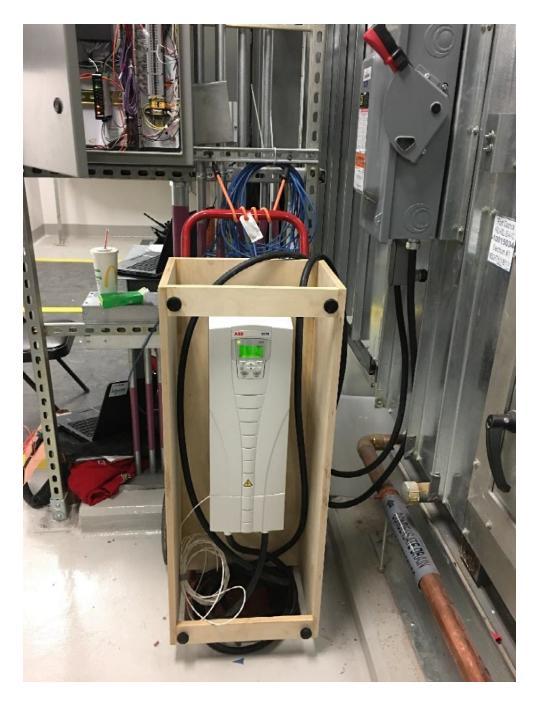
a. Installed a temporary portable VFD for testing.

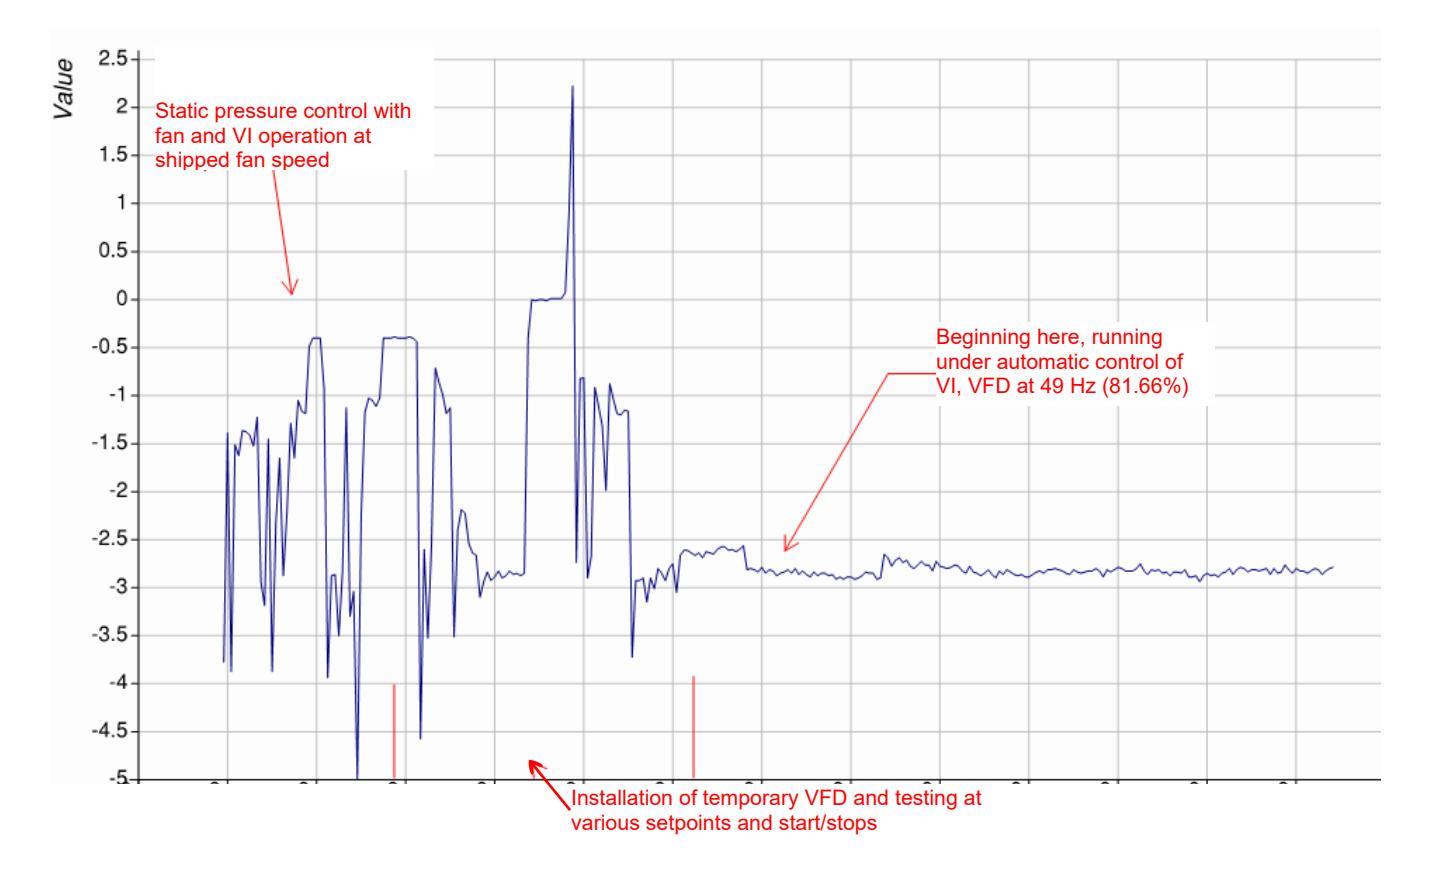
a. Obtained #4 static pressure trend log graph from the BAS contractor for the overnight. See below. The log shows stable static pressure control with VI control under automatic control by the BAS contractor. For this trend beginning 7/30/17, the static pressure setpoint at the sensor location (exhaust duct upstream of HEPA bank) was set to maintain -2.75" w.c. with a 0.2" w.c. dead band (VI doesn't move when static pressure is within -2.55" to 2.95" w.c.).
