## Rebuilding a Cooling Tower Fan Section

## ERU Case Study: Getting to the Root of a Lab Airflow Problem

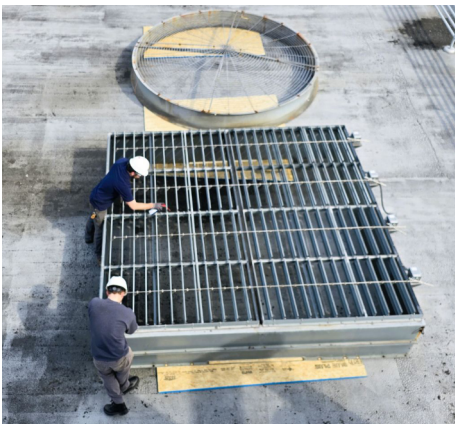
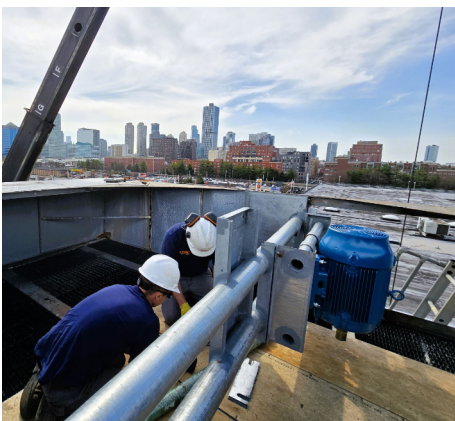
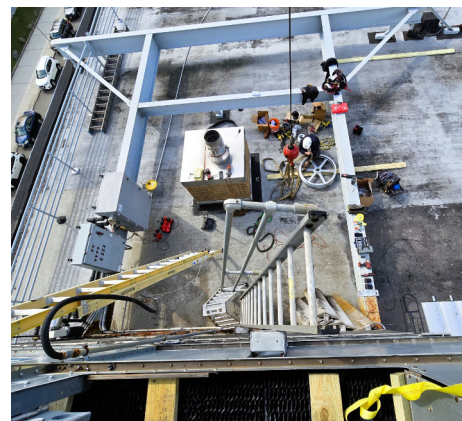
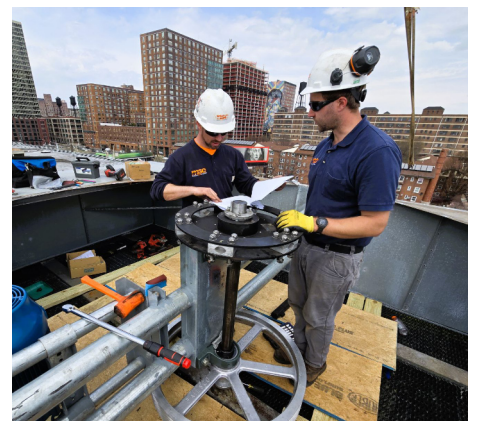
With the new structure installed, the team mounted the motor, sheaves, belts, shaft, bearings and blades, checking bearing alignment, pulley location, blade clearance and pitch, and torquing the blade hardware to the manufacturer's specifications for that blade type.

*Counterclockwise from top: The new fan motor is rigged to the tower; Apprentices Chris Struble and Nick DePascale lubricate damper louvers; Project Manager Glenn Daniel and Journeyman Alec Radovanovic review fan blade assembly clearance and pitch; The new pulley lands; Glenn and Alec verify pulley placement and the location of bearings on the fan shaft*

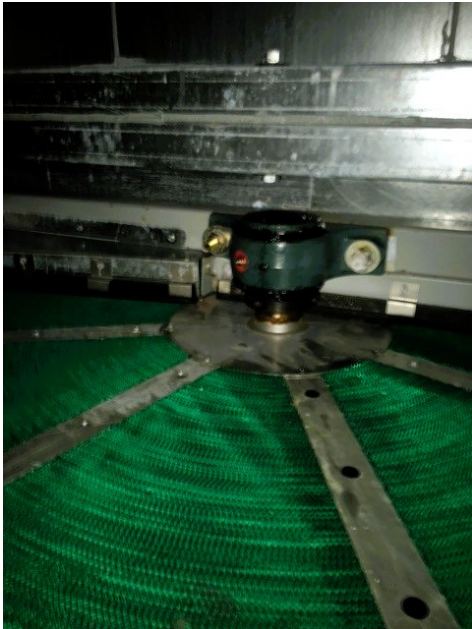
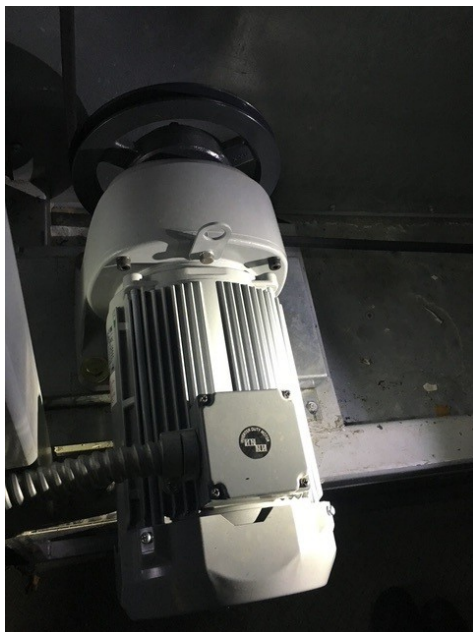
The supply and exhaust fan drives had crept up to 59 to 60 Hz, well above their original setpoints. The real answer came from diagnosing the ERUs while running rather than static. Once the slow-turning wheels were brought up to speed, the pie-shaped wheel sections were visibly uneven, with some protruding as much as an inch out of plane.

This misalignment, caused by faulty installation, accelerated mechanical wear between the wheels and their gasketing systems, prematurely degrading the seals and creating significant bypass between supply and exhaust airstreams. The longer the units ran, the worse it got.

Working one ERU at a time, technicians readjusted every section on all four wheels and retested at high RPM to confirm true rotation, a process that took several days per wheel. They then replaced all gaskets and brushes, verified seal performance against the manufacturer's tolerances, and installed and aligned new belts on the wheel drive motors.
