SERVICE CALL

Project Analysis: Screw Compressor Failure

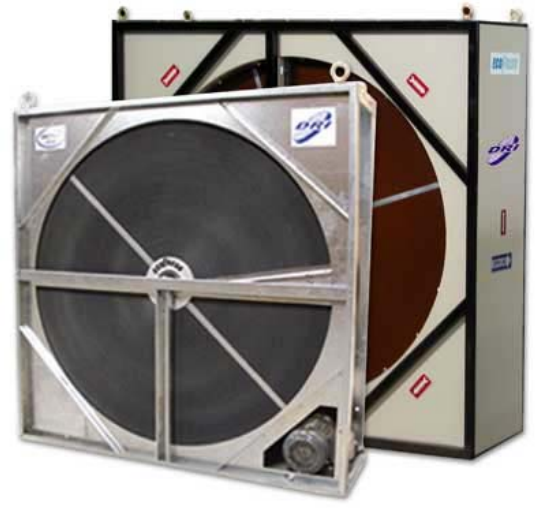
Heat Recovery - The two most common heat recovery systems are circulating glycol and heat recovery wheels. In this photo is a heat recovery wheel that rotates between the supply and exhaust duct work. A computer monitors the wheel performance and speed. This wheel is cooling 95F outside air to 79F. Pretty impressive.

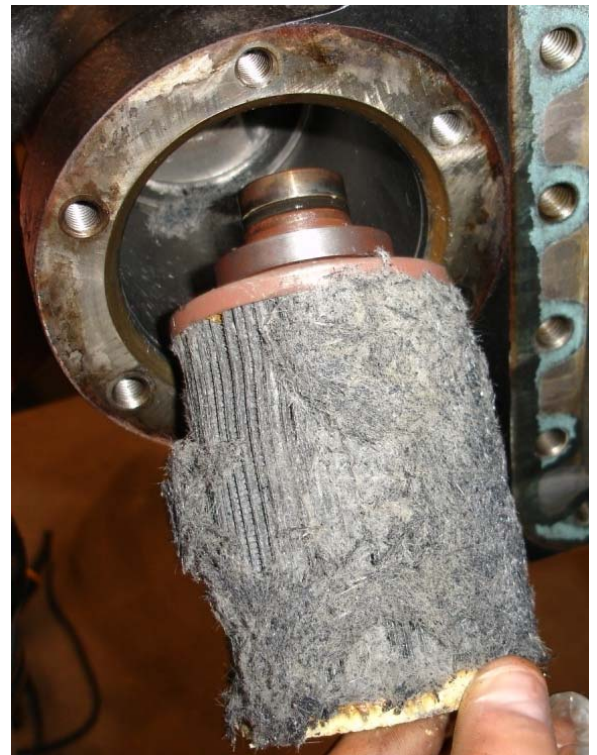
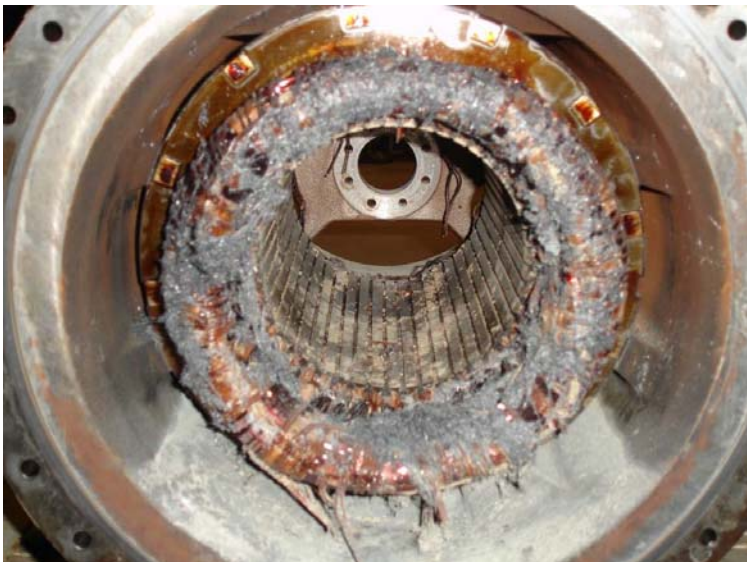
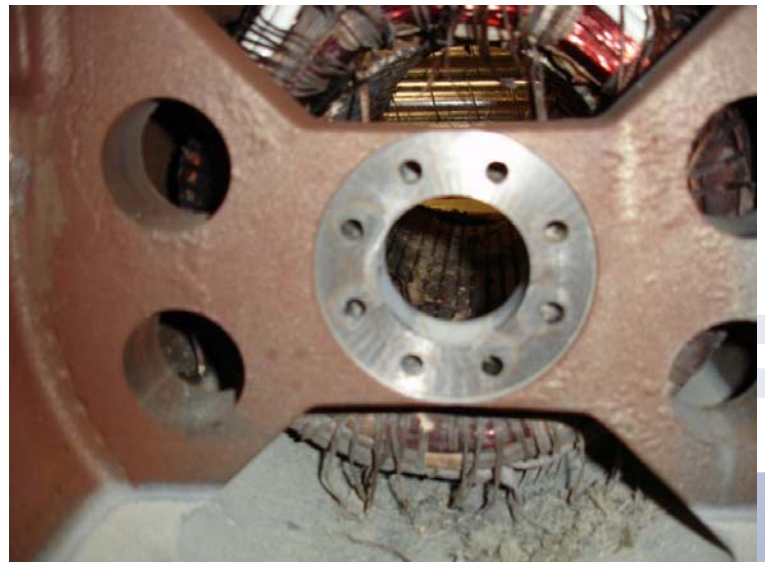
MSC recently performed a failure analysis of a McQuay screw compressor and prepared a fourteen page project report for a large New Jersey manufacturing firm. At teardown, gate rotor sealing gaskets were found to be shredded. The fibrous composite material was found throughout the compressor – in the separator, clogging the oil filter, and inside the screw end motor windings. Excessive heat had severely damaged motor windings and roller bearings.

MSC technicians concluded that a combination of rotor wear, excessive heat, and poor lubrication led to the failure of the screw compressor. Gate rotors had worn over time, and a low refrigerant charge contributed to the resultant overheating. The increased heat accelerated gate rotor wear, eventually restricting oil flow through the oil filter. Finally, heat levels were excessive enough to warp the composite gate rotor gasket material. This prevented the rotor from turning and resulted in complete compressor failure.
