CASE STUDY: Extending Chiller Life Through Strategic Tube Rehabilitation

Extending Chiller Life with Retubing and Epoxy Coating – Continued

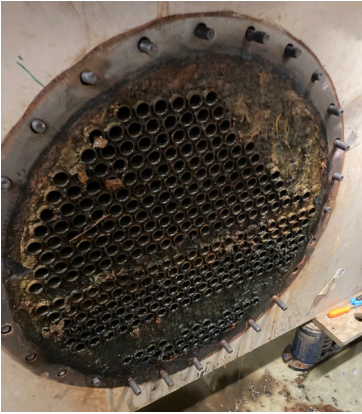
A large northern New Jersey medical facility's water-cooled centrifugal chiller was experiencing declining performance and increased maintenance issues. Based on MSC's proven track record and trusted relationships at sister facilities within their healthcare system, the facility management team selected us to perform a comprehensive assessment of their chiller's condition before deciding between costly emergency repairs, major rehabilitation, or complete replacement.

Our first step was comprehensive tube analysis using Eddy Current Testing (ECT) on both the condenser and evaporator tube bundles. This non-destructive testing method allows accurate assessment of tube wall thickness and identifies corrosion without dismantling the equipment.

1. Condenser tube replacement of the 48 most deteriorated tubes to restore heat transfer efficiency
2. Epoxy coating application to tube sheets to prevent future erosion and corrosion
3. Continued monitoring of evaporator tubes through annual ECT as part of preventive maintenance

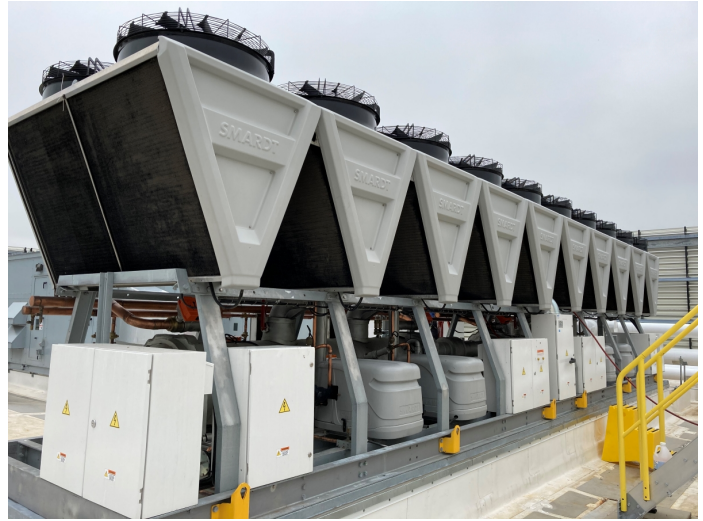
- **Performance Checks:** Thermal imaging provides valuable insights into the performance of heat exchange equipment. By scanning coils, heat exchangers, and piping systems, maintenance personnel can identify uneven heat distribution, blocked passages, air pockets, or fouling that might not be apparent through other testing methods. These proactive inspections can identify inefficiencies before they impact overall system performance, helping maintain optimal energy efficiency and extending equipment life.
