CASE STUDY

Lab Temperature and Humidity Swings Attributed to Sediment in Closed-Loop System

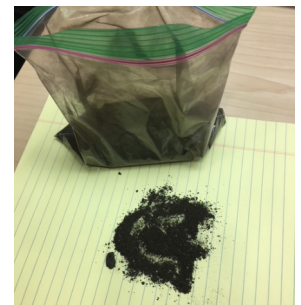
When black steel pipe is drained down and left unfilled for an extended period of time, rust can swiftly develop; this had been the case at the laboratory facility. The same can happen in pipes that contain air gaps and pockets due to failure to bleed the system after refilling. More common problems include lack of water treatment and poor preventive maintenance.

MSC blew down the system twice a day for the next two weeks, concentrating particularly on low points. We removed and cleaned strainers, and refilled the system with clean water treated with a rust inhibitor. Next, we installed a temporary sediment filtration system across the main supply and return lines. Filter socks were changed every other day. After two weeks of continuous filtering and blowing down the system, the water tested almost 100% rust-free and laboratory temperature and humidity were consistently back under control.
