Restoring Control: How MSC Resolved Critical TAB and Commissioning Issues on Laboratory Renovation Project

Static Pressure Diagnostic Solutions on Lab HVAC Commissioning and Start-Up

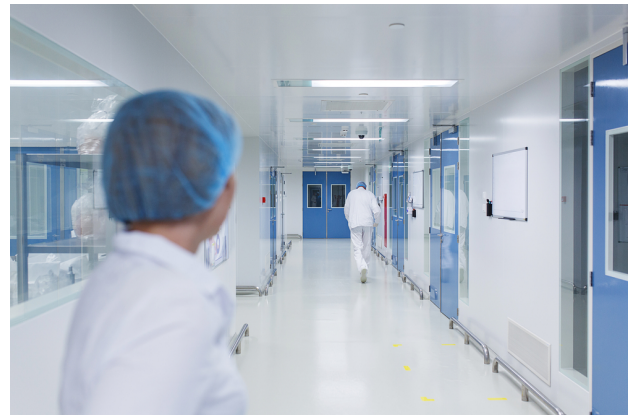
The facility's new laboratory space consisted of a common clean corridor that adjoined with a large office space. The corridor's ten process suites were difficult to control and in constant alarm.

The service technician and engineer MSC dispatched to the site began their diagnostic process with a physical inspection, and they found that numerous architectural finishes hadn't been sufficiently sealed to maintain a pressure cascade. Multiple door sweeps required height adjustments, and we noted various joints and crevices that were lacking sealant.

Once these repairs were underway, we determined that the corridor lacked a differential pressure transmitter (DPT) reading from a neutral reference. As a temporary remedy, we installed a Dwyer static pressure sensor outside the building from which to establish a steady corridor pressure of -0.05 inches of water column (WC). We advised that a permanent static pressure sensor be installed.

With the neutral reference point in place, we turned our attention to the differential pressure transmitters. We discovered that the selected DPTs were not rated for very low differential pressure, and as a result, they were recording inaccurate values and continually reporting false alarms. The DPTs were replaced with robust new instruments properly rated for the low-pressure application to provide accurate, repeatable DP readings between the corridor, airlocks, and suites.

We also inspected and tested all of the pneumatic fittings, revealing numerous leaks, one line that was cracked, and kinked tubing in several recessed static pressure tips. These issues were repaired and successfully pressure tested.

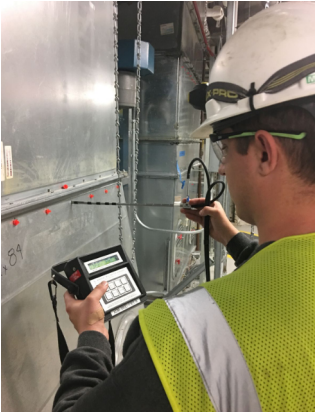
process suites. All VAV boxes on both supply and exhaust were tested, airflow-checked, and fine-tuned to maintain proper DP. We also discovered numerous automatic doors that were staying open too long or not fully closing against the air pressure, causing rooms to go into full-exhaust mode and triggering alarms.

Our team then set about installing NIST-traceable data loggers to measure differential pressure, temperature, and humidity throughout the space. We identified several loop-tuning errors as well as a number of actuator positioner problems. We worked with the BAS contractor to correct these issues and verify and test the sequence of operation.

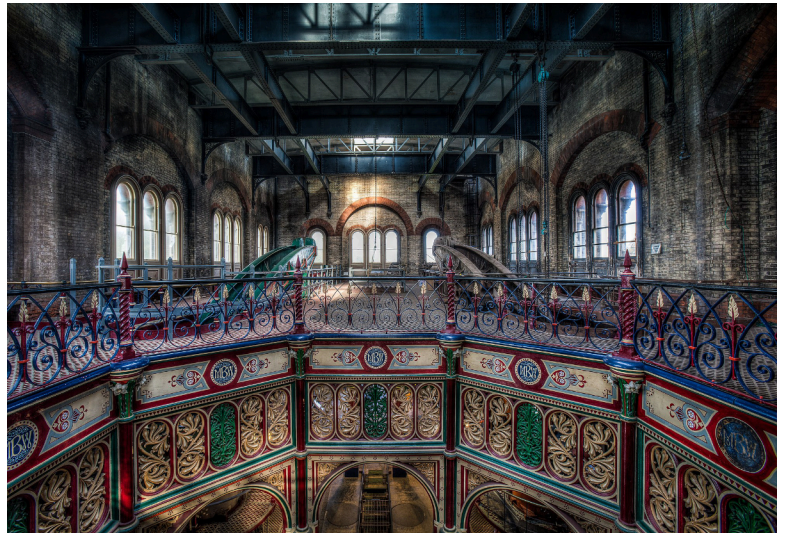
The steam engine was vital to British power and prosperity during the 19th century, which shows in the visual extravagance afforded to Crossness. Nicknamed the Cathedral on the Marsh, the station was adorned with intricate, colorfully painted ironwork, polished brass, grand columns, and ornate stone carvings. Four massive steam-powered beam engines, each featuring a 52-ton flywheel and a 47-ton beam and fed by twelve boilers consuming over 5,000 tons of coal each year, pumped sewage into a 6-acre reservoir, where it was held until being released into the ebb tide to be carried out to sea.

During the first half of the 1800s, London was plagued by a series of cholera outbreaks that claimed thousands of lives. The sewer system was overburdened by a growing population, and untreated waste overflowed into gutters and waterways unchecked. The breaking point came during the sweltering summer of 1858, infamously known as The Great Stink, prompting city officials to commission the construction of a new sewage system. The resulting 82-mile network of pipes culminated at the elaborate Crossness Pumping Station on the south shore of the River Thames.

Crossness Pumping Station was the first of its kind in the world, and it remained in operation until it was decommissioned and abandoned in the 1950s. Its historical and architectural significance was recognized in the 1980s, and the station was restored by the Crossness Engines Trust over the next 30 years. It is now open on Sundays for guided tours, during which one of the original pumping engines, the Prince Consort, is run under steam. [A video of the Prince Consort in operation can be viewed here.](#)
