SERVICE CALLS

LET THERE BE AIR: MSC Solves Church Air Balance Problems

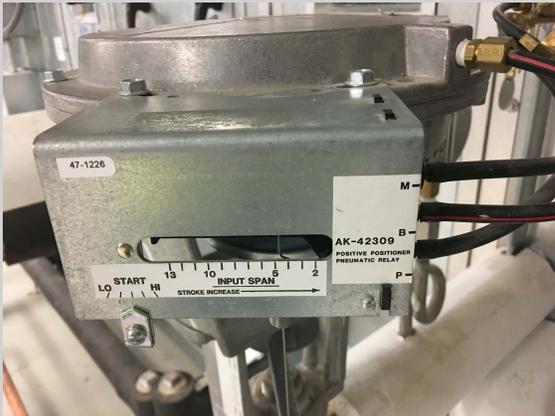
A new customer called MSC with **repeated valve and temperature control issues**. After our technician gathered data that showed that control signals were working fine with an AO 4-20 mA signal to the transducer, it soon became apparent that positioners were leaking and failing and did not have good repeatability. MSC recommended and the client agreed to replacing the positioners with higher-quality parts, completely eliminating the problem.

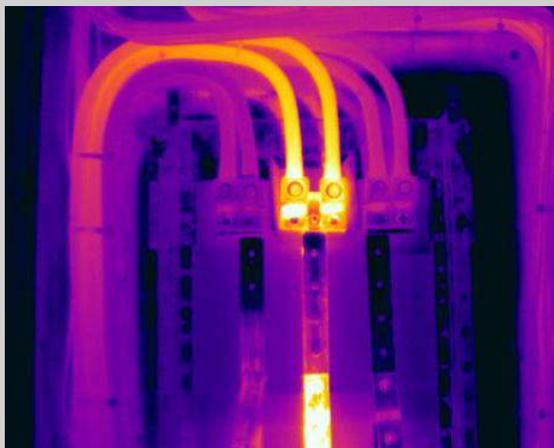
A large air handler supply fan was intermittently tripping a 125-amp breaker in an MCC. The fan was drawing 41 amps on each leg and had 480V present. A thermal imaging camera revealed that the B phase was very warm, and a hotspot on the side of the breaker confirmed a broken or loose connection inside the breaker. MSC located a reconditioned breaker at a substantial savings and had it installed within 48 hours.

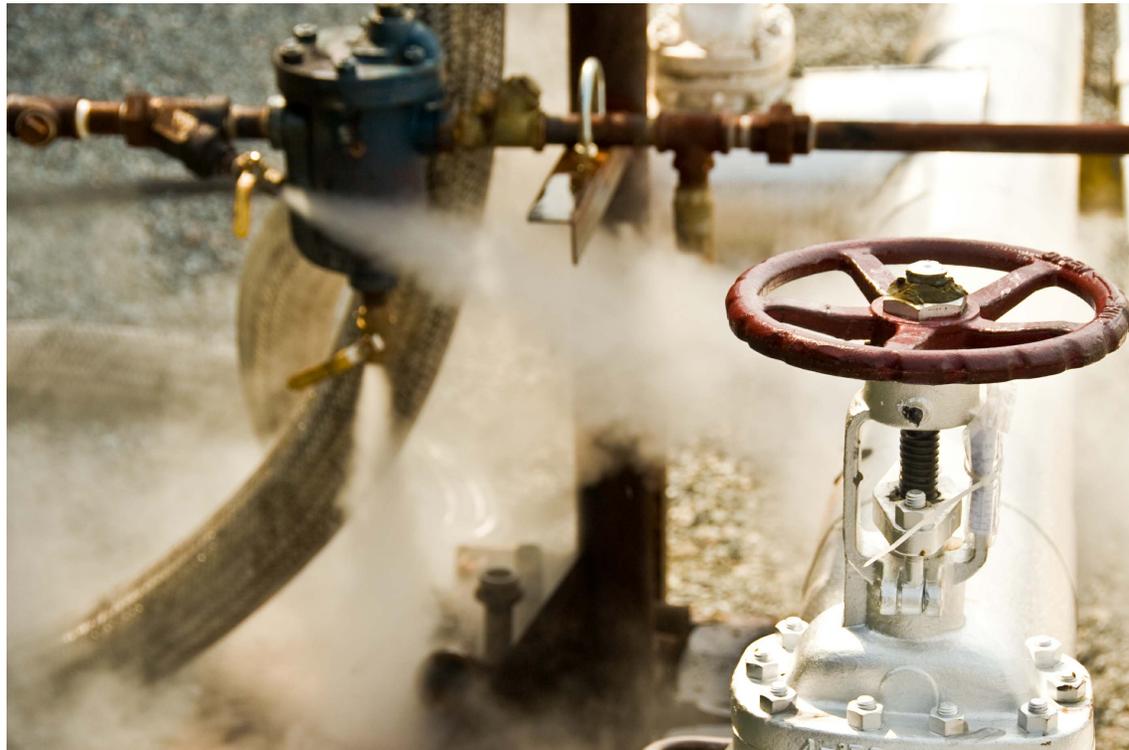
Steam systems are frequently afflicted with water hammer, a condition that can cause serious damage to vents, traps, regulators and piping. Water hammer can be identified by the hammer-like noise it creates.

The most common type of water hammer is usually caused by an accumulation of condensate trapped in a portion of horizontal piping. Steam picks up this “slug” of water and hurls it into the nearest pipe fitting at a high velocity. The second type is caused by a steam bubble being pushed into a wet return line or pump discharge piping. When the bubble cools, it implodes with great force. Main culprits are improperly dripped mains and faulty steam traps.

Water hammer is often considered to be more of a nuisance than a problem, but left unchecked, it can cause serious issues within a steam system that result in costly repairs. MSC is expert in steam systems and can resolve water hammer issue before major damage can occur.
