BACK-IN-BUILDING PREPARATIONS FOR WORKPLACE REOPENING

Proactive IAQ measures to safeguard the health of returning workers

MSC CASE STUDIES

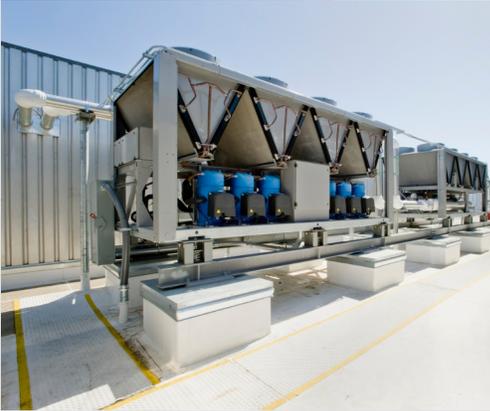
When a new manufacturing facility began experiencing **poor dehumidification**, MSC was called in to investigate. After noting high chilled water temperature readings of 52-53°F instead of the desired 44°F, we discovered two air-cooled chillers piped in parallel were missing isolation valves, causing chilled water to mix through both units. The resulting rise in AHU discharge air temperatures, in turn, caused humidity levels to rise. Installation of isolation valves solved the problem.

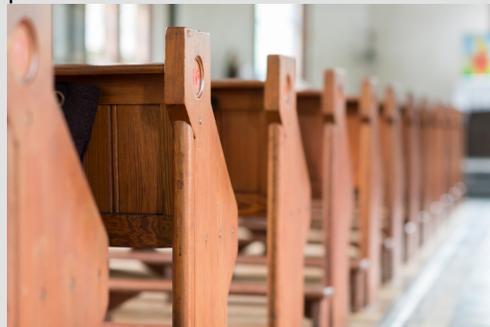
MSC was called in a panic one hot Saturday morning when **temperatures on one side of a church were steadily rising**, and a wedding was set to take place that afternoon. Finding very little air coming from the diffusers, our tech checked static pressure and traced all of the ductwork on the hot side of the church. It turned out that an access door latch had popped open in a rarely-used storage space, sending most of the cool air into the ceilings. Temps dropped back to normal within two hours, just in time for the ceremony.

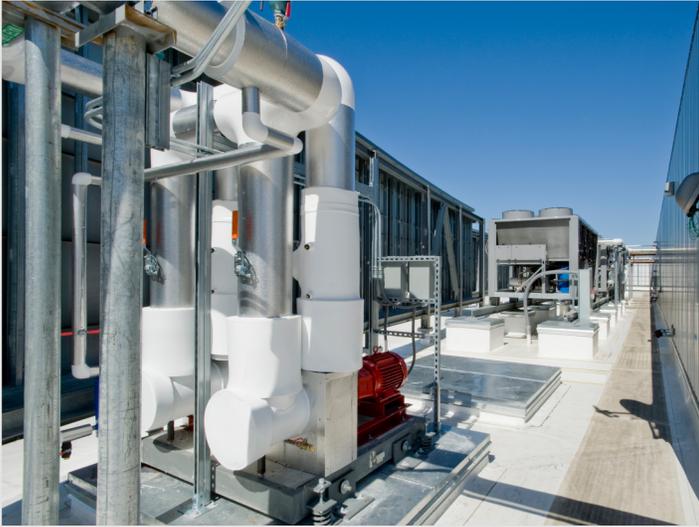
Multiple HVAC Problems Plague Newly-Opened School

A newly-constructed northern New Jersey school was granted a Temporary Certificate of Occupancy at substantial completion, allowing it to open at the beginning of a new school year. Staff and students immediately complained of comfort issues throughout the 100,000 sq.-ft. school, and local officials signaled that a final CO would not be granted until the problems were resolved. When project subcontractors denied responsibility and began pointing fingers at one another, MSC was called in to perform an extensive evaluation of the school's HVAC systems and report their findings in a presentation to all involved parties.

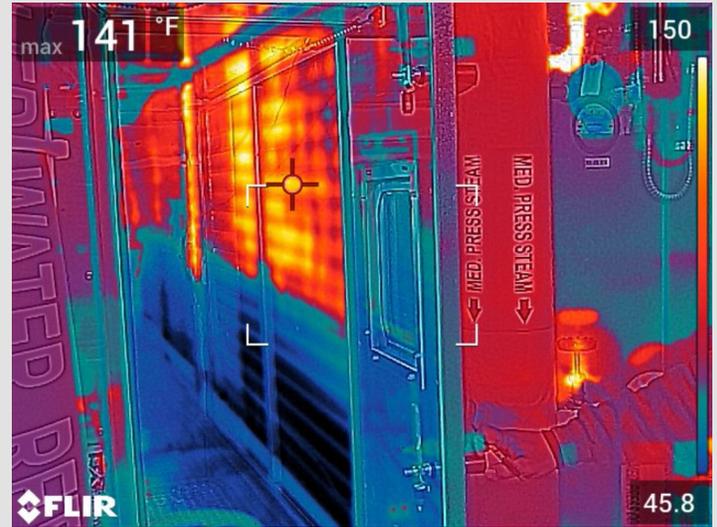
Underperforming Heating Coil at Large New Jersey Hospital

MSC was called in to examine and diagnose an issue with a steam heating coil located in a lower level mechanical room in a large NJ hospital. The coil was logging condensate and not draining properly, causing nearly half of the coil surface area to remain unheated. Freeze stats had been tripping so often that a hospital maintenance worker had jumped out the safety to stop it from happening. Utilizing a thermal imaging camera and various testing procedures, we determined that space and elevation issues rendered the existing coil and trap incapable of overcoming external pressure drops required to effectively remove the steam condensate.

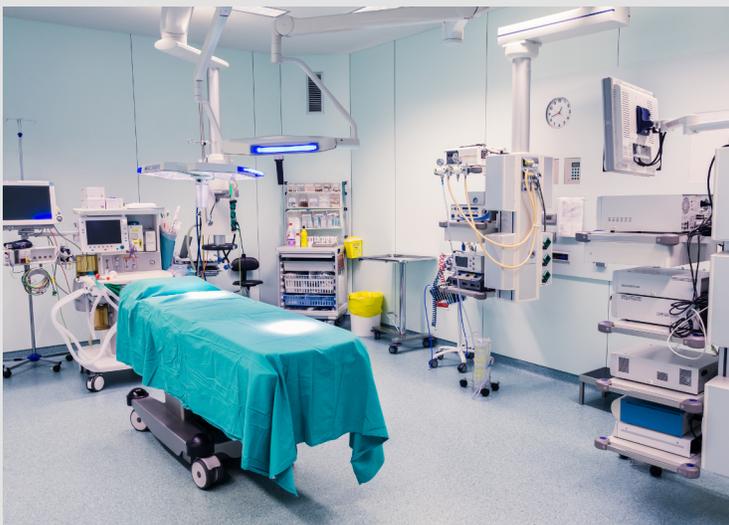
Slow Space Pull-Down and Poor Temperature Control in OR

A hospital reported slow temperature pull-down between surgeries involving surgical teams with different space requirements as well as poor temperature control. Mechanical Service Corporation was called in to determine the cause of these issues and provide recommendations for improving performance. While the equipment proved to be of adequate size and configuration, a number of system deficiencies were identified, the main problem being excessive air volume that did not allow proper heat exchange to occur.
