# STATE OF THE INDUSTRY REPORT

## COMMERCIAL HVAC

**2023**

COOLING  
SEASON RECAP

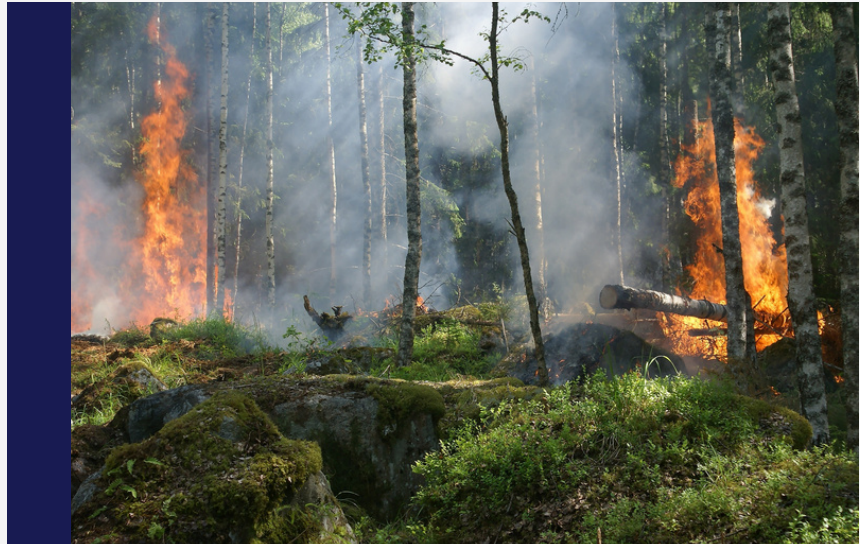
Massive levels of PM2.5 fine particulates caused accelerated filter loading, resulting in a large decrease in expected lifespan.

Due to the extreme smoke conditions MSC advised all clients to inspect all HVAC system filters once the current crisis abated.

In addition to advising facilities personnel to check filters and pre-filters to determine whether early replacement will be required, MSC techs also began checking clients' filters as part of all maintenance and service calls and recommending replacements when appropriate.

While techs observed that a handful of clients required early filter replacement, others who had installed bipolar ionization technology during the COVID-19 pandemic fared better and were less likely to require premature replacement.

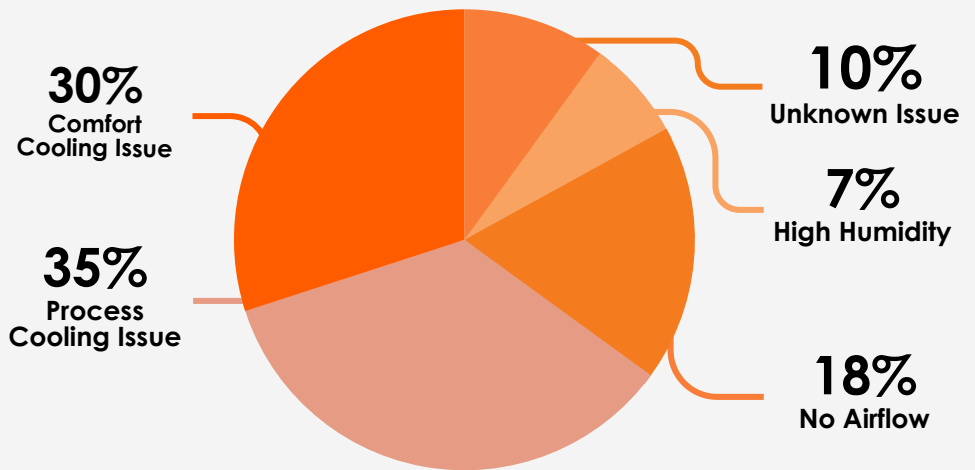
### REASONS FOR THE CALL

Overall, emergency service calls were on par with percentages of previous years with process cooling issues ranking as the top reason for the service call. These percentages are solely representative of customers' interpretations of the issue at hand.

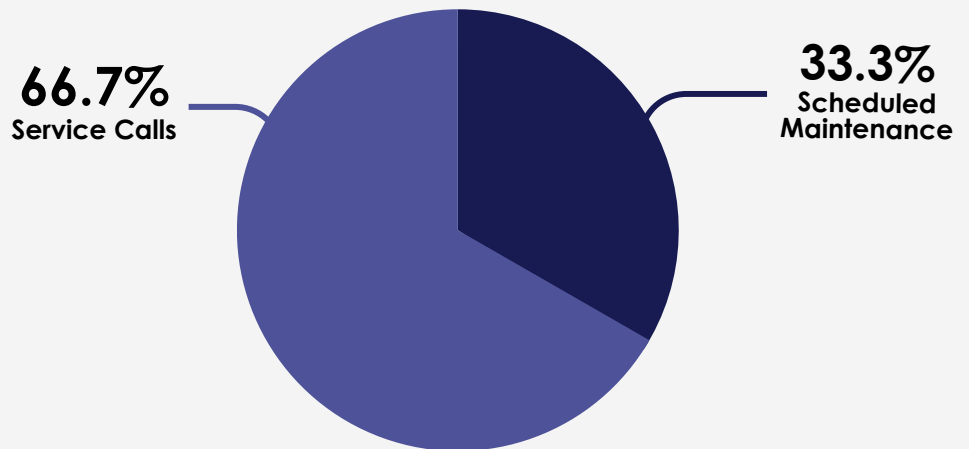
### BREAKDOWN OF JOBS

MSC techs spent the majority of hours in the field going on scheduled maintenance calls with only a little over 30% of their time allocated to emergency service calls.

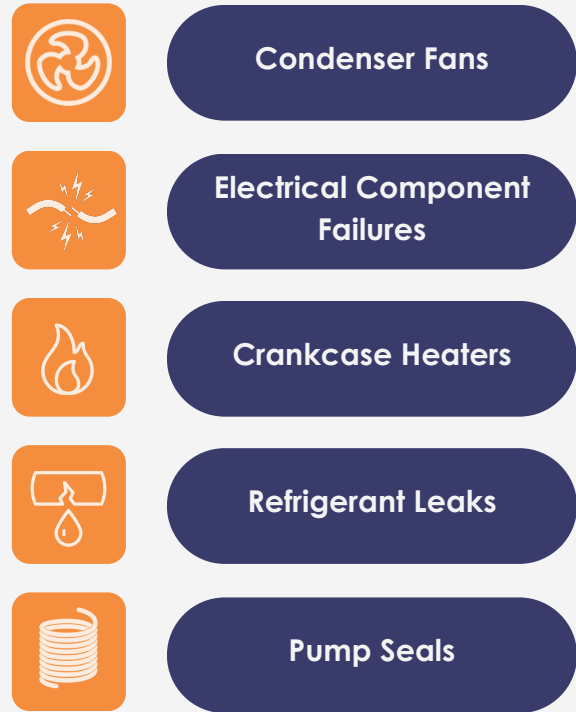
### TOP 5 MAINTENANCE ISSUES

The top maintenance issues observed by MSC technicians also correlate with data from previous years with condenser fans representing the top maintenance issue between January and June 2023.

During routine maintenance technicians also frequently observed plugged filters, dry-rotted belts, clogged pump strainers, and lack of cooling tower maintenance.

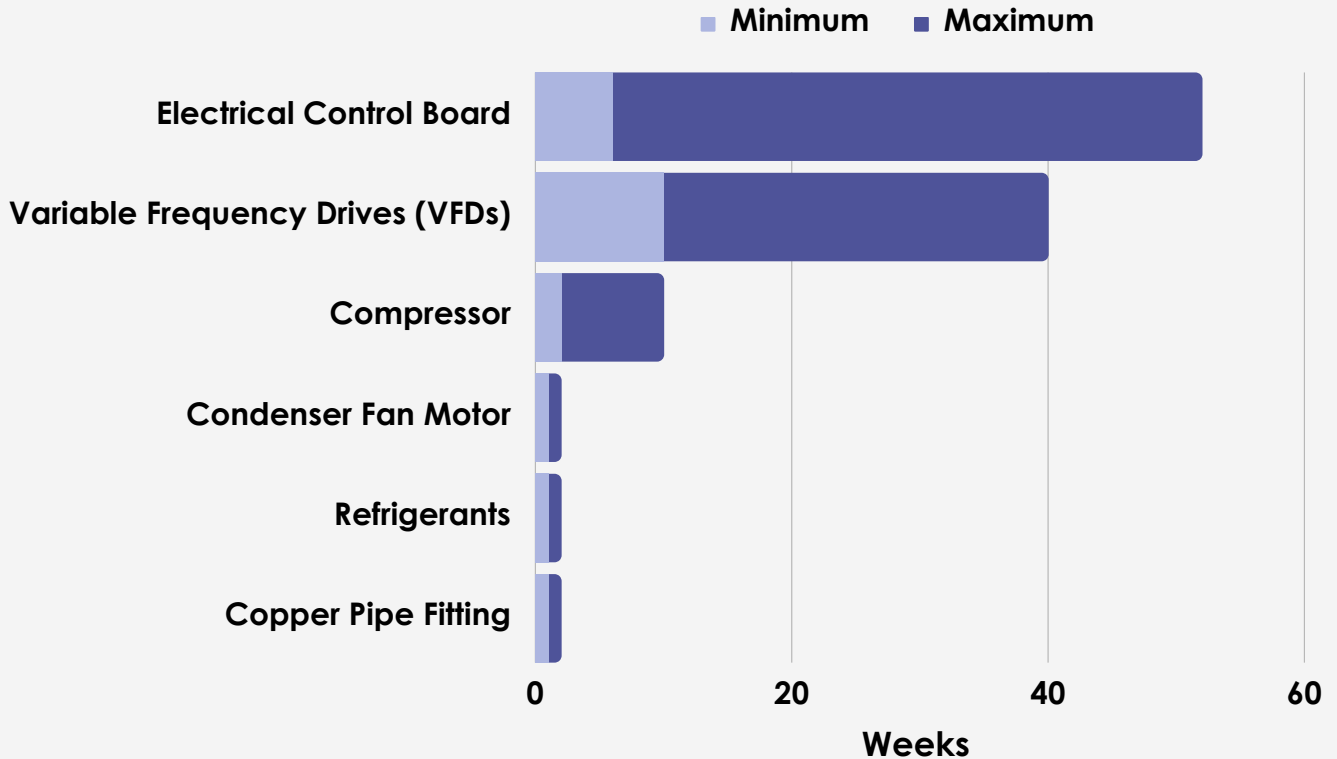
While lead times have decreased significantly for some key HVAC components such as refrigerants, copper piping and condenser fan motors, supply chain issues are still causing major delays for electrical components such as control boards and VFDs which can still take several weeks, months, or even a year to come in depending on the part.

Although many parts are currently in stock, more complex or larger items such as certain size condenser fans for example, may take longer to ship. At minimum, MSC technicians are advising facility managers who anticipate needing replacement parts to place orders two weeks to four months in advance.

Due to extended lead times for several parts, MSC is currently advising customers to **evaluate parts replacement needs as much as two years in advance**, especially for parts with electrical components.

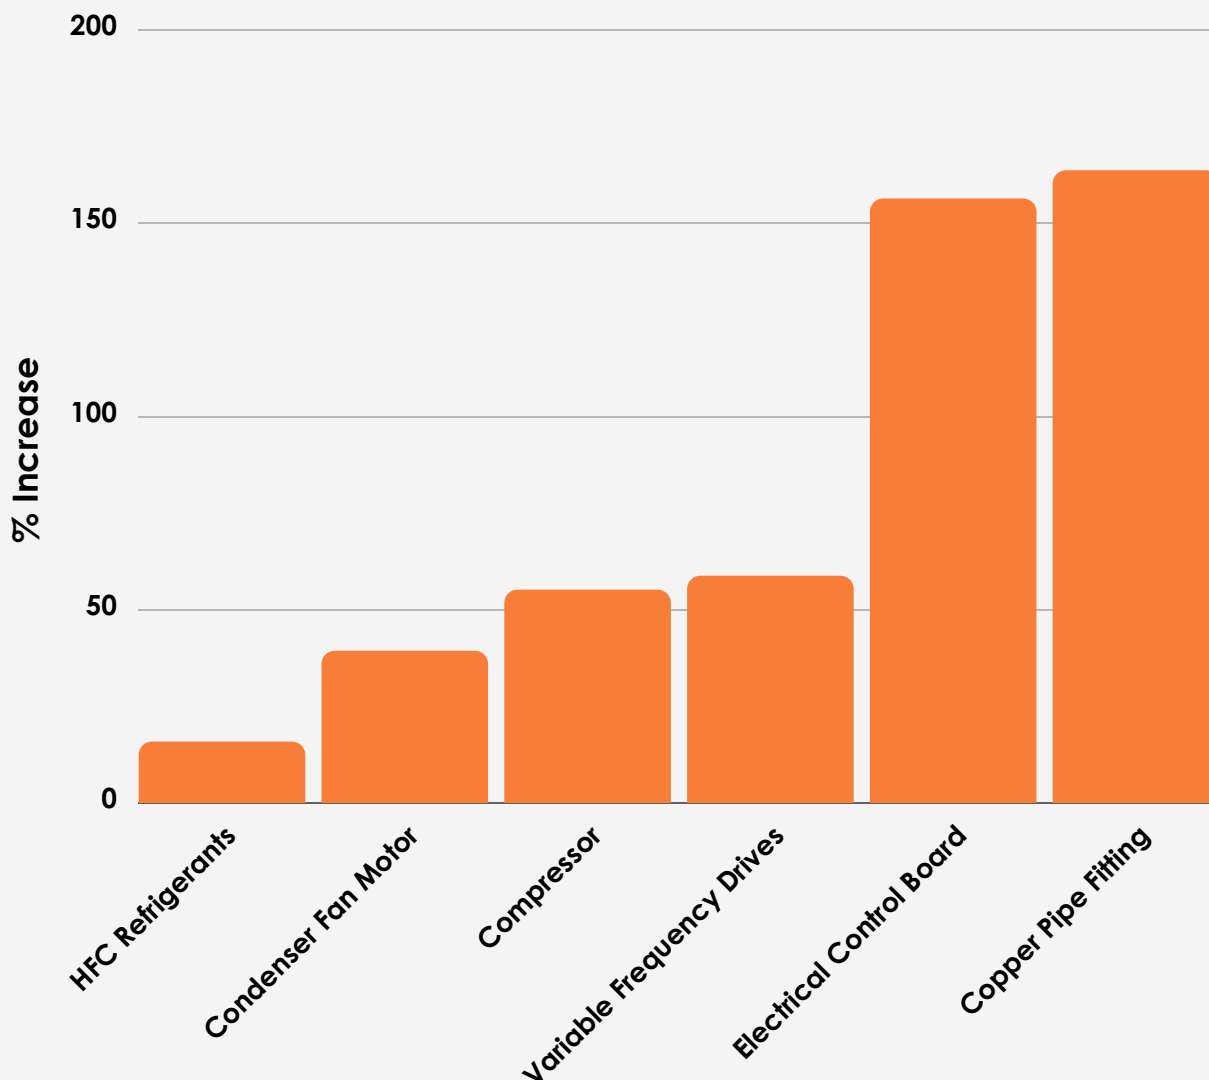
Coupled with the widespread impacts of inflation over the past several months, costs for various HVAC components have skyrocketed dramatically, most notably among electrical components such as control boards and copper pipe fittings, which have each experienced an over threefold increase in cost.

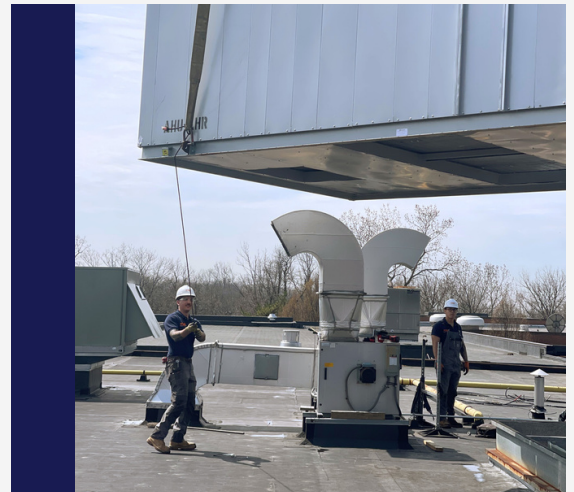
The day before the crane arrived, our crews shut down and disconnected the existing units, and prepped the rooftop for the new ones. Then, two dedicated crews facilitated the crane picks with one group assigned to manage the existing unit removal and another handling the new unit installation. Over the course of the following two days, MSC techs were hard at work connecting, configuring, and testing the new equipment to bring the system online and ensure critical operations were up and running before members returned to the center on Monday morning.
