INSIDE...

- Recognizing and Repairing Fan Stall
- Service Calls - LCD Thermostats & Dampers
- UV-C Systems Improve IAQ / Submetering Solved
- Warranty Shmarranty

NEWSLETTER - JULY 2017

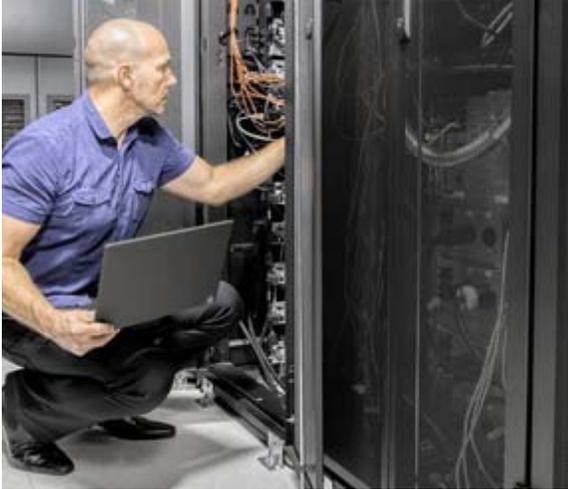
A new customer called MSC with HVAC problems in an MDF room housing critical servers & switches that operated the building's teledata systems. The secondary back-up cooling system, which consisted of two DX split systems, was not operating. MSC quickly discovered programming issues on LCD thermostats. As it turned out, the system had never been tested or set up properly, and a simple temperature adjustment brought the backup cooling system back online.
