SERVICE CALLS

LET THERE BE AIR: MSC SOLVES CHURCH AIR BALANCE PROBLEMS

NEWSLETTER - NOVEMBER 2018

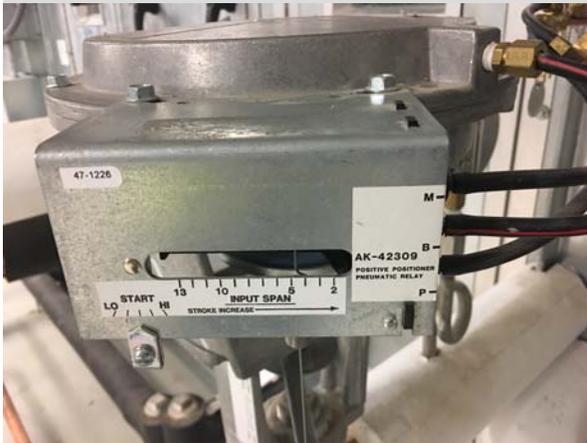
A New Customer called MSC with repeated valve and temperature control issues. After our technician gathered data that showed that control signals were working fine with an AO 4-20 mA signal to the transducer, it soon became apparent that positioners were leaking and failing and did not have good repeatability. MSC recommended and the client agreed to replacing the positioners with higher-quality parts, completely eliminating the problem.

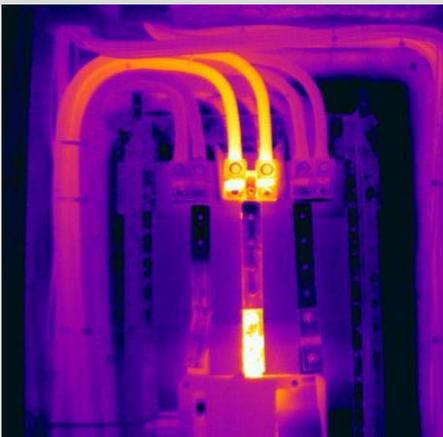
A Large Air Handler supply fan was intermittently tripping a 125-amp breaker in an MCC. The fan was drawing 41 amps on each leg and had 480V present. A thermal imaging camera revealed that the C phase was very warm, and a hotspot on the side of the breaker confirmed a broken or loose connection inside the breaker. MSC located a reconditioned breaker at a substantial savings and had it installed within 48 hours.

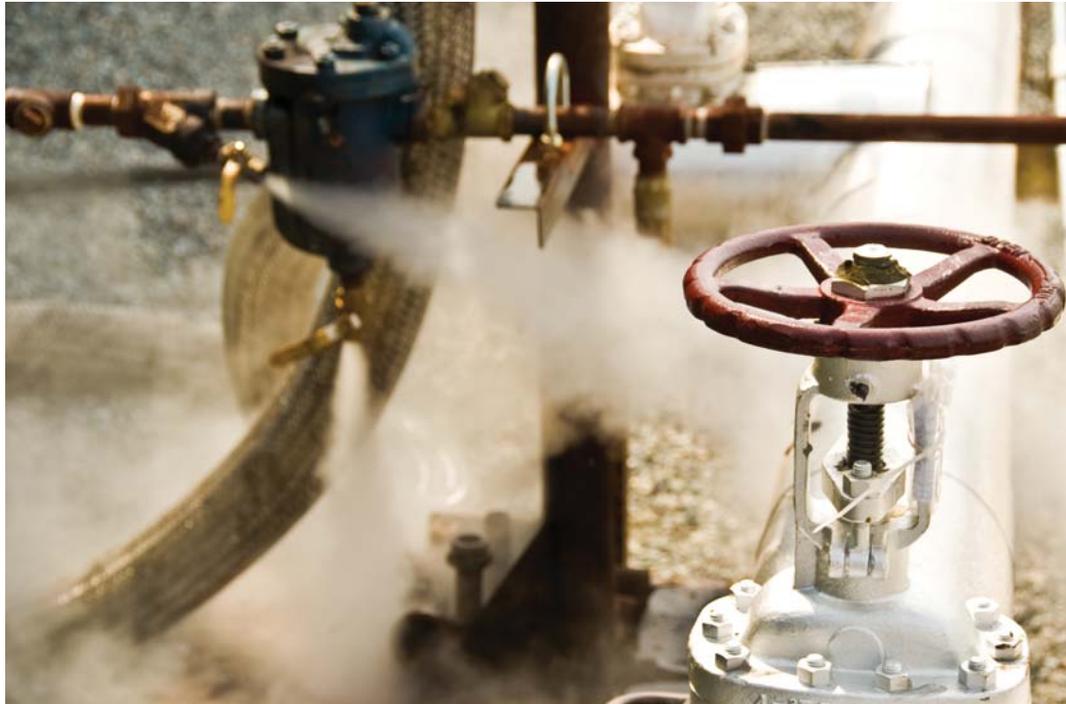
Steam systems are frequently afflicted with water hammer, a condition that can cause serious damage to vents, traps, regulators and piping. Water hammer can be identified by the hammer-like noise it creates.

The most common type of water hammer is usually caused by an accumulation of condensate trapped in a portion of horizontal piping. Steam picks up this “slug” of water and hurls it into the nearest pipe fitting at a high velocity. The second type is caused by a steam bubble being pushed into a wet return line or pump discharge piping. When the bubble cools, it implodes with great force. Main culprits are improperly dripped mains and faulty steam traps.

Water hammer is often considered to be more of a nuisance than a problem, but left unchecked, it can cause serious issues within a steam system that result in costly repairs. MSC is expert in steam systems and can resolve water hammer issue before major damage can occur.
