# Middle School

Summary Update of Diagnostic Work  
Performed Over a 3-Week Period

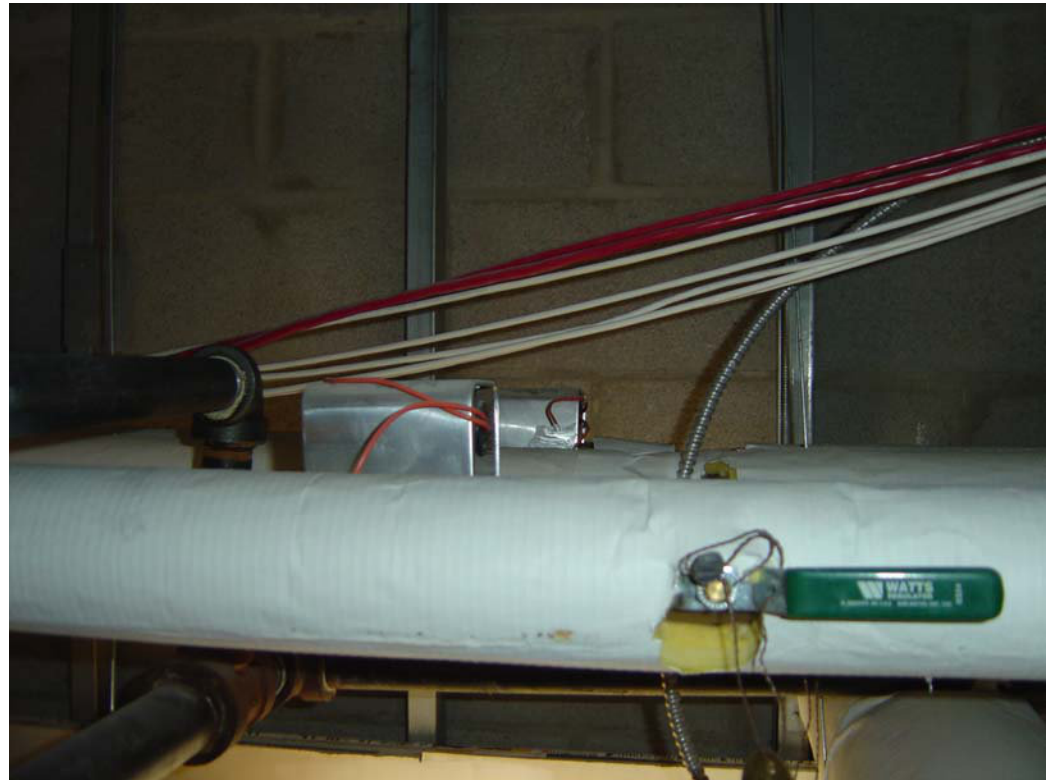
## Unit ventilator, Photo #1422 room #127 ceiling

- Photo shows two hot water baseboard zone valves installed above the ceiling of room #127. These valves control the hot water baseboard behind the book cases in rooms #127 and #222.
- Both valves are not wired and are manually locked in the open position.
- Both rooms have been reported to overheat.
- We only sampled this area. We did not check other units.

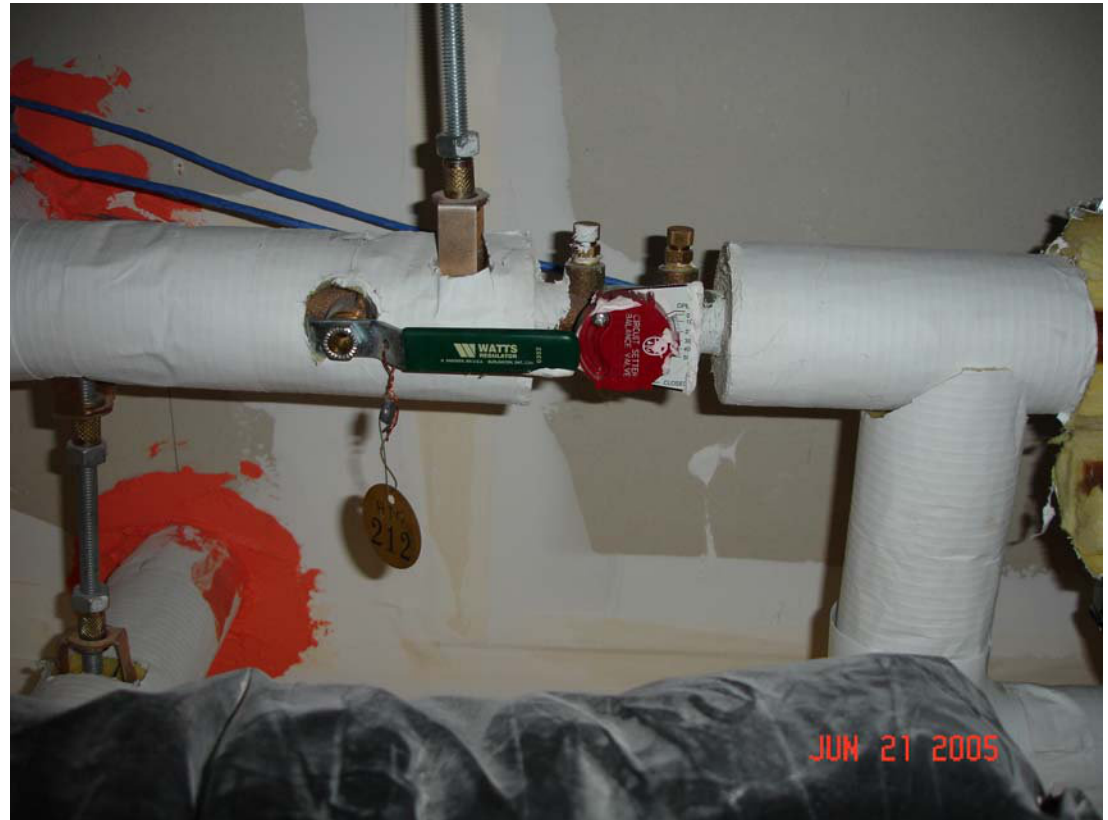
## VAV 104 , Photo #1547

View of balancer's flow reading location. AI took flow readings on the other side of the tee and read 0.75 GPM. The balancer reported 0.1 GPM. Flow is available, but the 3-way will not permit it to flow through the coil.
