## Rebuilding a Cooling Tower Fan Section

## ERU Case Study: Getting to the Root of a Lab Airflow Problem

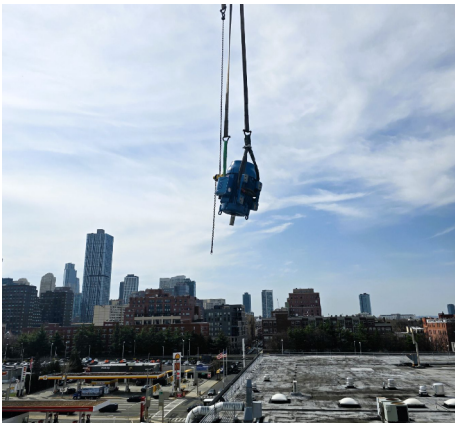
MSC recently completed a full fan section rebuild on a cooling tower in Jersey City. The project involved replacing nearly every component of the fan assembly, including the motor mounting cross structure and tensioner, fan motor, motor and fan drive sheaves and belts, fan drive shaft and bearings, and the fan blades with their mounting hardware.

To gain access, our crew disconnected the tower's discharge damper assembly and rigged it off the tower. A lumber work platform was built inside the tower to protect the fill media while the old driveline was removed. A crane handled the heavy lifts, taking out the existing motor bracket and cross member and setting the new components in place.

With the new structure installed, the team mounted the motor, sheaves, belts, shaft, bearings and blades, checking bearing alignment, pulley location, blade clearance and pitch, and torquing the blade hardware to the manufacturer's specifications for that blade type.
