SERVICE CALLS

LAB: Project Report

NEWSLETTER - JANUARY 2015

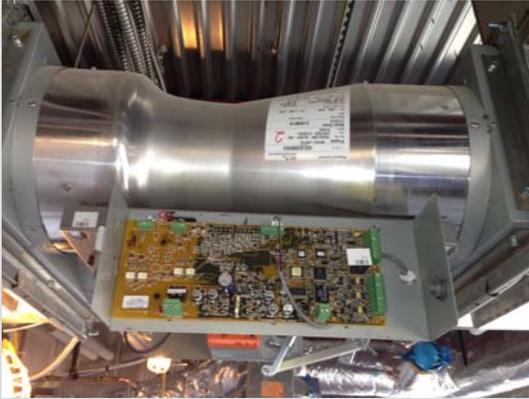
Low exhaust - Above, MSC was called in to troubleshoot a low exhaust airflow condition. Though the exhaust boxes were constant-volume Venturi-style valves, normally very reliable, flow stations were reading low CFM. After some investigative work, MSC technicians discovered and removed latex gloves stuck in the air valve, and the lab was back in business.

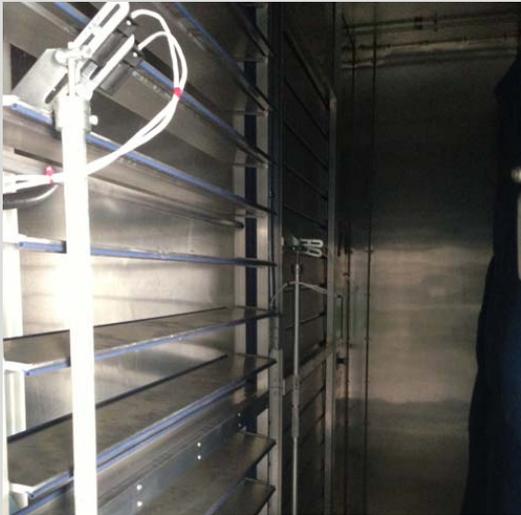
Damper positioning - Fresh air intake and economizer cycle functionality require proper actuator control and damper limit switch positioning. Above, several limit switches that had become loose required readjustment and testing to allow the supply and return fans to start and run properly.

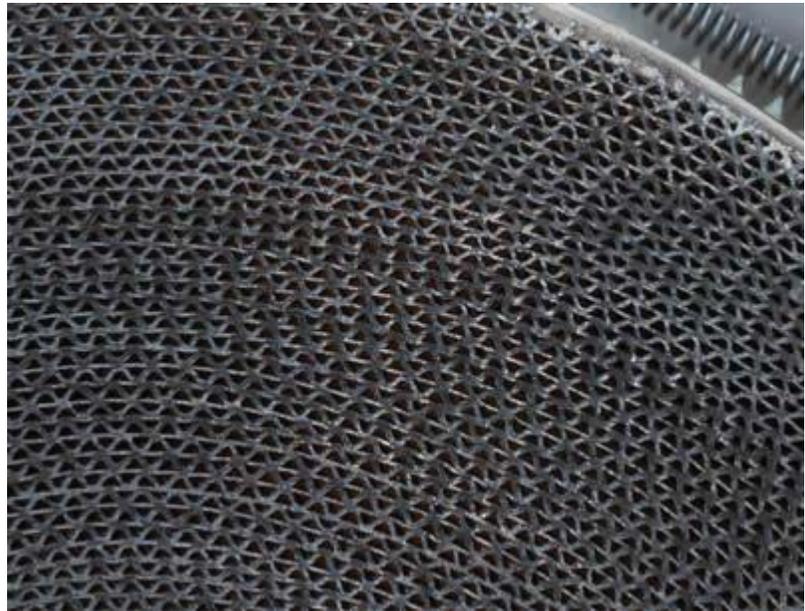
The fiber tower is served by an Innovent roof mounted constant volume desiccant dehumidification unit equipped with mechanical DX precooling and post cooling coils and natural gas fired heat. The unit (via an onboard controller) operates all functions to satisfy the desired space conditions. The desired space conditions are reported to be 70° dry bulb and a maximum permitted space relative humidity of 30% with the space in a positive pressure relative to surrounding spaces and to outdoors. No requirement for space humidification during winter months was reported.

The Fiber Tower is a four story room within a lab facility. The building construction is steel frame on a concrete slab with additional floors being poured concrete on corrugated decking. The two exterior walls in the fiber tower room are block walls with large glass window arrays. The two interior walls are conventional sheetrock walls that run from the floor to the bottom of the roof deck.

1. The unit was found upon arrival to be set (in the unit controller) to 72°F and 35% RH. This condition is in excess of the conditions noted to us.
2. A balance report was not available for the fiber tower and lathe room. Air flow readings were not taken during this assignment.

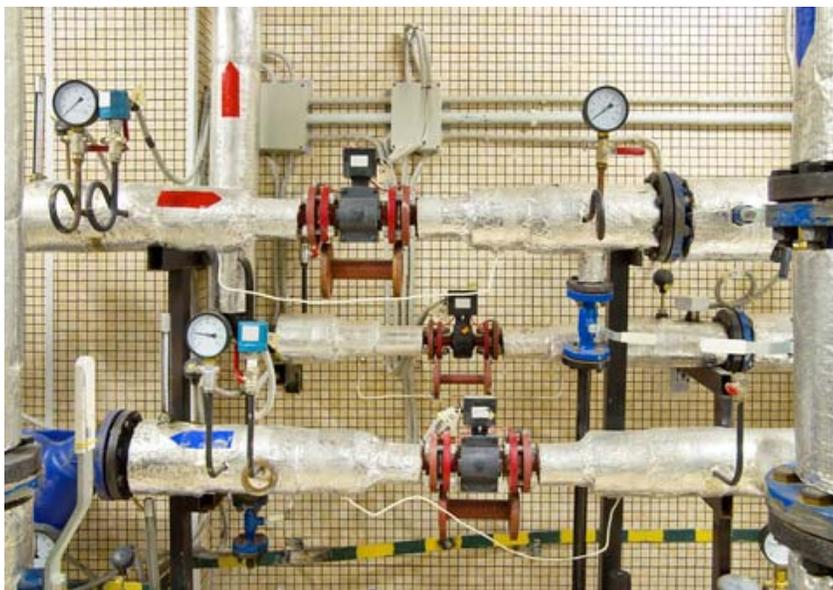
Water hammer is a troublesome but commonly-occurring issue that can plague a steam system. The most obvious symptom is the hammer-like noise it creates, but, when left unchecked, water hammer can cause serious damage to vents, traps, regulators, and piping. There are two types of water hammer. The most common type is usually due to an accumulation of condensate trapped in a portion of horizontal piping. Steam picks up the resulting water “slug” and hurls it into the nearest pipe fitting at high velocity. The second type is caused by a steam bubble forming or being pushed into a wet return line or pump discharge piping. When the bubble cools, it implodes with great force. Other main causes are improperly dripped mains and faulty steam traps. The causes of water hammer are often difficult to identify, so it is oftentimes tolerated, considered to be more of a nuisance than a problem. But when left unchecked, water hammer can result in costly repairs.

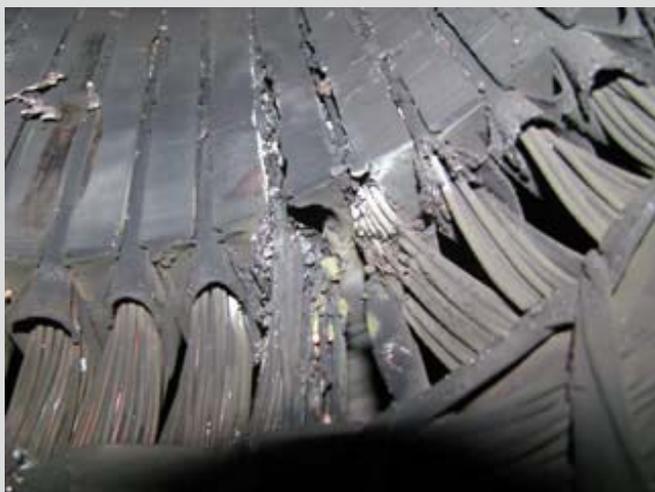
Six common causes of motor failure are 1) over-current, 2) low resistance, 3) overheating, 4) dirt, 5) moisture, 6) vibration. Photo: a 75 hp motor's stator winding that failed due to overheating.

Motor failure, which usually occurs at startup, always seems to happen at the most inopportune time. To prevent motor failure, ensure that voltage is neither too low nor too high, and that the motor is running within acceptable amperage according to the nameplate rating. Check for vibration, especially on larger motors of 20 hp and up. When motor failure does occur, it is imperative to determine exactly what caused it to fail. If the underlying issue is not corrected, the replacement motor is likely to fail as well.
