## Why NEBB Certification Matters for Complex HVAC & Process Cooling

# CASE STUDY: MSC Solves Refrigerant Piping and Compressor Problems in 7-Story Corporate Building

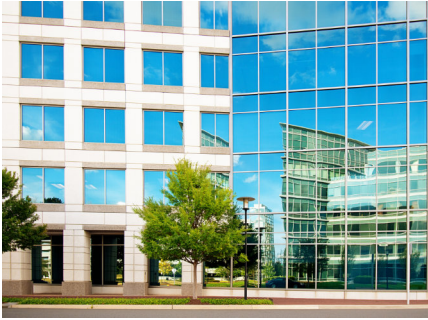
MSC was called to investigate a malfunctioning HVAC system in a 7-story corporate headquarters building. The system consisted of a 100-ton roof-mounted condensing unit and an air handler located six floors below. Refrigerant piping design came into question when both scroll compressors failed due to high head pressure and high full load amperage (FLA) readings, causing the unit to trip on the overloads. System inoperability had forced the use of temporary cooling units to condition the space.

System lacks intentional traps, instead utilizing “running” traps due to elevation changes

Non-uniform pitch in liquid and suction lines

Numerous direction changes contributing to pressure drop

Potential for cross-connection in areas where pipes double back and cross over themselves

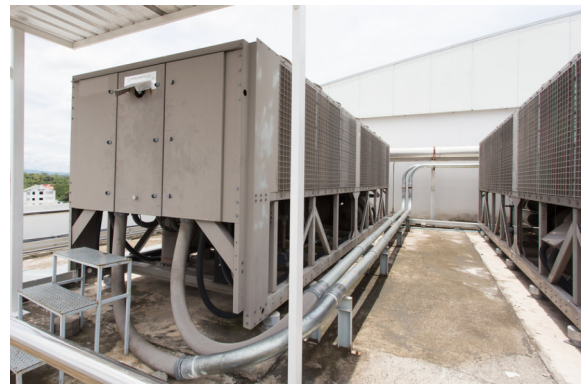
- Two interlaced, dual-coils with independent TXVs
- Improper mounting angle of TXV sensing bulbs
- Absence of liquid line solenoids and sight glasses

- Both compressors, one variable speed and one standard, were non-operational
- Varying oil levels in compressors (one  $\frac{3}{4}$  full, one  $\frac{1}{4}$  full with dark oil)
- Unknown control parameters for the variable speed compressor

- Absence of critical components like liquid line solenoids, sight glasses, and suction accumulators
- Unusual coil circuiting arrangement
- Lack of clear labeling on components
