TECH TALK

MSC - THE ONLY TRUE HVAC SERVICE COMPANY - WE FIX IT

NEWSLETTER - OCTOBER 2017

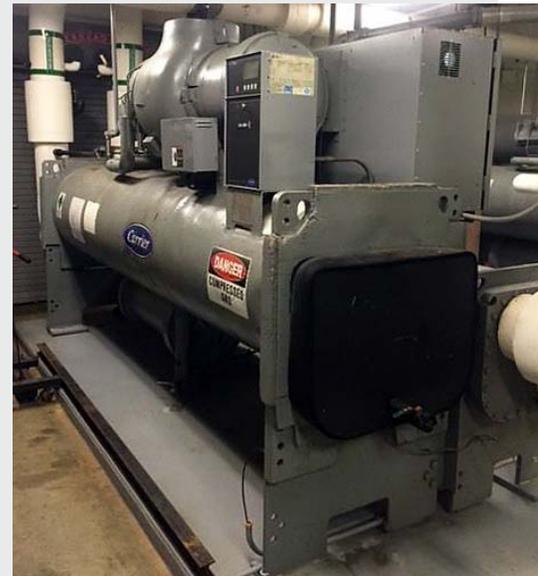
CAVITATION & AERATION in a Chilled Water Pump System

A new hospital mechanical room was undergoing balancing recently when a distinct whining noise in a chilled water system pump was noted. The balancing contractor suspected a condition known as aeration and notified MSC, who was on the job performing commissioning. As it turned out, the balancer had made a common error. The actual problem was cavitation, a phenomenon that can cause pitting and erosion of the impeller, pump housing failure, excessive vibration, decreased flow, and energy inefficiency.

In the case of the chilled water pump at the new hospital, an MSC technician suspected cavitation, rather than aeration, after listening to the chilled water pump's steady whine, and promptly traced the problem to a plugged strainer. It turned out that, instead of using a chilled water strainer, the contractor had mistakenly installed a steam strainer that had quickly become clogged with accumulated debris. MSC replaced the strainer and the pump was soon up and running normally.
